# MnDOT RICWS Safety

Prepared for  
Minnesota Department of Transportation

June 29, 2015

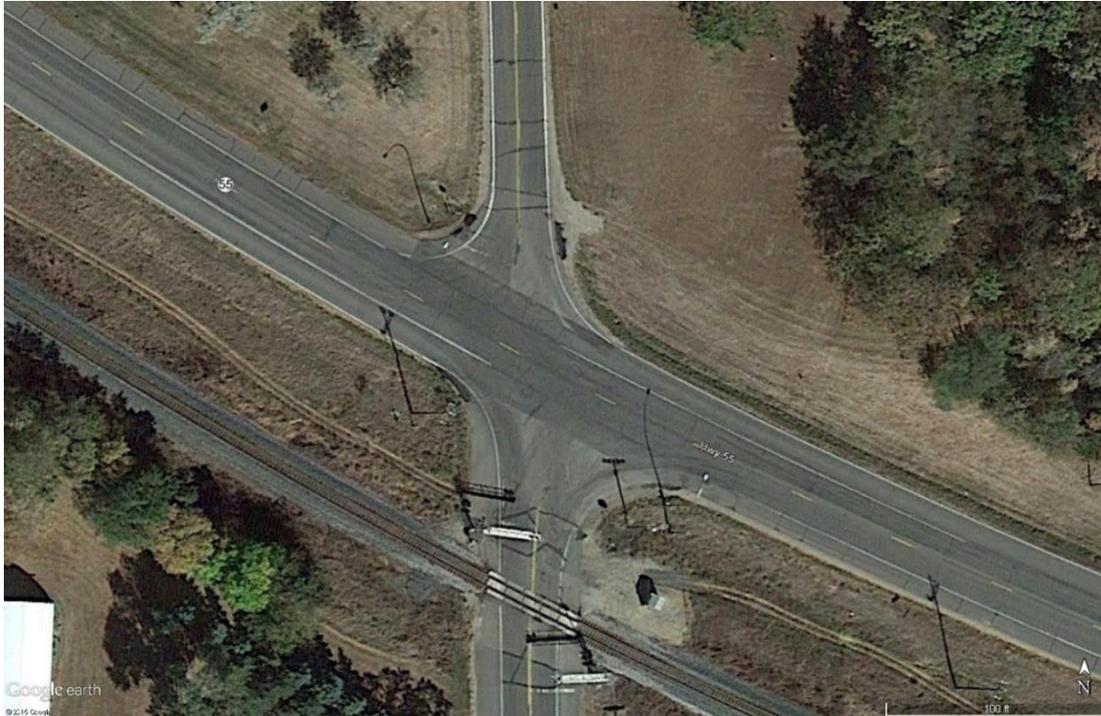
Figure 2-1: TH 55 and Wright CSAH 3

One site selected for installation was the intersection of Trunk Highway (TH) 55 and Wright County State Aid Highway (CSAH) 3, west of Annandale (Figure 2-1).

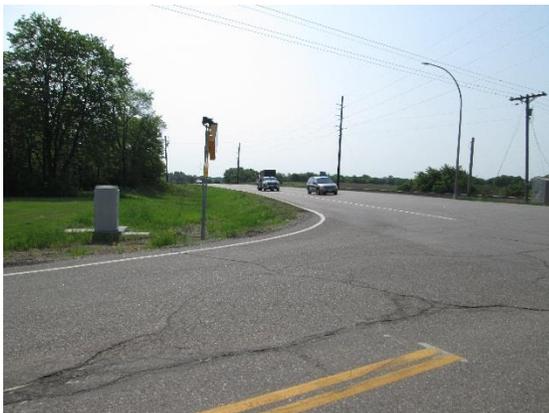
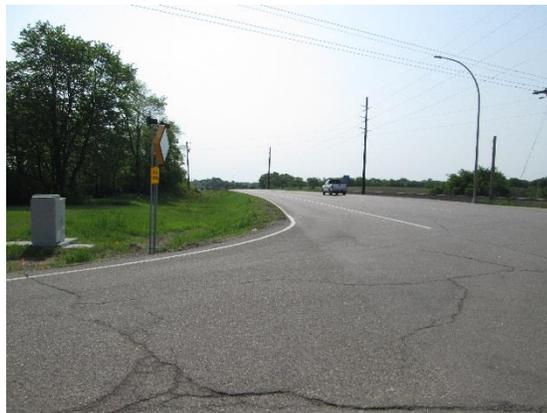
*Sight Line from STOP Sign*

*Sight Line from Advanced Stopped Location*

**Figure 3-1: Intersection Sight Lines for Southbound CSAH 3 Looking East**

- The intersection sight distance (ISD) on the northbound and southbound approaches was observed to be at least 10 seconds in all directions.
- However, the combination of skew and mainline horizontal curvature could impair sight lines in vehicles (passengers and vehicle pillars) and utility poles, back slopes, and trees. Sight lines could be obstructed if drivers on the minor road stopped their vehicles at the wrong spot. Unobstructed sight lines are available/improved at points further into the intersection illustrated in Figure 3-1.

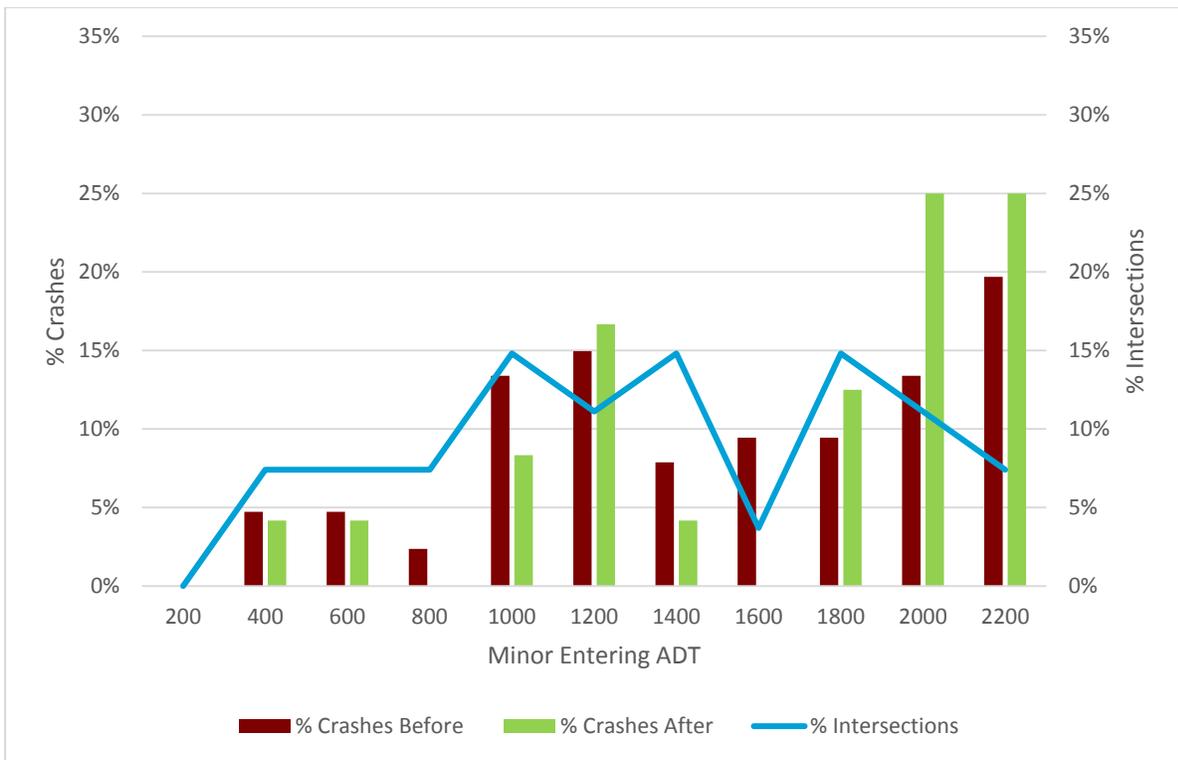
Figure C.2 [RICWS Locations]

Crashes in the “Before” condition were generally uniformly distributed across the range of minor entering daily traffic but with the majority of crashes occurring at the sites with volumes greater than or equal to 1,000 vehicles per day. In the “After” condition crashes decreased at the RICWS sites with less than 1,200 vehicles per day and increased at the sites with volumes greater than 1,200 vehicles per day.
