Performance of Thin Bituminous Treatments for Low-Volume Roads

Greg Johnson

Minnesota Department of Transportation

June 25, 2003

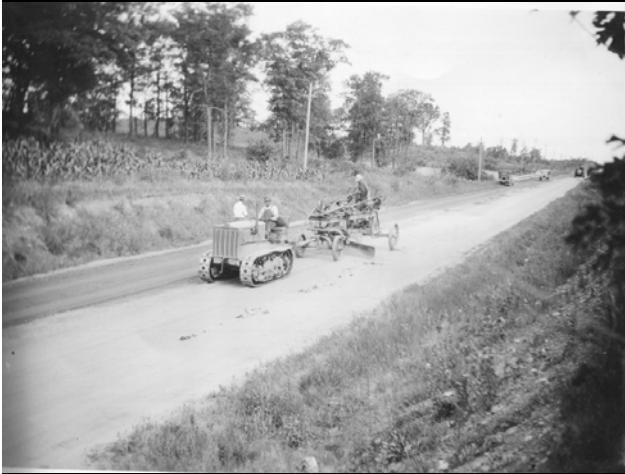
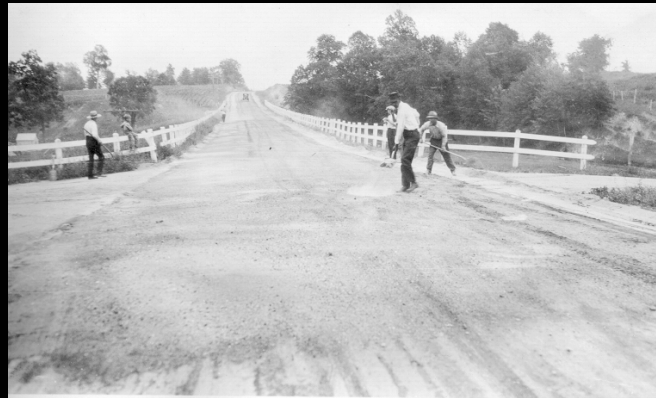
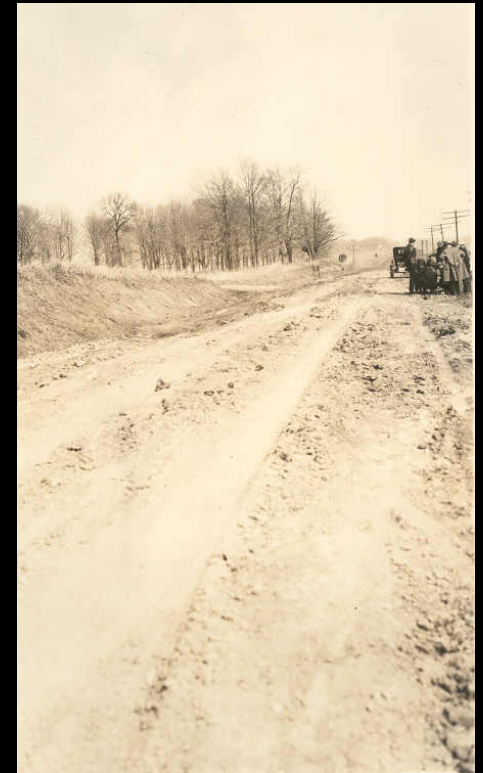
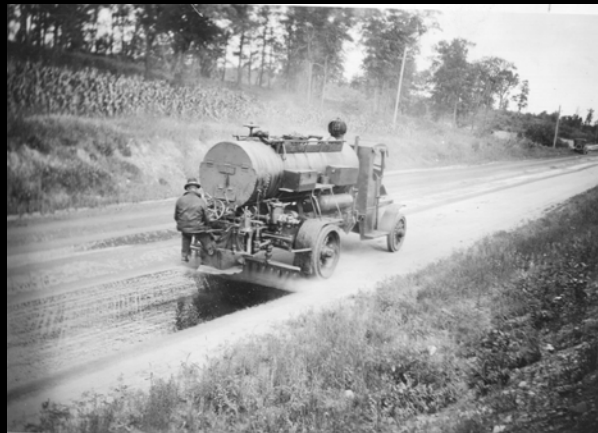
Minnesota Historical Road Oil Treatments

1925-1929

TH18 (169)
Elk River, MN

TH10 (12)
Waverly, MN

TH10 (12)
Waverly, MN
Frost Blowup

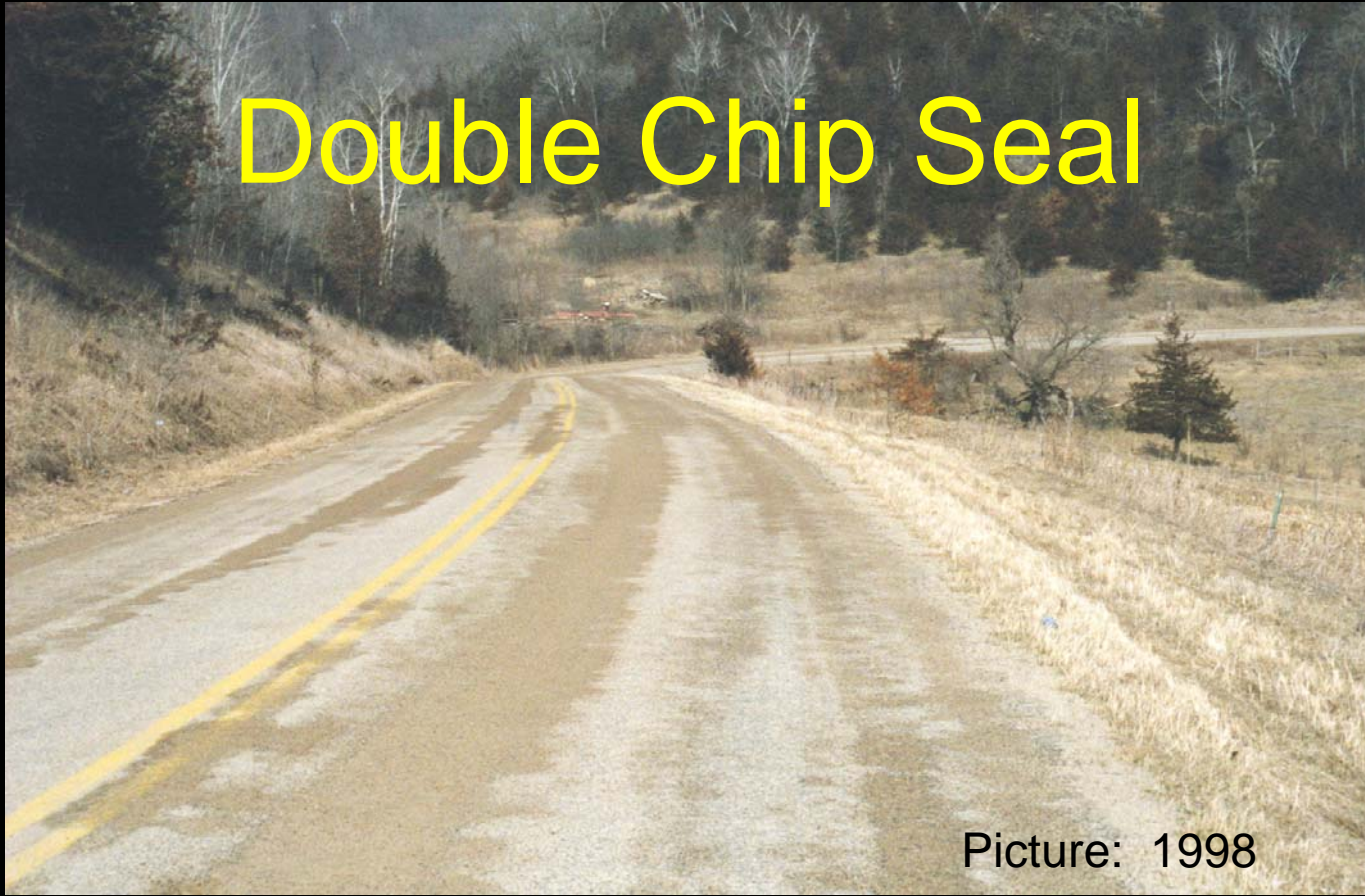
Double Chip Seal

Picture: 1998

8 in.
(203 mm)
Aggregate
Base

Silty
Clay
Subgrade

1st Layer = 0.45 gal./yd² (2.0 L/m²)
2nd Layer = 0.40 gal./yd² (1.8 L/m²)

½ inch limestone (Single Size)

1st Layer = 45 lb/yd² (24 kg/m²)
2nd Layer = 35 lb/yd² (19 kg/m²)

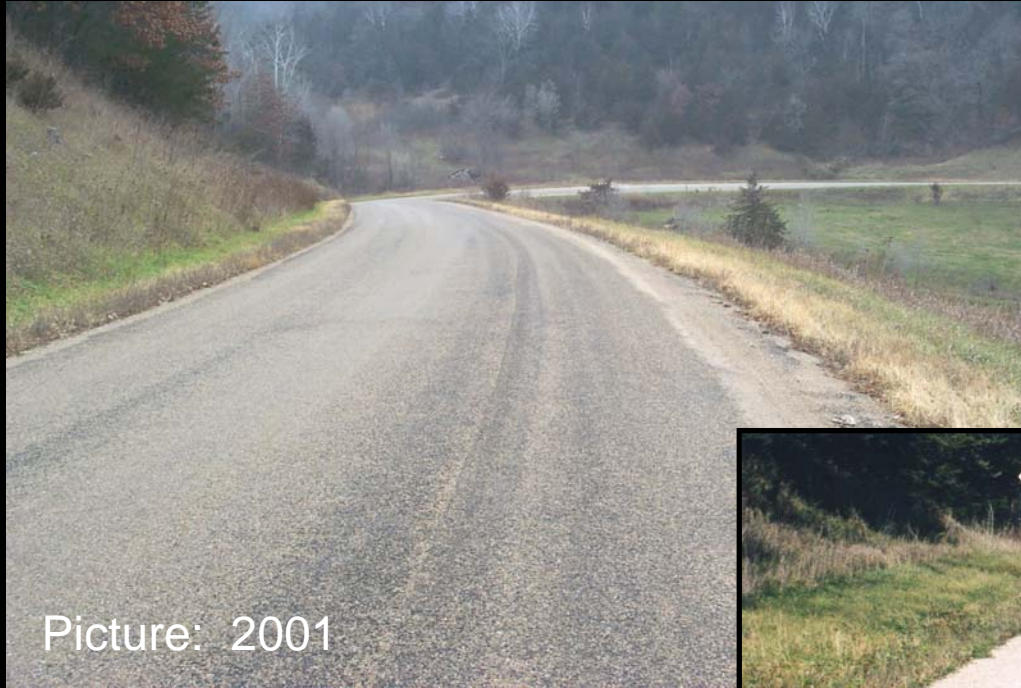
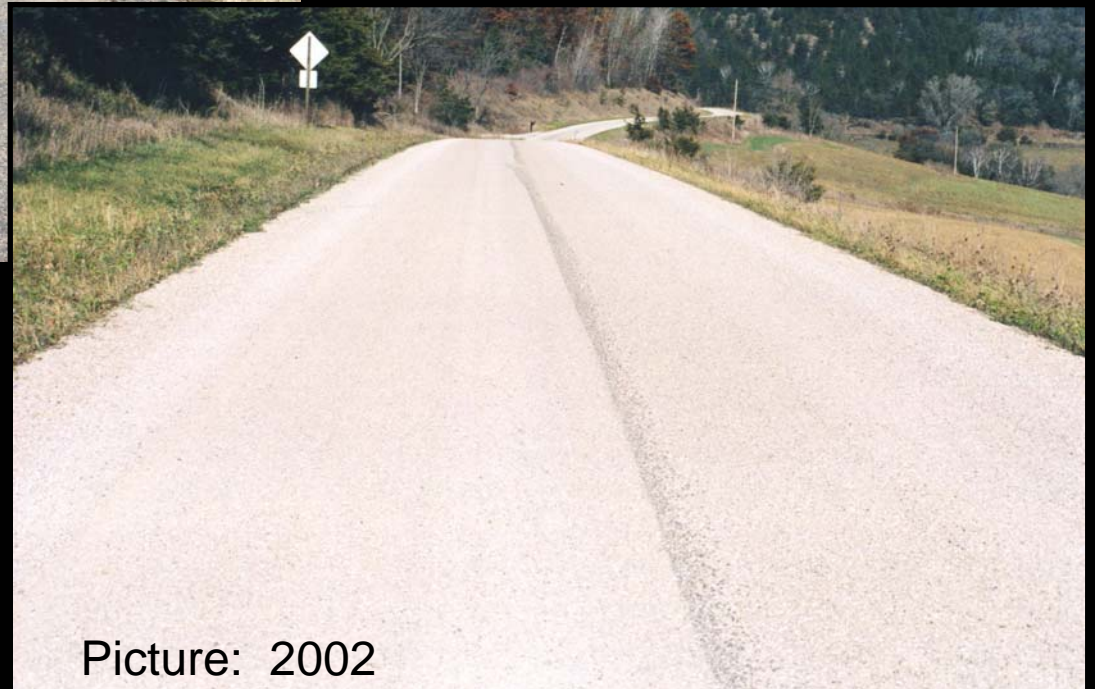
Chip Seal Performance

Constructed: 1996

Maintenance Reseal
2000 & 2002

- Occasional Thermal Cracks
- No rutting

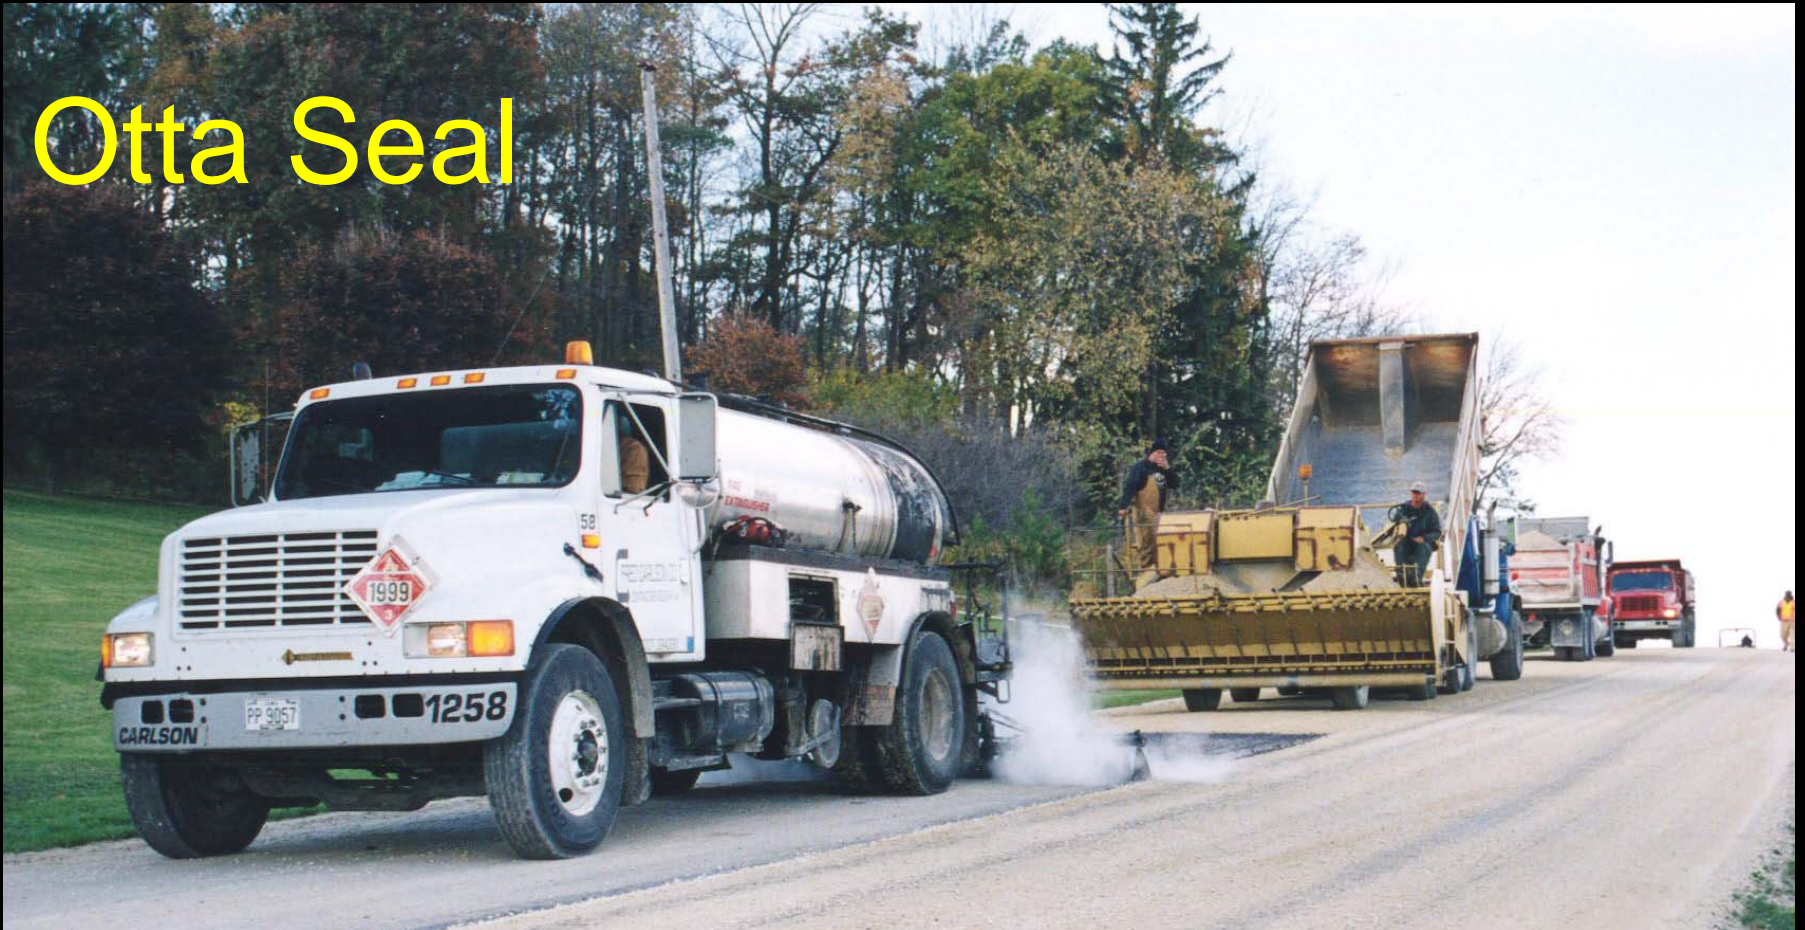
Otta Seal

Asphalt Emulsion

High Float Medium Set (HFMS-2s)

1st Layer = 0.5 gal./yd² (2.2 L/m²)

2nd Layer = 0.5 gal./yd² (2.2 L/m²)

Aggregate

MnDOT Class 5

1st Layer = 50 lb/yd² (27 kg/m²)

2nd Layer = 50 lb/yd² (27 kg/m²)

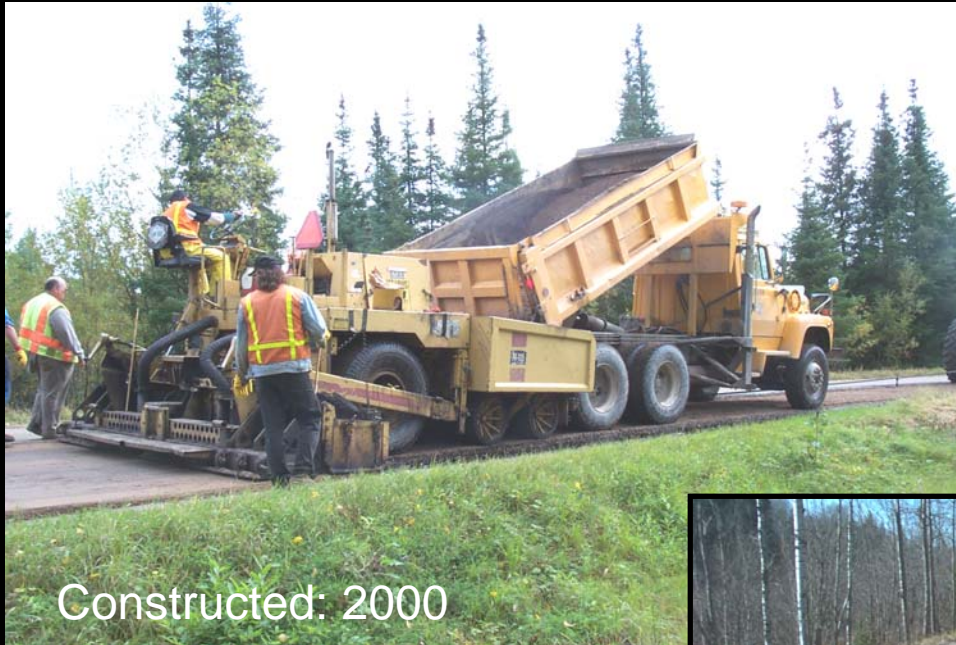
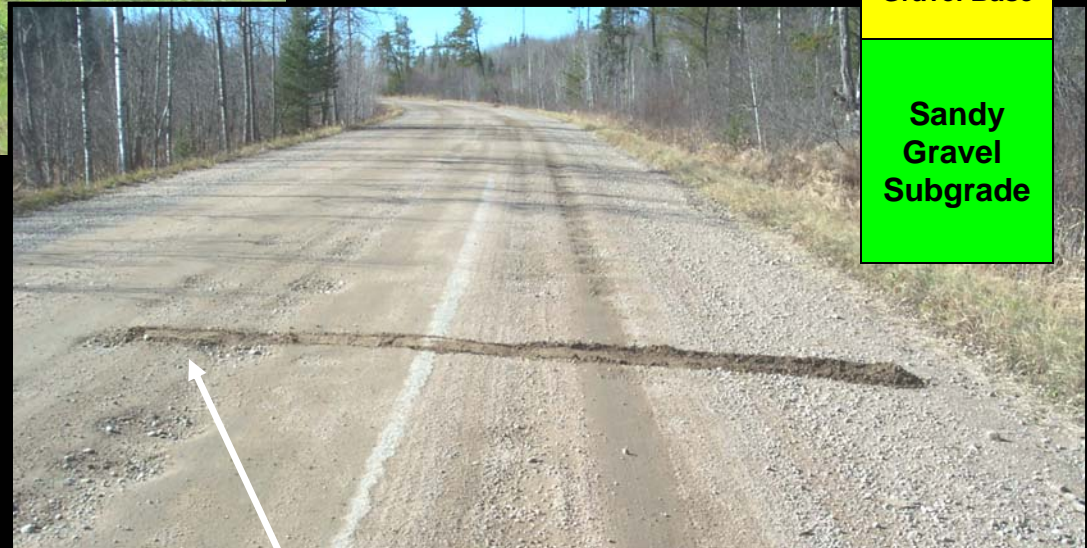
Otta Seal - St. Louis County

Constructed: 2000

Applied aggregate with a paver over the emulsion

Result:
Non-uniform aggregate application led to potholes and loose aggregate on surface

Up to 2 inches (51 mm) of aggregate over emulsion

1. Use of a chip spreader for accurate aggregate application rate
2. No driving on the emulsion before aggregate is applied

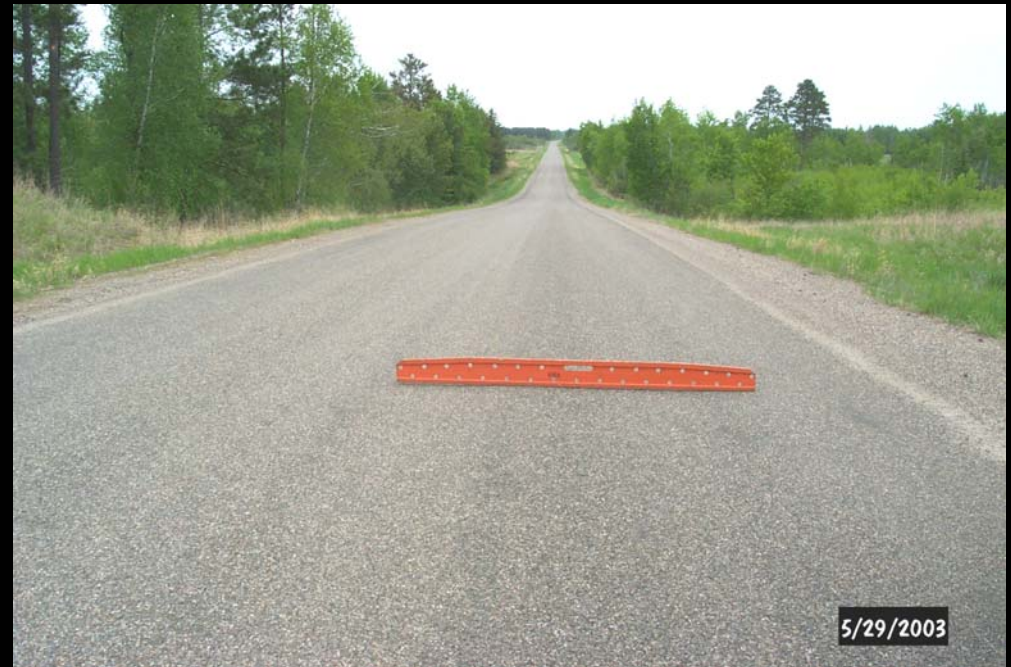
Otta Seal - Cass County

Constructed: 2001

- Good performance overall
- Bleeding issue in area with high agricultural traffic

4 in. (100 mm)
Gravel Base

Silty
Sand
Subgrade

145 vehicles per day

- Chip seal applied in 2002
- No raveling or rutting
- 100 to 425 feet (30 to 130 m) between thermal cracks

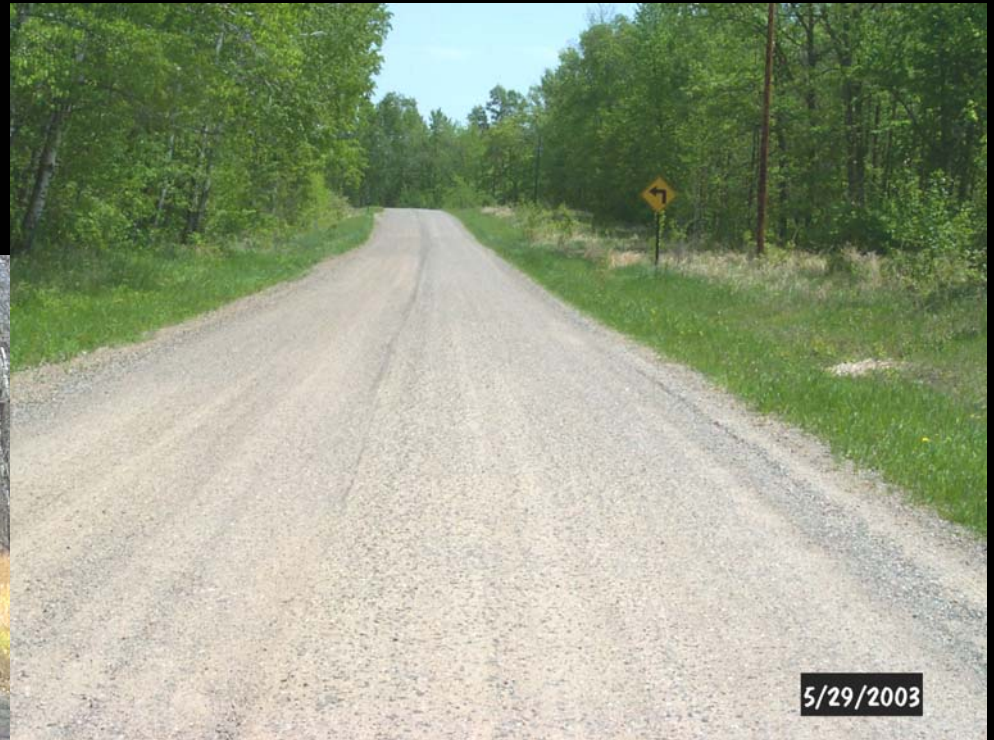
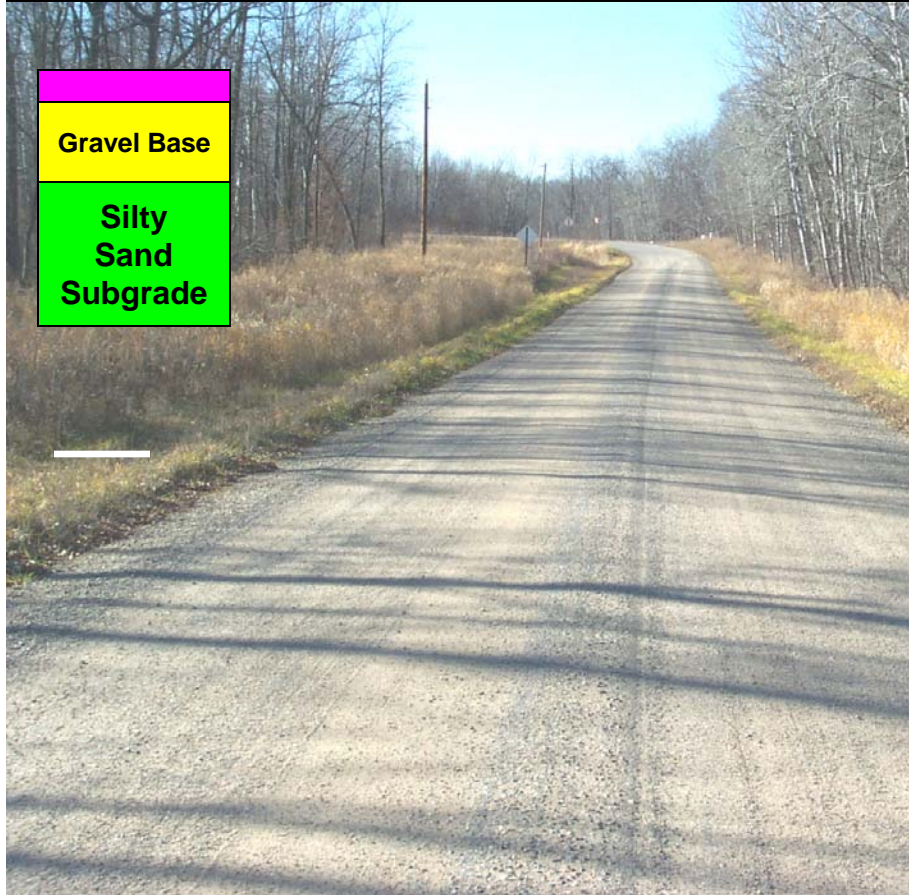
Otta Seal Cass County Township Road

- Sandy loose aggregate on surface
- No thermal cracks or rutting

60 vehicles per day

Constructed: 2001

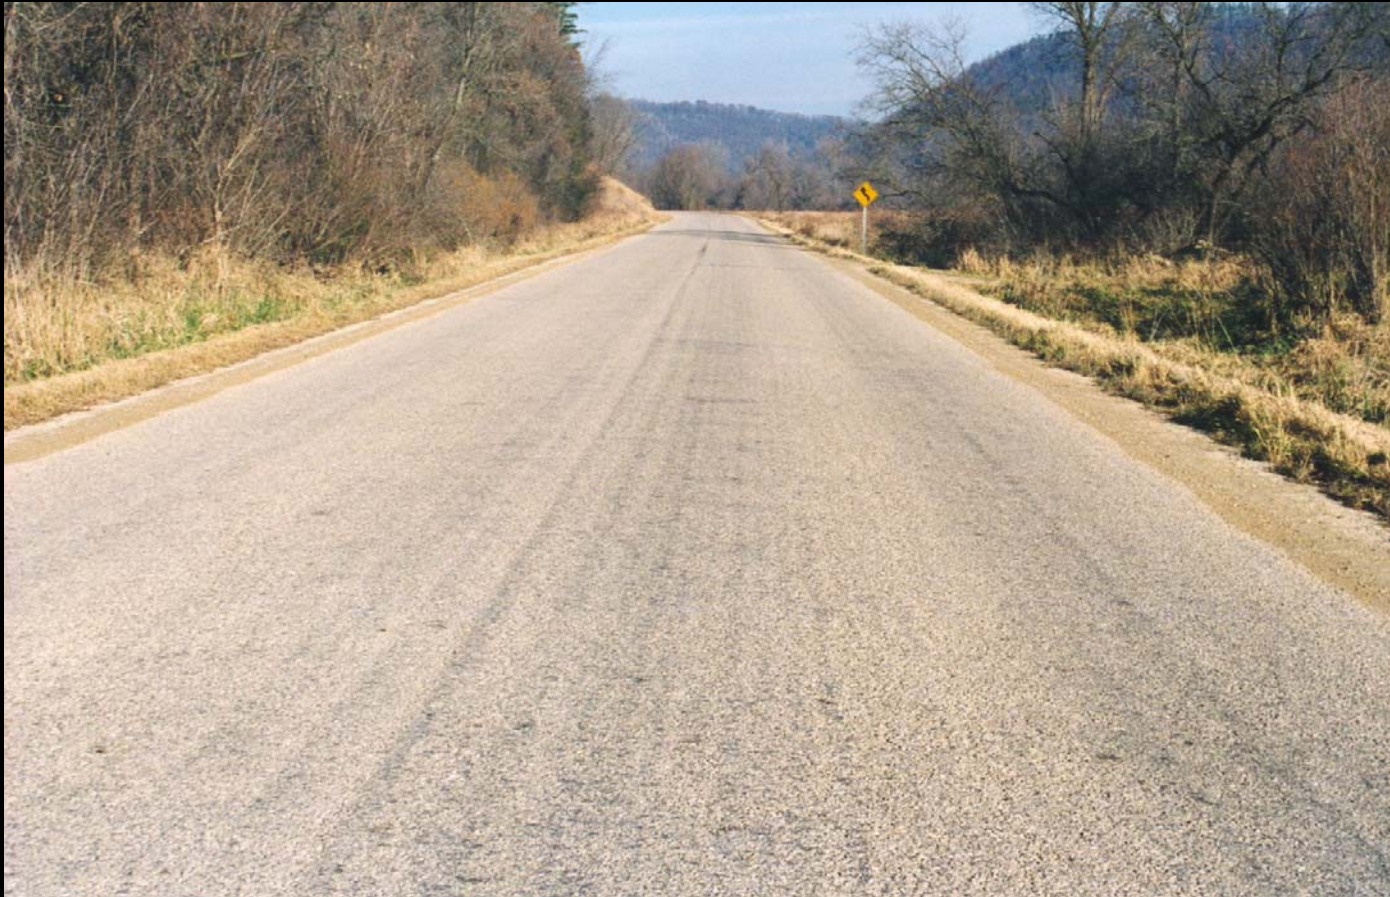
Otta Seal - MN74

6 in.
(152 mm)
Gravel Base

Loamy
Sand
Subgrade

No thermal cracks, dust, or loose aggregate

Constructed: 2001

Picture: Fall 2002

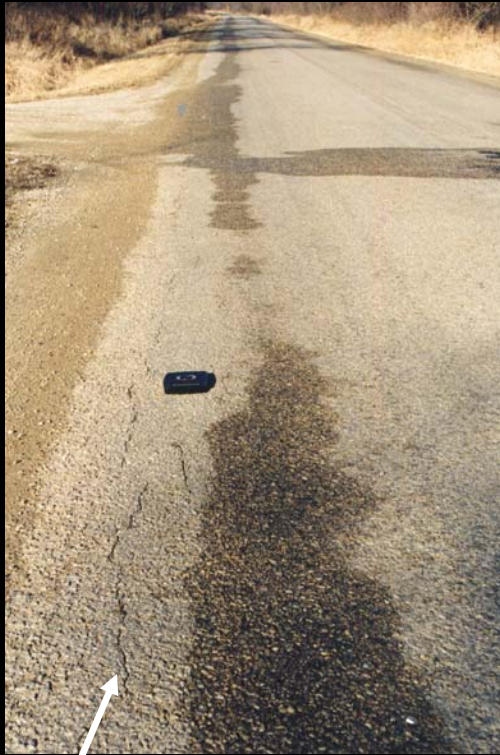
Cracks along shoulder

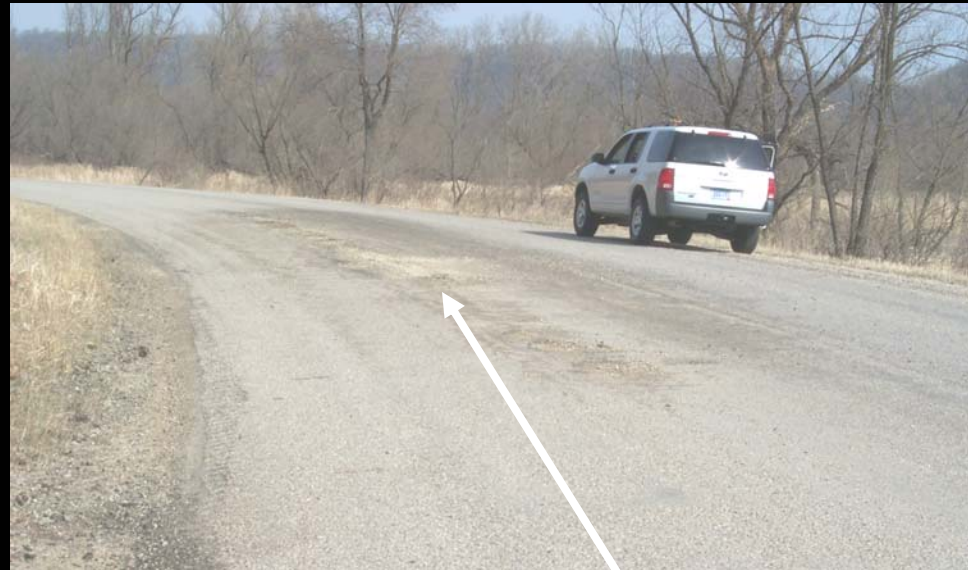
Frost Boil

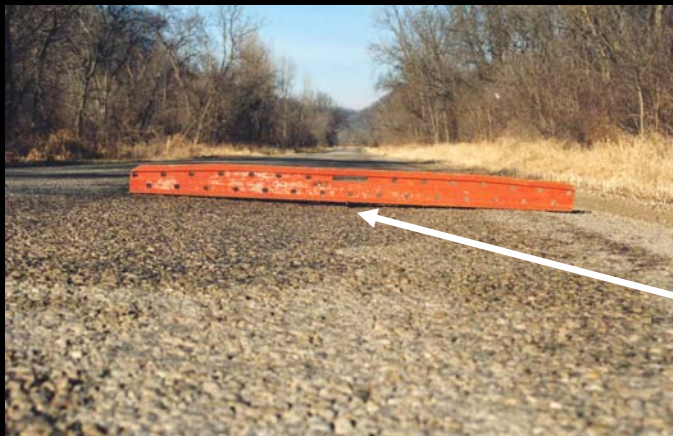
$\frac{3}{4}$ inch (19 mm) rut in "outer wheel path"

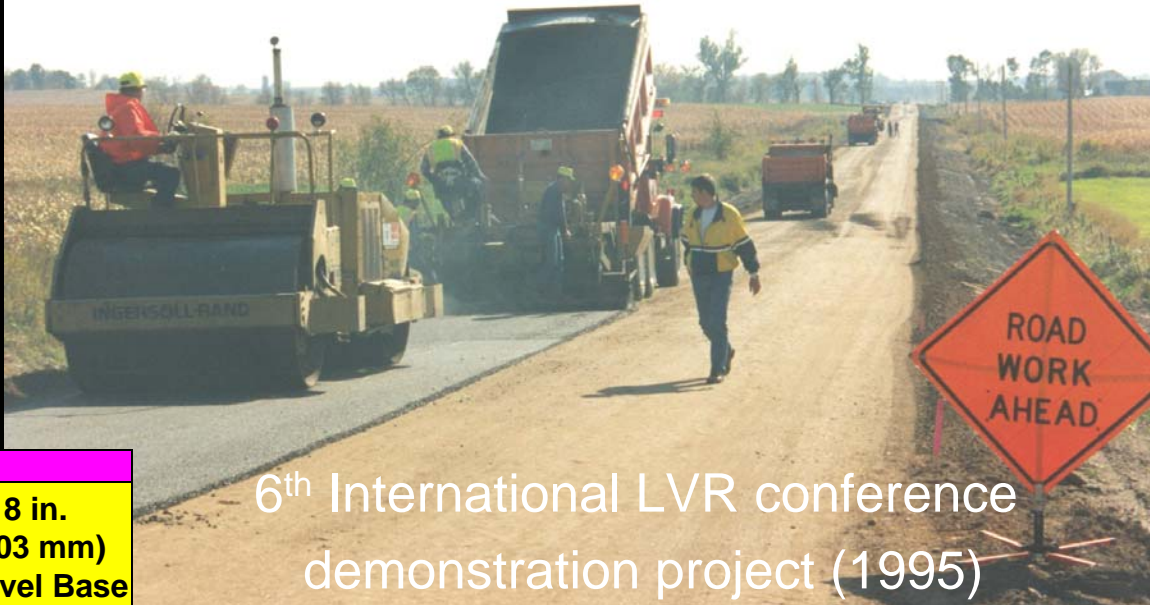
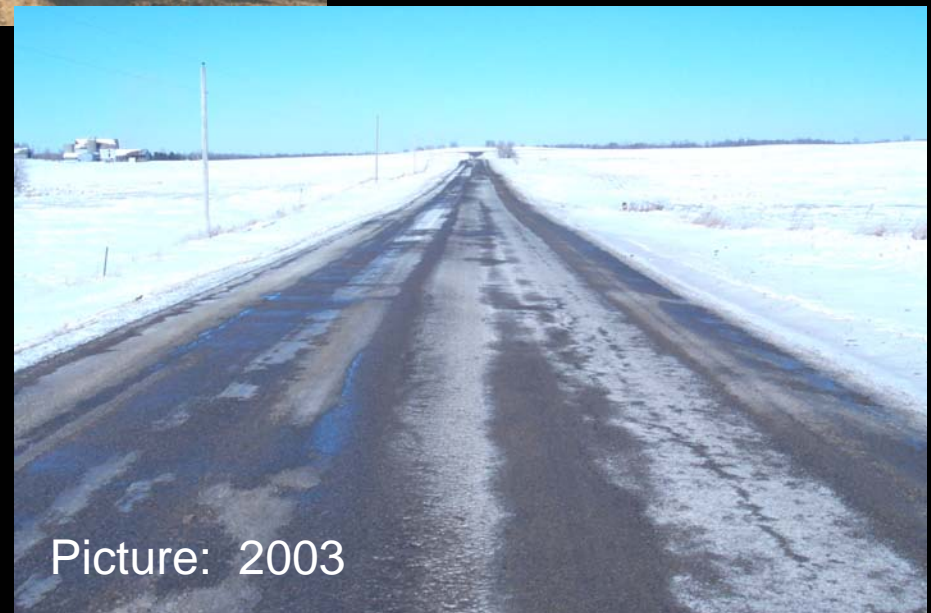
Oil Gravel - City of Ostego

6th International LVR conference
demonstration project (1995)

- Distressed areas repaired.
- Inadequate base strength

8 in.
(203 mm)
Gravel Base

Silty
Clay
Subgrade

- No rutting
- 3 major thermal cracks
- Oxidized surface

Picture: 2003

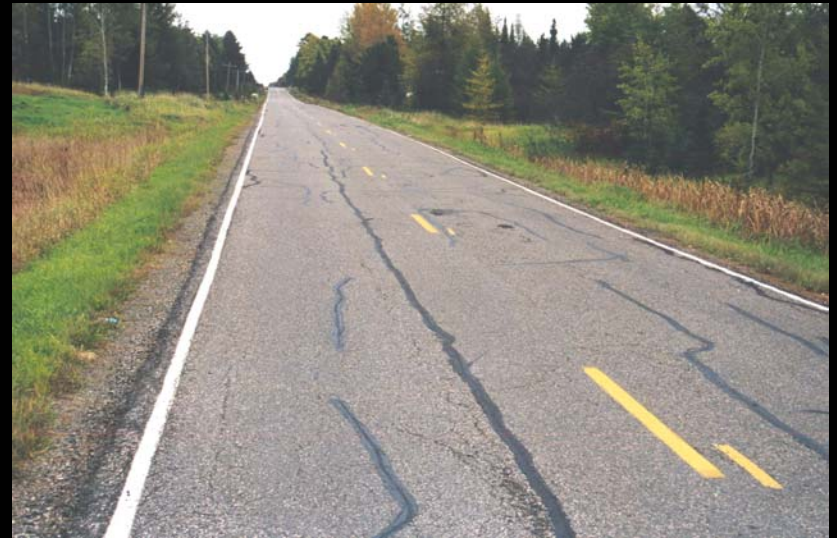
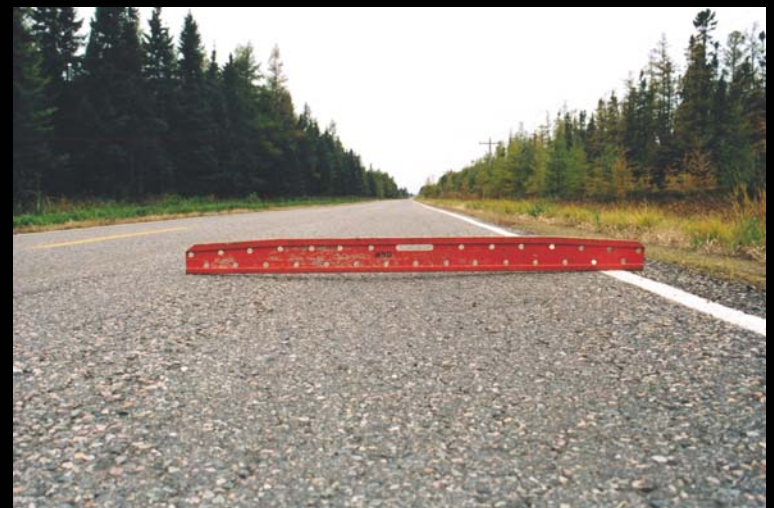
Oil Gravel - St. Louis Co. Rd. 68

Constructed: 1996

Pictures: Fall 2002

- Ruts

1 to 1.5 inch (25 to 38 mm)

- Thermal cracks

3 foot (0.9 m) spacing

12 in. (305 mm) Reclaimed HMA & Aggregate Base
3 ft (0.9 m) Granular Fill
Peat

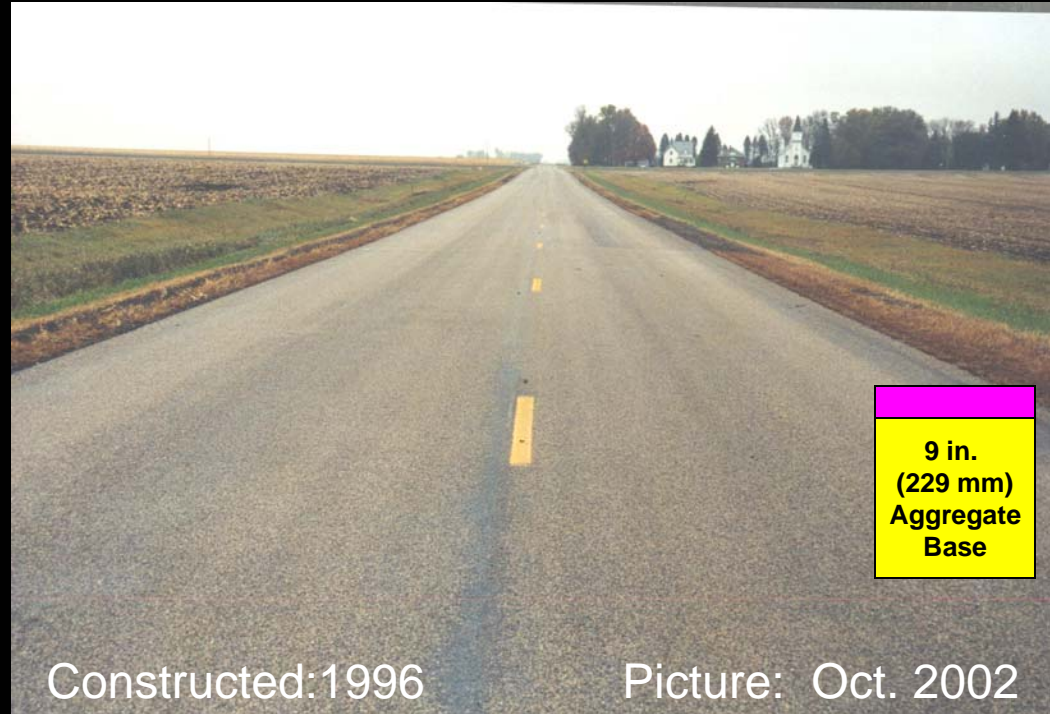
Oil Gravel - Blue Earth County

- Thermal Cracking
70 to 200 ft
(21 to 61 m)

- 1/8 in. (3 mm) rutting

- No performance difference between
100% quartzite and 50/50 gravel blend
- Segregation problems at time of construction
- Seal coat applied one year later
