MnROAD / NCAT Pavement Preservation Visual Survey Record

MnROAD Low Volume Road cells 55 - 58 Open Graded Friction Course

MnROAD Low Volume Road cells 55 - 58 OGFC Performance

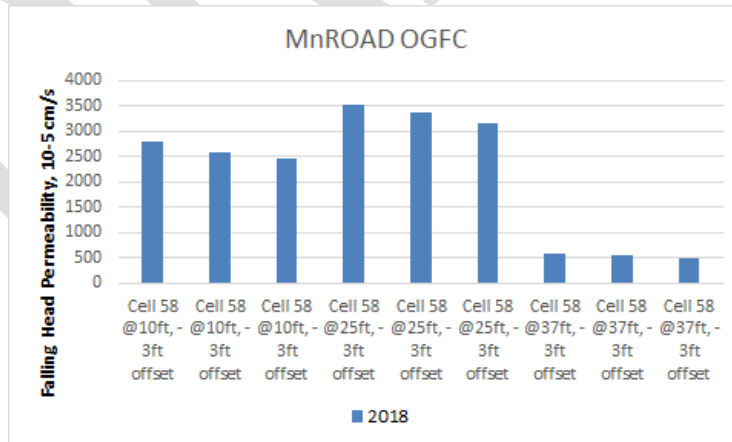
Cell 58: Partially covered with slurry after 2017 construction activities. Outside Lane currently 5% (30 sf) covered. Inside Lane currently 20% (120 sf) covered, and permeability varies with the coverage severity.

Figure 2 Falling Head Permeability of various locations on Cell 58, Inside Lane, Left Wheel Path.

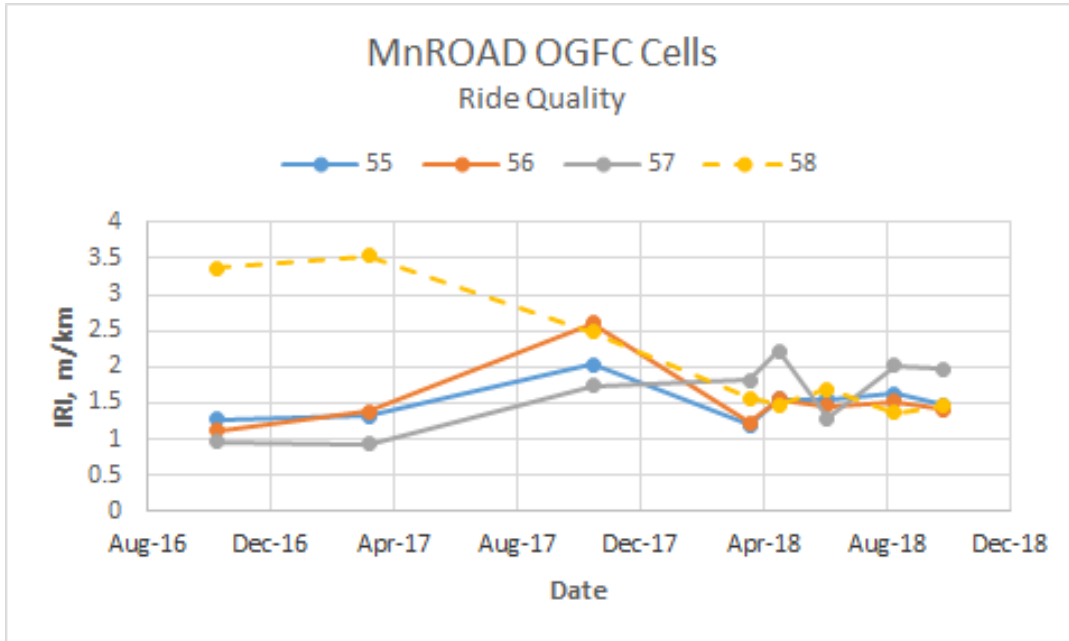
Note the decline in roughness of Cell 58 that occurred in late 2017 (Figure 3). Continued monitoring is planned.

Figure 3 OGFC: Ride Quality of Trafficked (Inside) Lane.

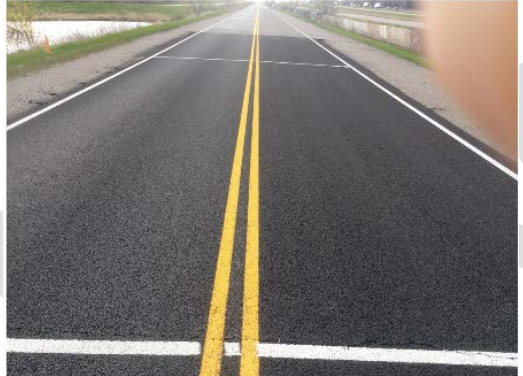
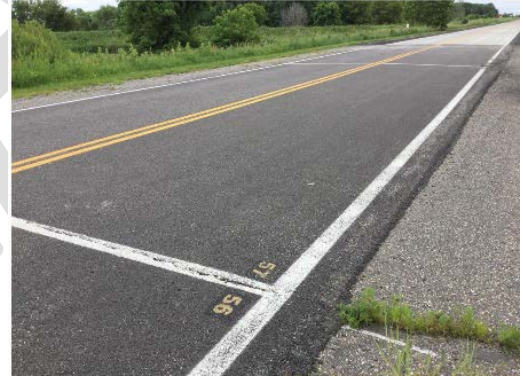
CELL	April 2017	July 2018
55	 	 
56	 	 
57

Figure 5 Photos of MnROAD OGFC Cells: Viewed Eastbound.
