# Pavement Preservation Treatments: Background

# Minnesota's Pavement Preservation Treatments: Delta-S Modification

In 2016 a total of 60 pavement preservation test sections (31 low traffic volume and 29 high volume) were installed in Mille Lacs County, Minnesota as part of a MnDOT/NCAT research partnership. Thinlay sections were constructed in August 2016. Section lengths were 0.1 mile and the depth of mill and overlay treatment was 0.75 in.

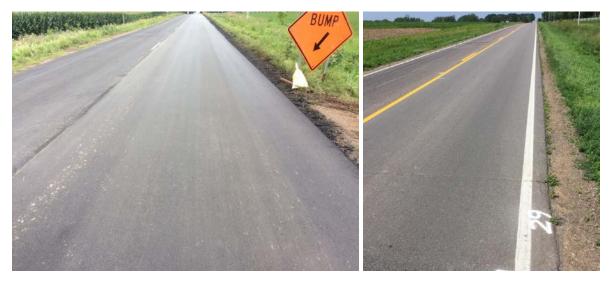
Date	IRI in/mi	Locked Wheel Friction FN <sub>40</sub>	Fatigue	Raveling	# Transverse Cracks	Reflected Cracks
2016, Untreated	119.6	Not measured, Control Cell 8030 = 51.0 at time of 2016 treatments	NA	NA	NA	NA
2016, Treated	41.2	51.3	0	0	0	0%
April-May 2017, Treated	43.5	55.8	0	0	7	90%
September 2017, Treated	44.6	54.7	0	0	7	90%
May 2018, Treated	56.9	55.8	0	0	8	100%
May 2019, Treated	77.1	57.2	0	0	9	100%
Mill and Delta-S Thinlay on US Highway - High Volume Cell 169022						
	Mill a	nd Delta-S Thinlay on US Highway - High Vo	olume	Cell 16	<u>59022</u>	
Date	Mill a	nd Delta-S Thinlay on US Highway - High Vo Locked Wheel Friction FN40			# Transverse Cracks	Reflected Crack
Date 2016, Untreated						Reflected Crack
	IRI in/mi	Locked Wheel Friction FN <sub>40</sub>	Fatigue	Raveling	# Transverse Cracks	
2016, Untreated	<b>IRI in/mi</b> 81.1	Locked Wheel Friction FN <sub>40</sub> 46.7	Fatigue NA	Raveling NA	#Transverse Cracks NA	NA

Cell 8029: As constructed in 2016 (left) and inspected 7-15-19 (right).

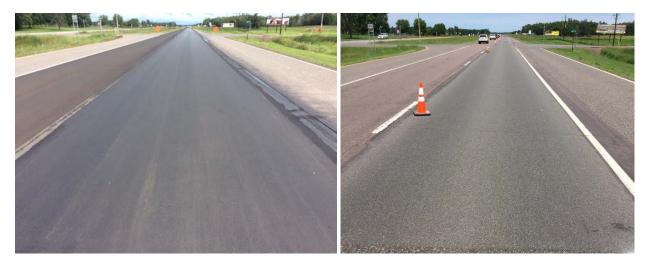
2016, Untreated 2016, Treated	<b>IRI in/mi</b> 81.1 44.0	Locked Wheel Friction FN <sub>40</sub> 46.7 48.5	Fatigue NA 0	Raveling NA 0	#Transverse Cracks NA 0	NA 0%

Cell 169022: As constructed in 2016 (left) and inspected 7-16-19 (right).

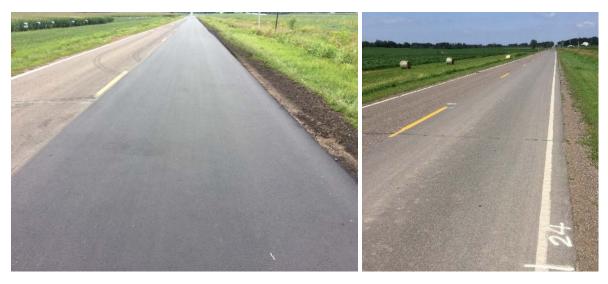
Mill and Thinlay on County Road - Low Volume Cell 8024							
Date	IRI in/mi	Locked Wheel Friction FN <sub>40</sub>	Fatigue	Raveling	# Transverse Cracks	Reflected Cracks	
2016, Untreated	88.0	47.8	NA	NA	NA	NA	
2016, Treated	33.5	55.5	0	0	0	0%	
April-May 2017, Treated	36.2	54.4	0	0	7	100%	
September 2017, Treated	37.4	52.0	0	0	8	100%	
May 2018, Treated	42.7	54.4	0	0	8	100%	
May 2019, Treated	48.6	53.2	0	0	8	100%	
Mill and Thinlay on US Highway - High Volume Cell 169026							
Date	IRI in/mi	Locked Wheel Friction FN <sub>40</sub>	Fatigue	Raveling	# Transverse Cracks	<b>Reflected Cracks</b>	
2016, Untreated	81.1	46.7	NA	NA	NA	NA	
2016, Treated	44.0	48.5	0	0	0	0%	
July 2017, Treated	41.0	51.1	0	0	14	83%	
May 2018, Treated	75.2	53.7	0	0	14	90%	
May 2019, Treated	74.2	55.3	0	0	26	57%*	
(*) 2019 Decrease in Thinlay Reflected Cracks (driving lane) was not due to patching or healing. Reduction resulted after additional working transverse cracks were identified in the Passing Lane (PL micro surfacing placed 2016).

Cell 8024 as constructed in 2016 (left) and inspected 7-15-19 (right).

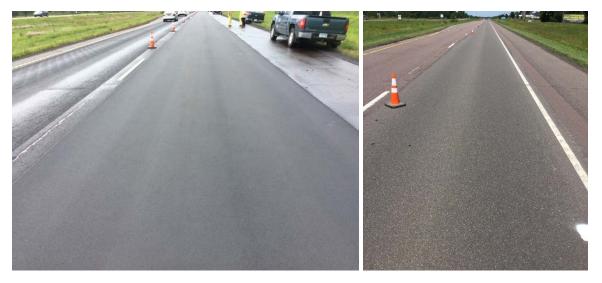
Cell 169026 as constructed in 2016 and inspected 7-16-19 (right).
