Missouri University of Science and Technology  
*Civil, Architectural and Environmental Engineering Department*

**Compacted Concrete Pavement  
Activity Report**

Progress Report

January 2020

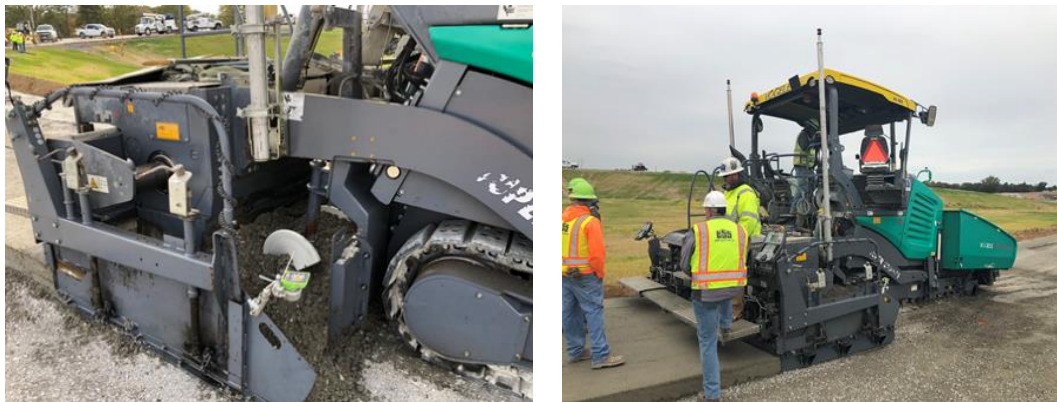
Figure 2 - Paving process

The paving of the test strip was initiated at 1 pm on October 24<sup>th</sup>, 2018 in Scott County, Missouri. Figure 1 shows the location of the project. Figures 2 and 3 shows the paving process implemented

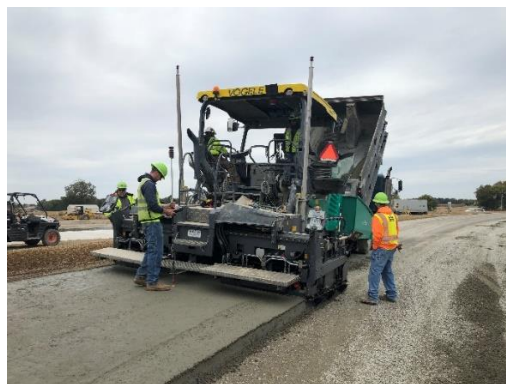
Figure 3 - Surface adjustments

using a concrete slip-form paving equipment. As indicated in Figure 3 the surface alignment was tested constantly, and the paver was adjusted accordingly.

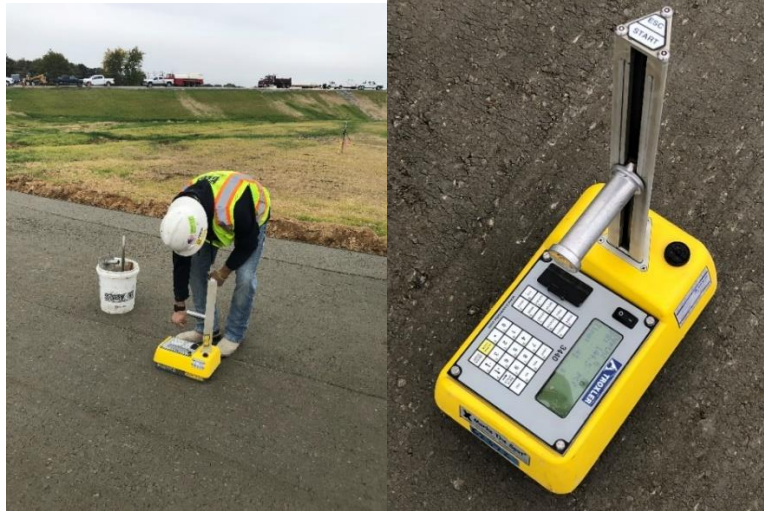
Figure 4 - Density measurement

The density test was conducted with a non-destructive method Nuclear Density Meter Ground Test Equipment at both sides of the pavement. Nuclear density gauge measures in-place density using gamma radiation. Gamma rays are emitted from the source and interact with electrons in the pavement through absorption, Compton scattering, and the photoelectric effect. A Geiger-Mueller detector (situated in the gauge opposite from the handle) counts gamma rays that reach it from the source. Pavement density is then correlated to the number of gamma rays received by the detector (<http://www.troxlerlabs.com>).

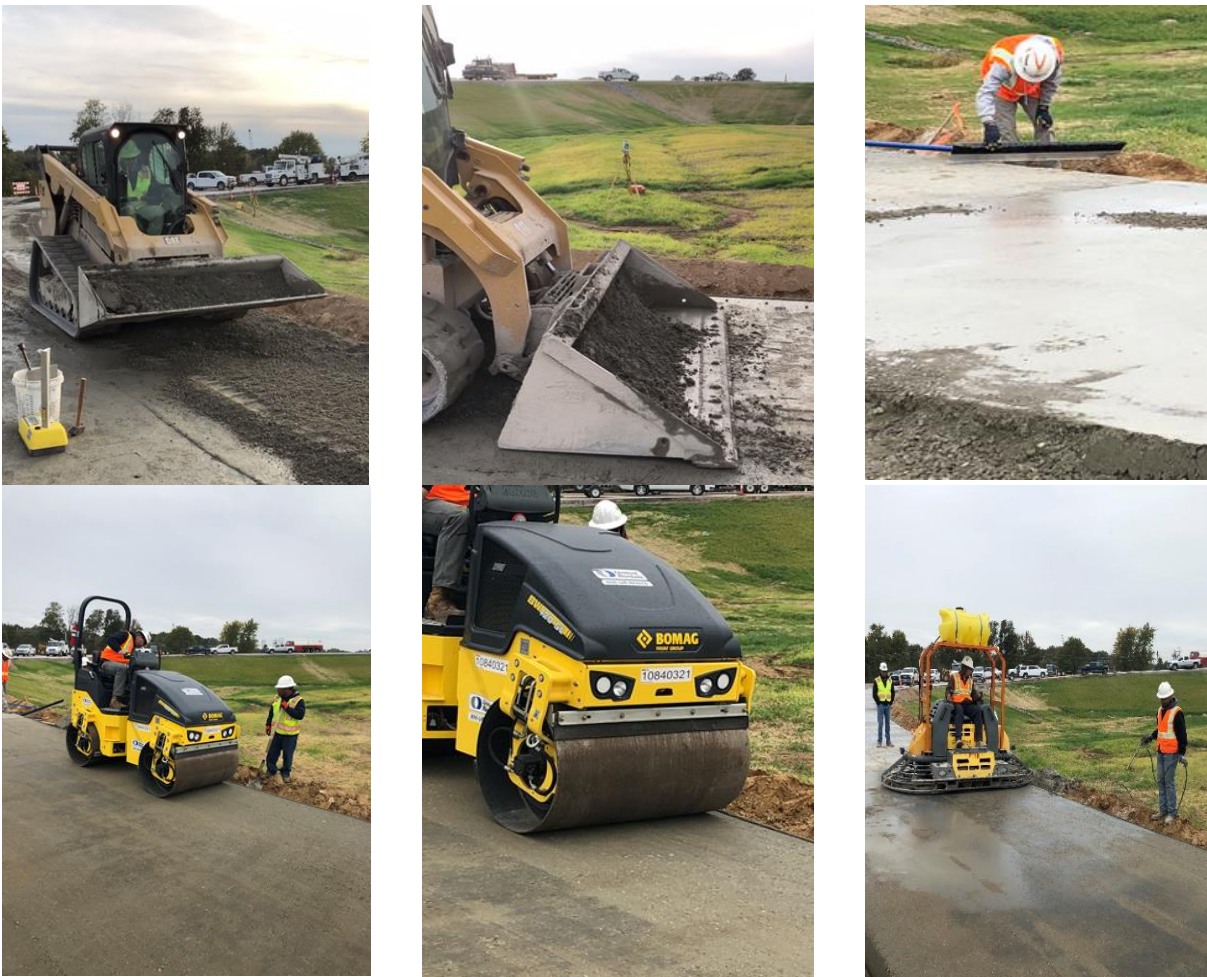
Figure 5 - Density adjustments

The test results showed that the density was not uniformly distributed. For the test strip, the amendments were made using addition of concrete and further compaction, as shown in Figure 5.

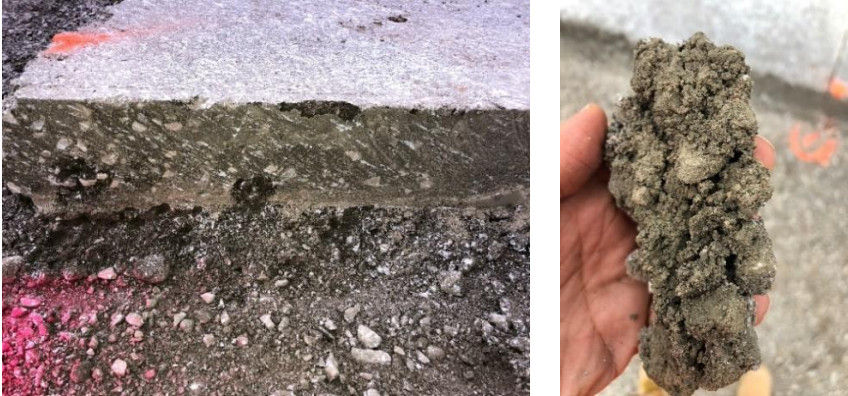
Figure 6 - Visual observation of the cross section

Even after the further compaction, visual observation of the cross section of the pavement (Figure 6) showed that the pavement was less dense at both ends, while the compaction was effective at the center. The cast CCP was poor in paste at some parts. Therefore adjustment in the mix design were made accordingly.

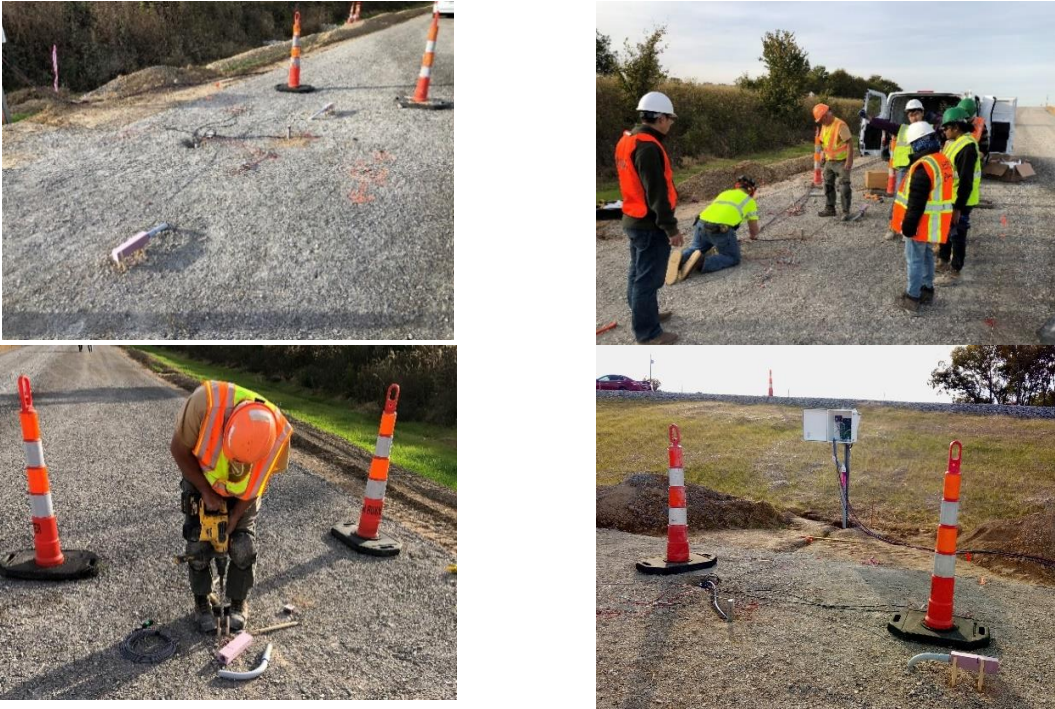
Figure 7 - Instrumentation operation

The sensor installation and instrumentation, including sensors of strain due to environment, dynamic load response, and joint opening, with minimal disturbance to grade were carried out by MnDOT. Figure 7 shows the instrumentation of cells 1, 2 and 3.

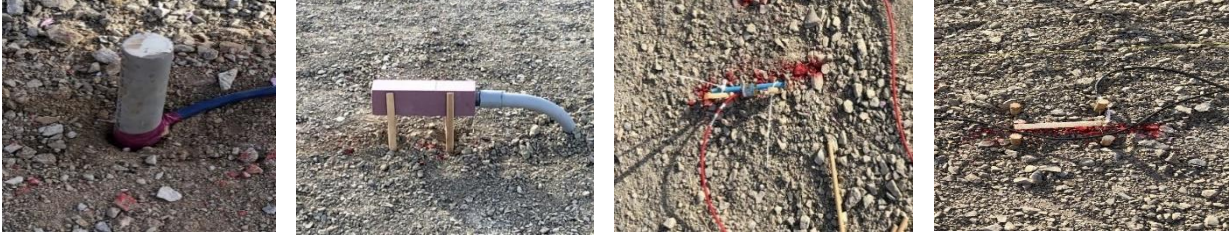
Figure 8 - Sensors and gauges applied in Cell 1, 2 and 3

The applied sensors and gauges are shown in Figure 8. A brief description of each sensor is given in Table 3. Figure 9 Illustrates the instrumentation schematics that were used.

Thermocouple Tree,

Joint Opening Block Out

Vibr. Wire Strain Gauges

Dynamic Strain Gauges

Item	Sensor	Description
1	Thermocouple Tree	To measure frost depth, temperature gradients in pavement layers and temperature compensation for other instruments
2	Joint Opening Block Out	Placed within 1-inch PVC conduit, which is held within a joint opening block out that crosses the joint between the two panels for measurement of the displacement of the pavement joint.
3	Vibrating Wire Strain Gauges	Two gauges has been placed in the longitudinal and transverse direction of the pavement to evaluate the effects of both directions for determining effects of applied loads to the pavement
4	Dynamic Strain Gauges	Two more dynamic strain gauges are placed near the edge of the pavement in the longitudinal direction to measure the edge deflection due to traffic loads.

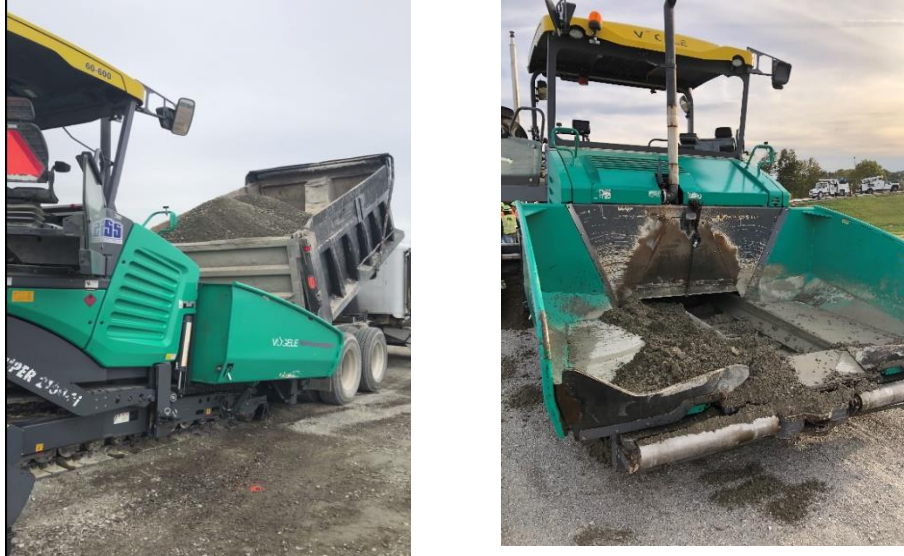
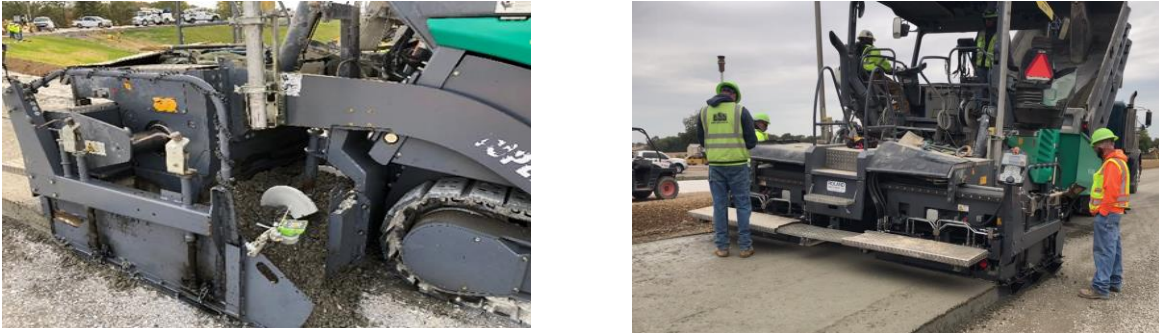
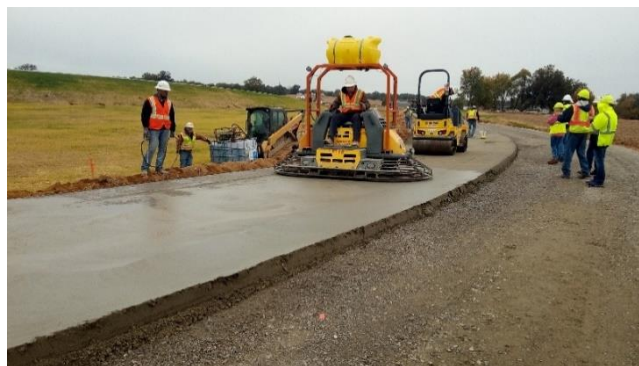
Paving operation started at 12 pm on 25<sup>th</sup> of October 2018. The project was initially on hold due to precipitation. Figures 10 to 12 illustrate phases associated to loading of the paver, compaction and measurements, and surface finishing. Curing in a form of spray was then applied, as shown in Figure 12.

Figure 10 - Loading process of the slip-form paving

Figure 11 - Paving and adjustments

Figure 12 - Finishing process

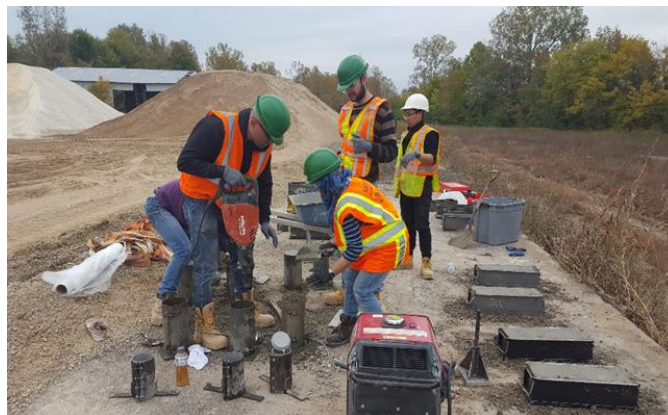
Figure 14 - Sampling

Two mixtures were sampled in 18 prism molds (6" ×6" ×24") for flexural test and 18 cylindrical molds (6" ×12") to test in compression. Mixture 1 represented Cells 1 and 2 as the base mixture without any fiber, while mixture 3 was reinforced with 5 pcy of fibers as in Cell 3. The moisture content was maintained between 5-6% with water-to-cementitious materials ratio (w/cm) between 0.31-0.38. Figure 14 shows the sampling operation.

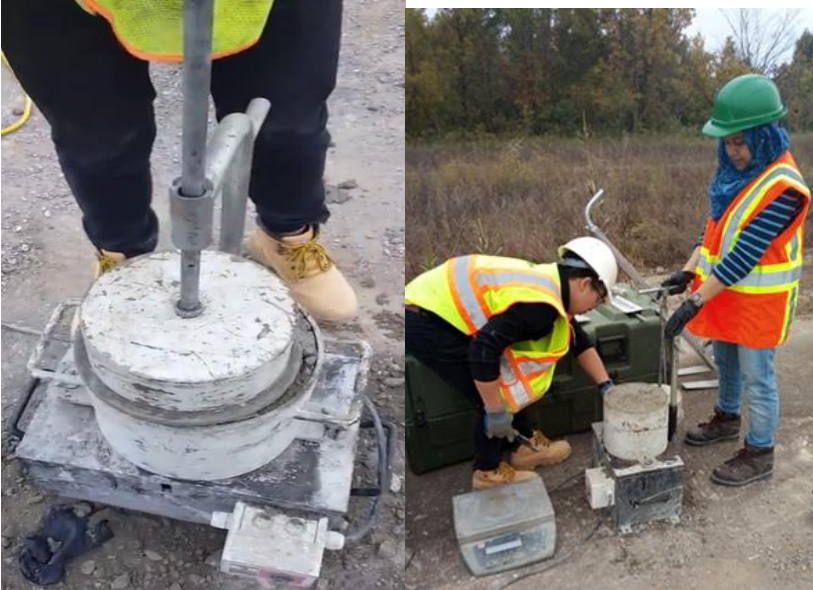
Figure 15 – Vebe test apparatus for determining consistency/density of fresh CCP

During sampling, Vebe consistency time and density of compacted concrete with and without fiber were measured, as per Procedure A, ASTM C 1170. The Vebe test setup is shown in Figure 15. The procedure is described in details in Section 4.1

The Vebe consistency time and density of fresh compacted concrete were measured during the paving in compliance with ASTM C 1170. The procedure consists of placing a representative sample of CCP mixture of approximately 29.5 lb (13.5 kg) in a standardized cylindrical steel mold. The mold was fixed on a vibrating table, and a circular plastic plate was placed on top of the concrete sample. In order to consolidate the concrete, a removable mass of 50 lb (22.7 kg) was applied to the plate, and the vibrating table was turned on. Figure 20 shows the Vebe test apparatus for determining consistency/density of fresh CCP.

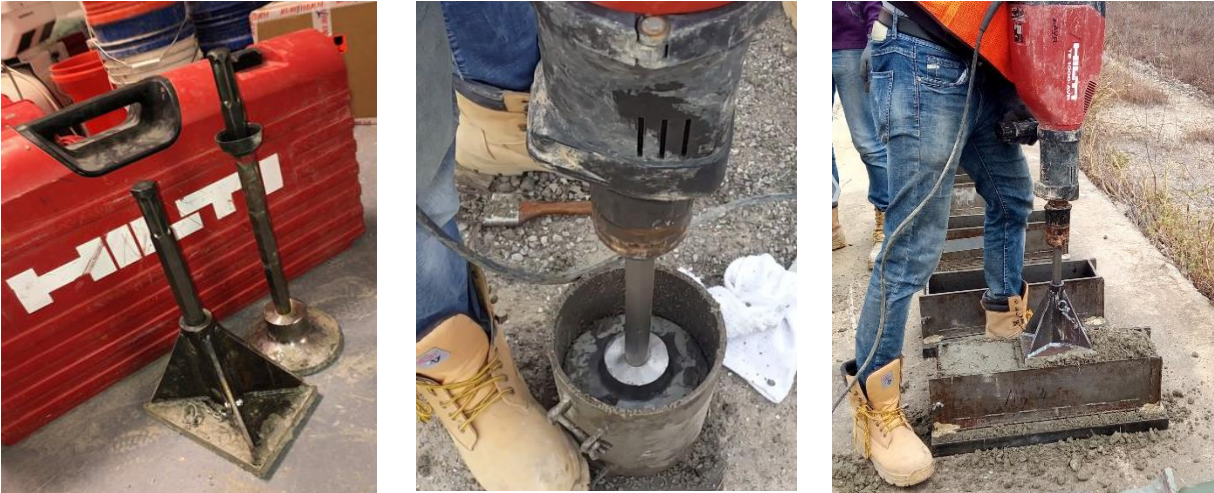
Figure 16 - Compaction tools and process

Compaction was adequately provided by a jackhammer using rectangular plates of 5.75” ×8” and circular plates of 5.75” in 3 and 4 layers for prism and cylindrical molds, respectively (Figure 16). The compaction of cylindrical samples was in compliance with ASTM C 1435.

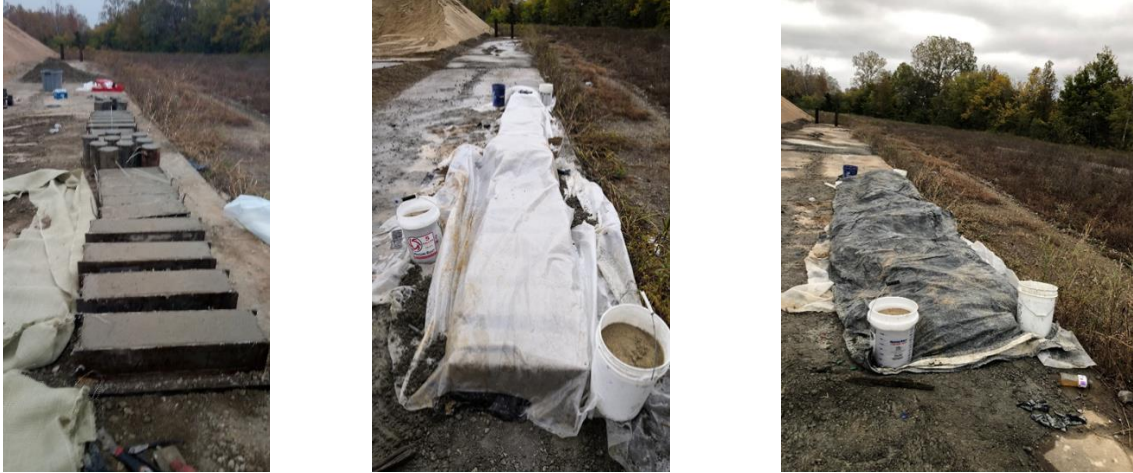
Figure 17 - Maintenance of samples before transport to Missouri S&T

The samples were covered with wet burlaps, followed by plastic bags and blankets to maintain appropriate curing moisture and temperature. Figure 17 shows the maintenance of the samples after casting and prior to transport to laboratory in Missouri S&T.

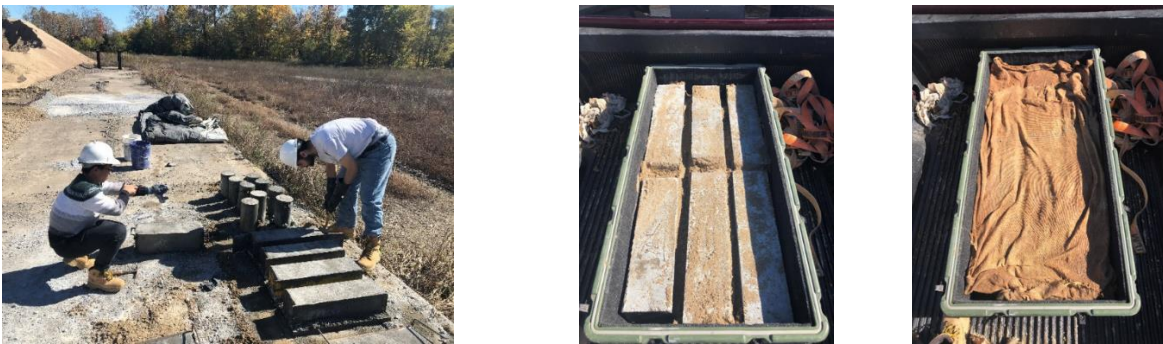
Figure 18 - demolding and transportation of samples

On October 29<sup>th</sup>, the samples were demolded and transported to Missouri S&T. The transportation was done in compliance with ASTM C 31. Accordingly, samples were protected with sand as suitable cushioning material in boxes to prevent damage from jarring. And to prevent moisture loss during transportation, samples were wrapped with wet burlap. Transportation time was within 4 h as allowed by the ASTM code. Figure 18 shows the demolding and transporting of the samples.

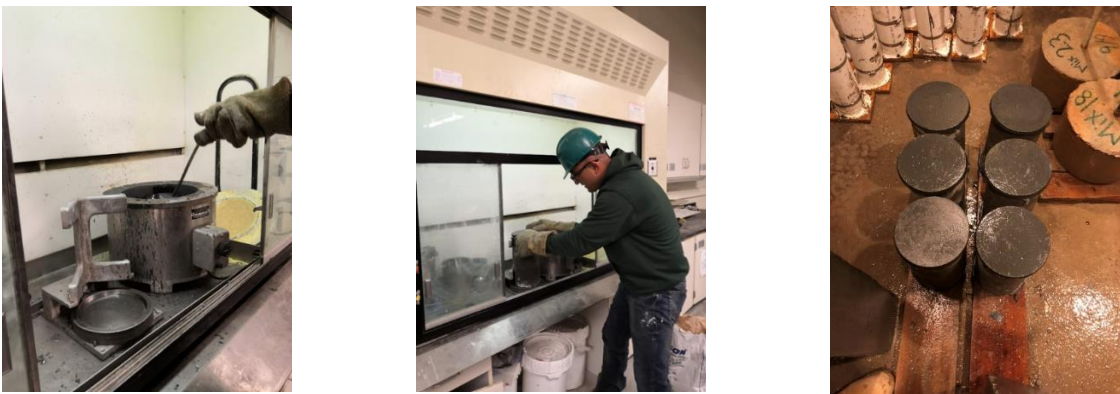
Figure 19 - Capping process of cylindrical samples

The samples were cured in standard curing conditions prior to the testing day. The cylindrical samples were capped according to ASTM C 617 using Sulphur mortar (Figure 19).

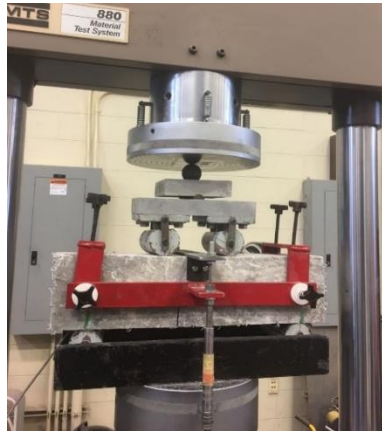
Figure 21 - Third-point flexural testing setup

The flexural strength test was conducted on prismatic samples measuring 6”x6”x24” (span of 18”) according to ASTM C1609. The loading rate was maintained at displacement control of 0.0035 in. /min until reaching a deflection of 0.02”. The rate of loading was then increased to 0.012 in. /min until failure. Figure 21 shows the test set-up for the flexural test.

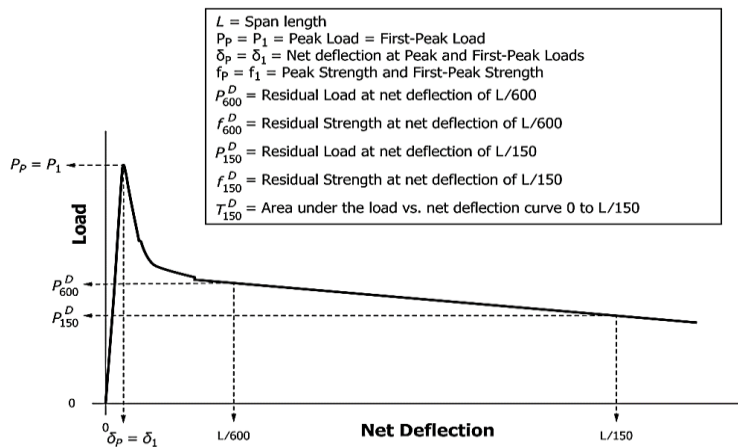
Figure 22 - Example of parameter calculations for first-peak load equal to peak load (ASTM C1609)

The residual strength was calculated by using the residual load in Eq. 1. The residual loads were determined at deflections of L/600 and L/150, respectively, according to Figure 22.

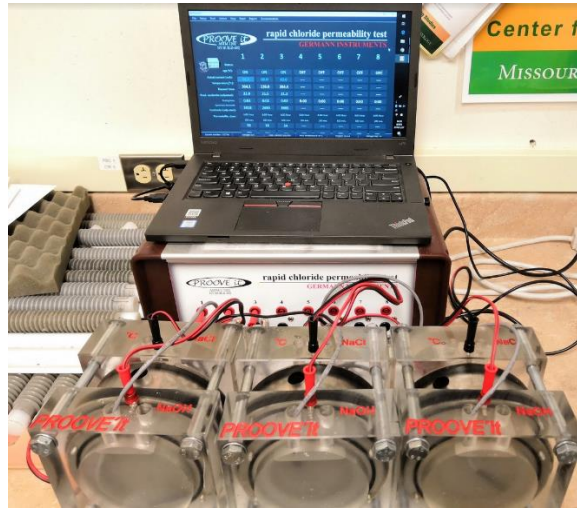
Figure 25 - Testing apparatus for RCPT

The chloride permeability of samples measuring 4"×2" was evaluated for saw-cut samples in accordance with ASTM C1202. Figure 25 shows the testing apparatus. The permeability scale for chlorides and the tested results are summarized in Tables 7 and 8. The results represent the average value of three samples for each mixture. The values of charge passed for the Mixtures 1 and 2 were 3740 and 5090 Coulomb, respectively. This indicates that the Mixture 2 had a high electrical conductivity, while the Mixture 1 exhibited a moderate electrical conductivity. The higher RCPT

value for the Mixture 2 might be due to the higher level of pores caused by a porous interfacial zone around the fibers.

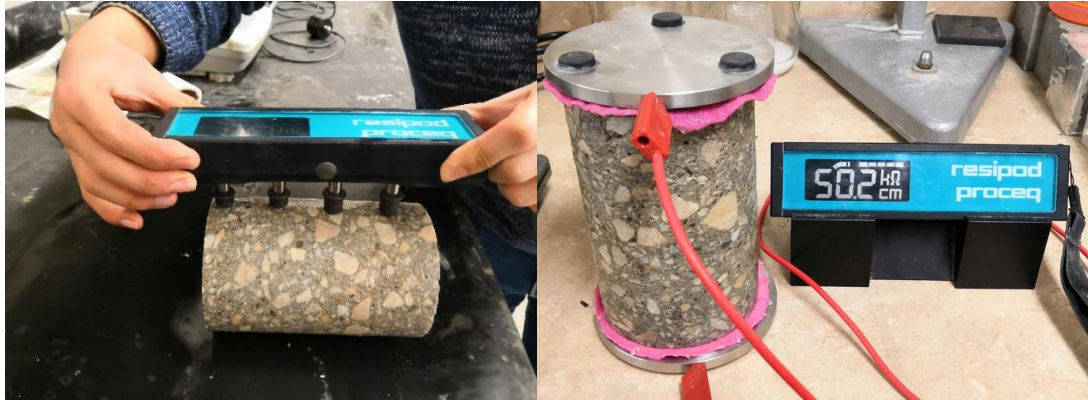
Figure 26 - Testing apparatus for surface resistivity (left) and bulk resistivity (right)

Surface electrical resistivity of samples was measured in accordance with AASHTO T95. The surface resistivity test method consisted of measuring the resistivity of 4" × 6" cores using a four-point Wenner probe array, as illustrated in Figure 26. An AC potential difference was applied in the outer pins of the Wenner array generating current flow in the concrete. The potential difference generated by this current was measured using the two inner probes. The current used and potential obtained along with the area affected were used to calculate the resistivity of cores. Bulk resistivity was also conducted on the same cored samples in compliance with ASTM C1760. In this method, bulk electrical resistivity was measured as the voltage between the two ends of cores as a small AC current was applied. The surface and bulk resistivity of concrete samples at the age of 91 days were measured for two samples of each mixture, and the average value is reported.

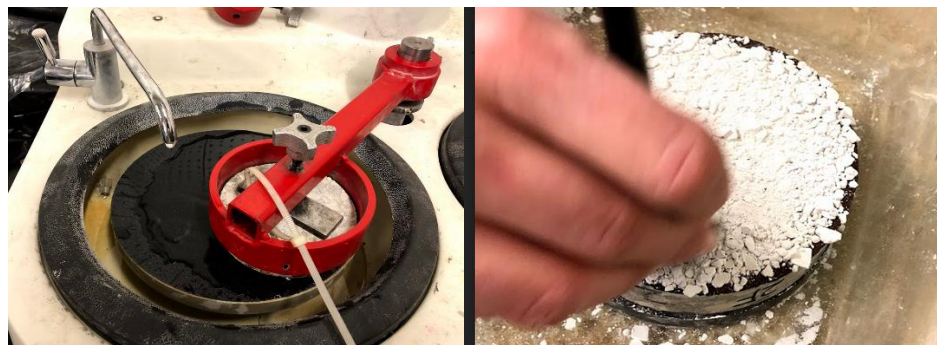
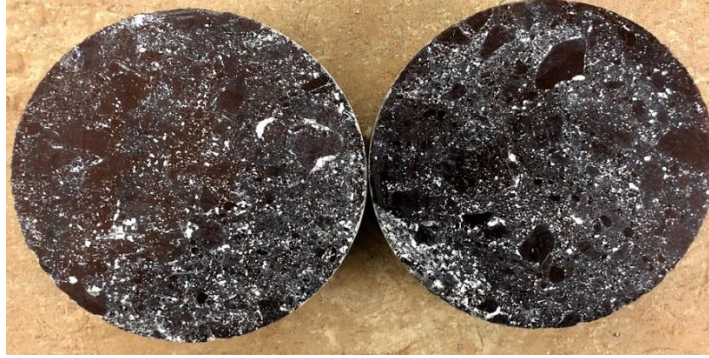
Figure 27 – Sample preparation for air-void system analysis

Samples measuring 4"  $\times$  1" cut from cores were prepared to determine the air-void system according to ASTM C 457. Two samples for each mixture were tested. The time required for the measurement of each sample was about 10 min on average. Figure 27 shows sample preparation for air-void system analysis. Each sample was tested four times, rotating the sample by 90° each time, and the average of the four results was calculated as the air-void system parameters for that sample. By this means, the variations in the results would be averaged out, and more reliable values would be obtained.

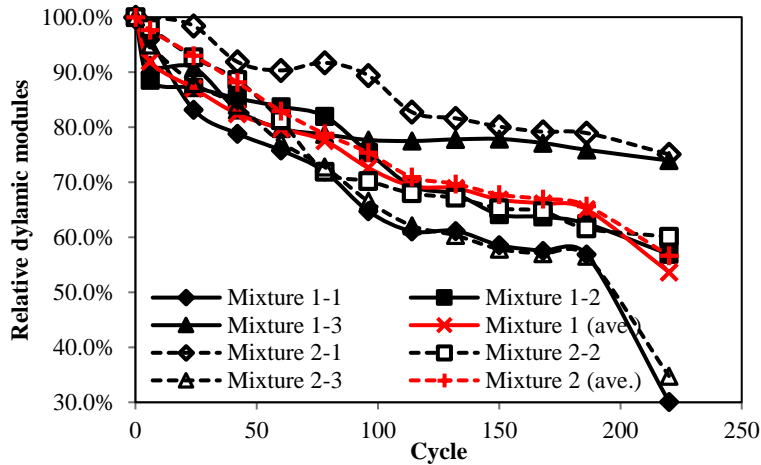
Figure 28 - Variations of relative dynamic modulus of elasticity of Mixture 1 (without fibers) and Mixture 2 (with fibers) determined on saw-cut samples

Figure 28 shows the variations of dynamic modulus of elasticity during 220 cycles of saw-cut samples taken from the fiber-reinforced and non fiber-reinforced concrete pavements. For each concrete type, three samples were extracted from various locations in the pavement. Test results showed that the relative dynamic modulus gradually decreased for Mixtures 1 and 2 with the increase of freeze-thaw cycles. For each concrete type, the changes in dynamic modulus of elasticity were significantly different. This can reflect the uneven degree of consolidation of the concrete.

The durability coefficient was calculated as the square of the ratio of pulse velocities of P waves in the concrete at the end of the testing period to the value recorded at the beginning of the test, multiplied by the number of cycles at the termination of the test divided by 300. The test was terminated soon after the relative dynamic modulus of elasticity decreased to a level lower than 60%. Test results showed that the incorporation of fibers did not have a significant effect on frost

durability. The relative dynamic modulus of elasticity at 220 cycles was 56% for Mixture 2, which translates into a durability coefficient of 41%. These values were 53% and 39% for Mixture 1, respectively. This indicates poor frost durability for both mixtures used in the CCP project.

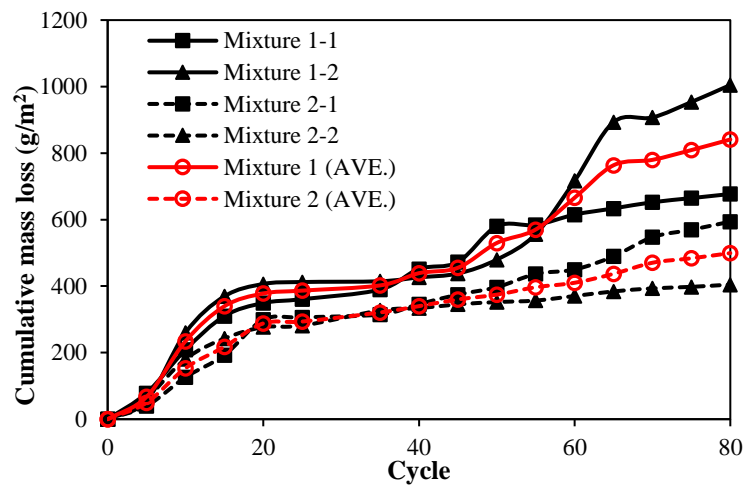
Figure 30 – Weight loss of saw-cut slabs after different cycles

Figure 30 shows the cumulative mass loss of the two mixtures during salt scaling test after 80 freeze-thaw cycles.

The cumulative mass loss increased rapidly with the increase of freeze-thaw cycles. The scaled-off mass collected from the Mixture 1 was noticeably higher than that of the Mixture 2, especially after 35 cycles, which was around 0.17 lb/ft<sup>2</sup> (840 g/m<sup>2</sup>) compared to 0.10 lb/ft<sup>2</sup> (500 g/m<sup>2</sup>) in the case of the mixture with fibers. However, the weight loss recorded for both mixture (with and without fibers) were below the acceptable range of 0.20 lb/ft<sup>2</sup> (1000 g/m<sup>2</sup>) at 50 cycles, which is mainly attributed to the high surface density of mixtures due to the compaction during paving.

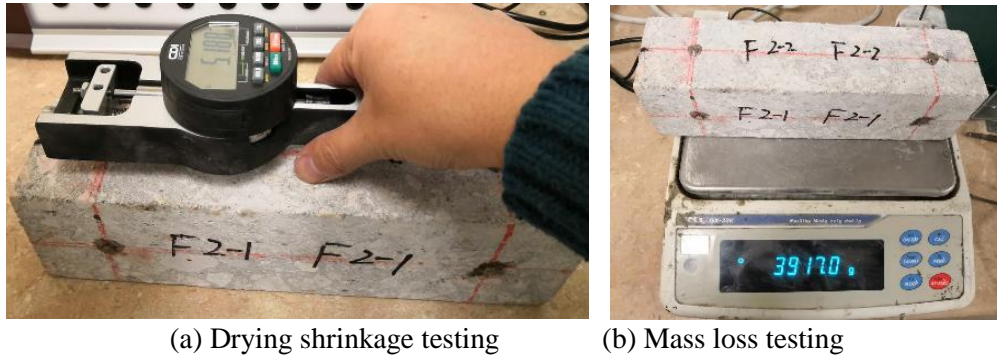
Figure 31 - Drying shrinkage and mass loss measurement

Drying shrinkage of mixtures was determined for saw-cut prisms measuring 3"× 3"×11.3" according to ASTM C157 using a digital type extensometer (DEMEC gauge). Shrinkage of saw-cut prisms was measured during 180 d in a temperature of  $70 \pm 3$  °F and relative humidity of  $50\% \pm 4\%$ . Figure 31 shows the shrinkage setup used and mass loss measurement of investigated samples.

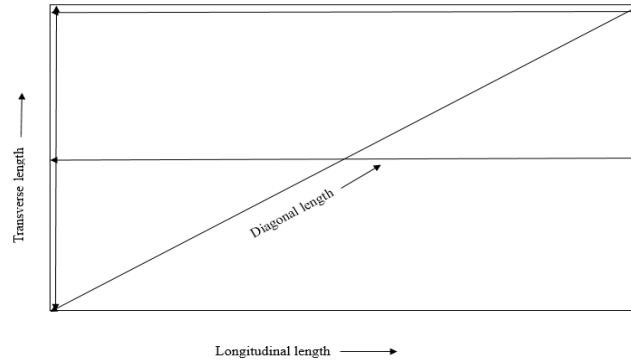
Figure 33 - Direction of measurements - longitudinal, diagonal, and transverse lengths.

The curling and warping measurements were conducted as per ASTM E1364 on December 19th, 2018 and September 27<sup>th</sup>, 2019. For all three CCP cells (Cells 1, 2, and 3). curling and warping measurements were conducted in the longitudinal, transverse, and diagonal directions (Figure 32). Both morning and afternoon measurements were taken on the day of testing to obtain values under variable temperature and moisture conditions.

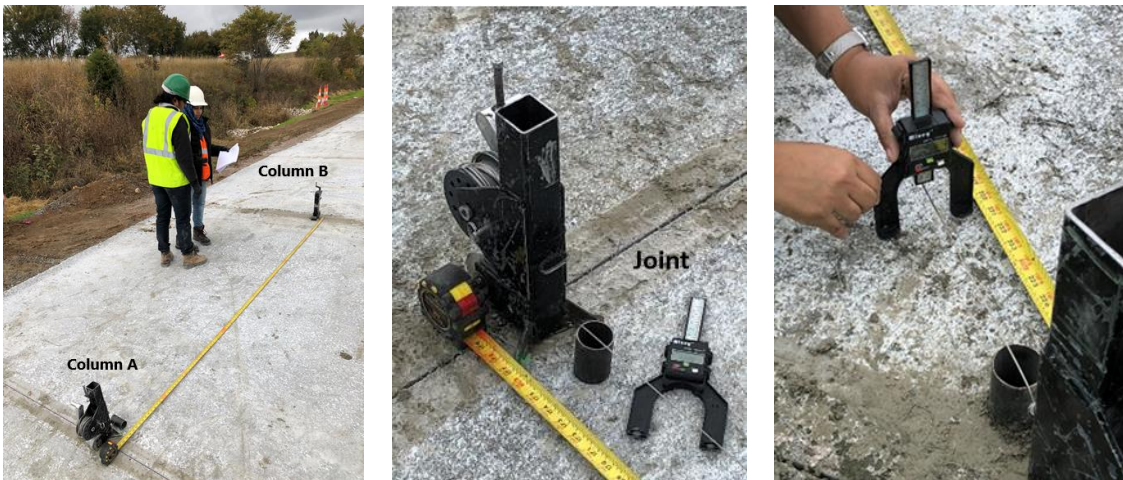
Figure 34 - Test setup and measuring equipment

Figure 34 shows the testing equipment for curling and warping measurements, which comprised of two steel columns (A and B) connected with metal string adjusted and tightened with roller components of the columns.

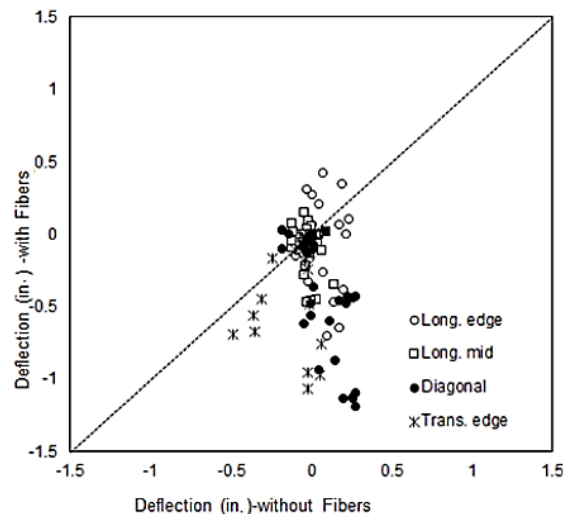
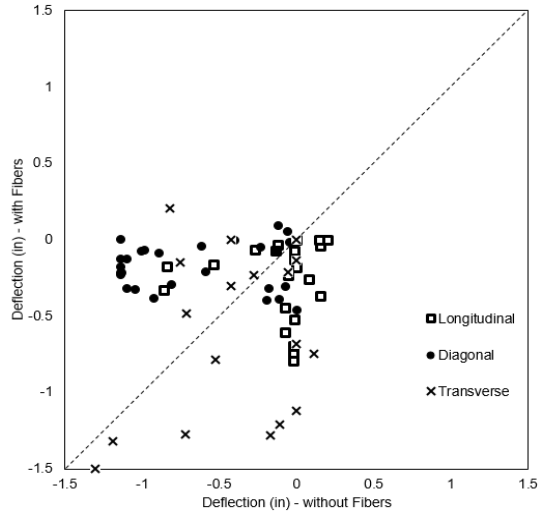
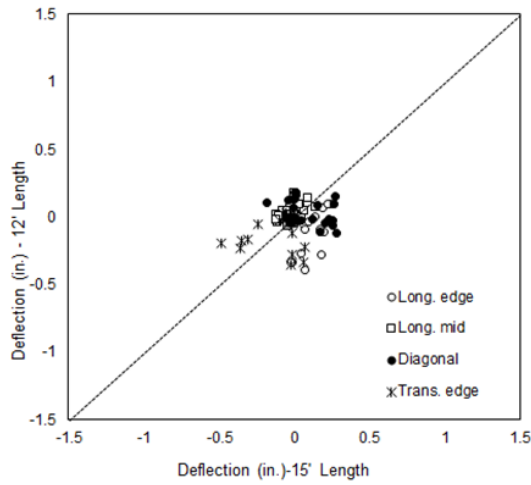
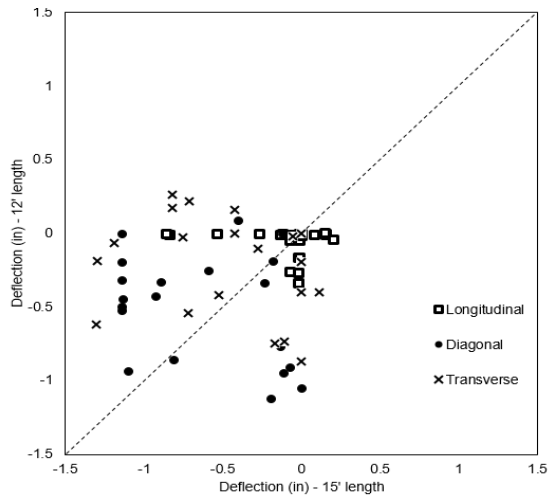
Figures 35 – 38 compare curling and warping readings of Cells 1 and 3 (with and without fibers) and Cells 1 and 2 (without fibers with different panel sizes) measured on 12/19/18 and 09/27/19 in four reading directions. The results showed that the cell with fibers (Cell 3) had more significant deflection at early age, especially those recorded in the diagonal direction. As can be seen from Figure 5, the deflection readings of Cell 3 ranged from -1.25 to 0.5 in. These readings were limited to -0.5 to 0.5 in. for Cells 1 and 2. The increased deflection of Cell 3 can be related to higher crack resistance developed by fiber reinforcement. Possible formation of microcracks in Cells 1 and 2 (without fibers) can increase the degree of freedom of the system and reduce the deformation. On the contrary, comparing results from Cells 1 and 2 (Figure 38) shows that the size of the cells had negligible influence on curling and warping deflection.

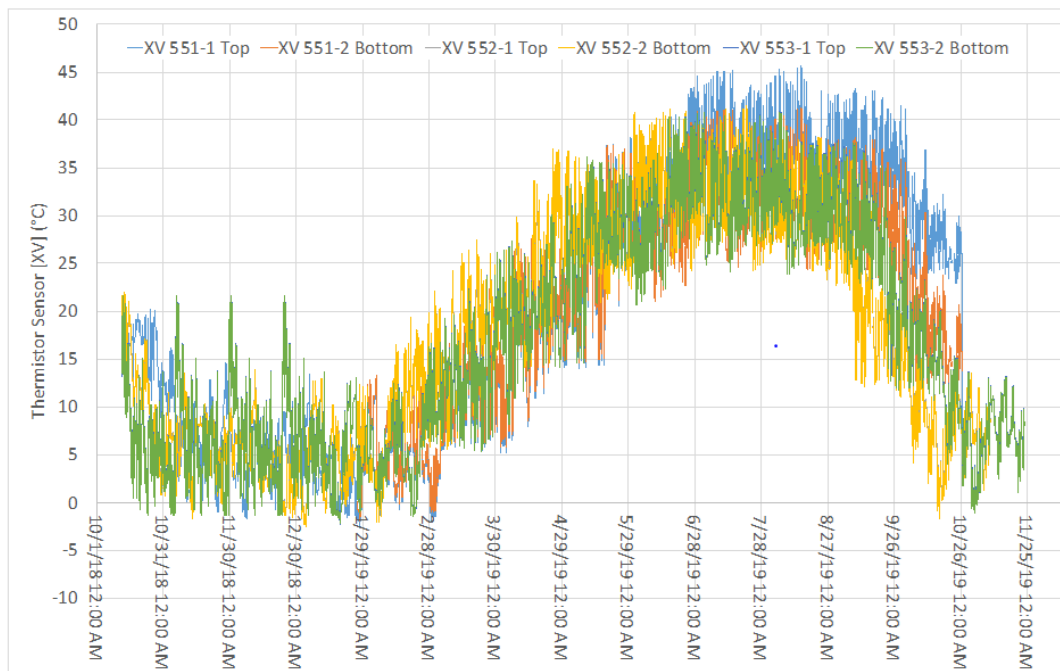
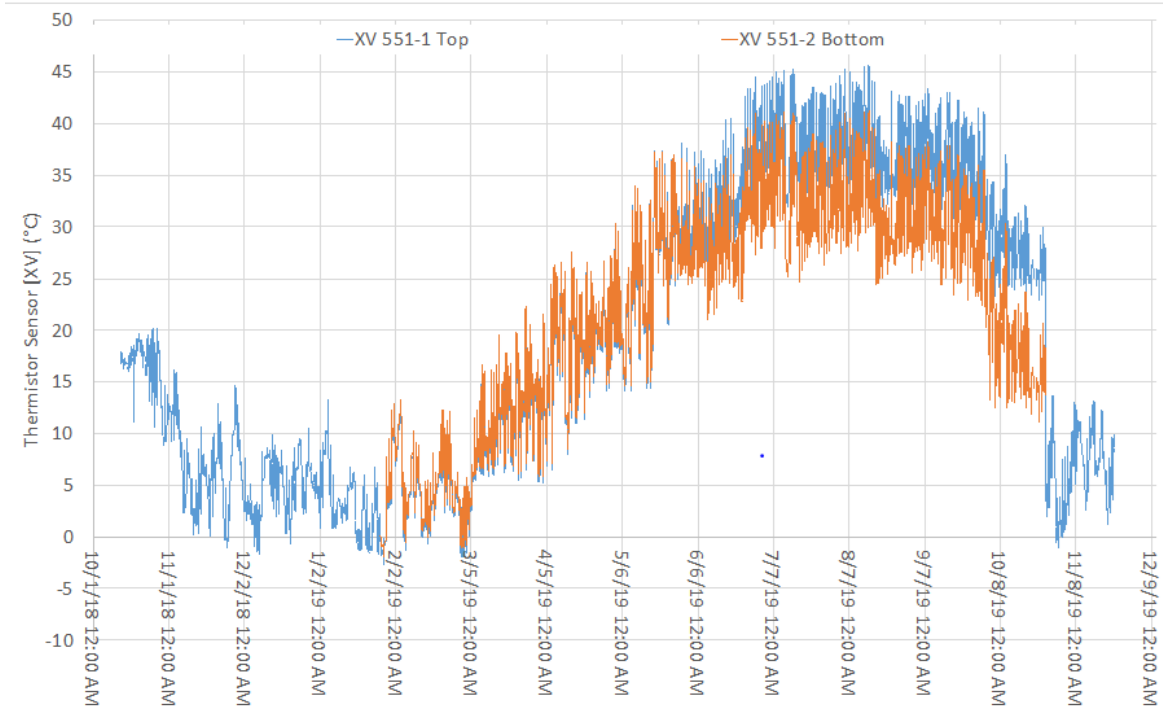
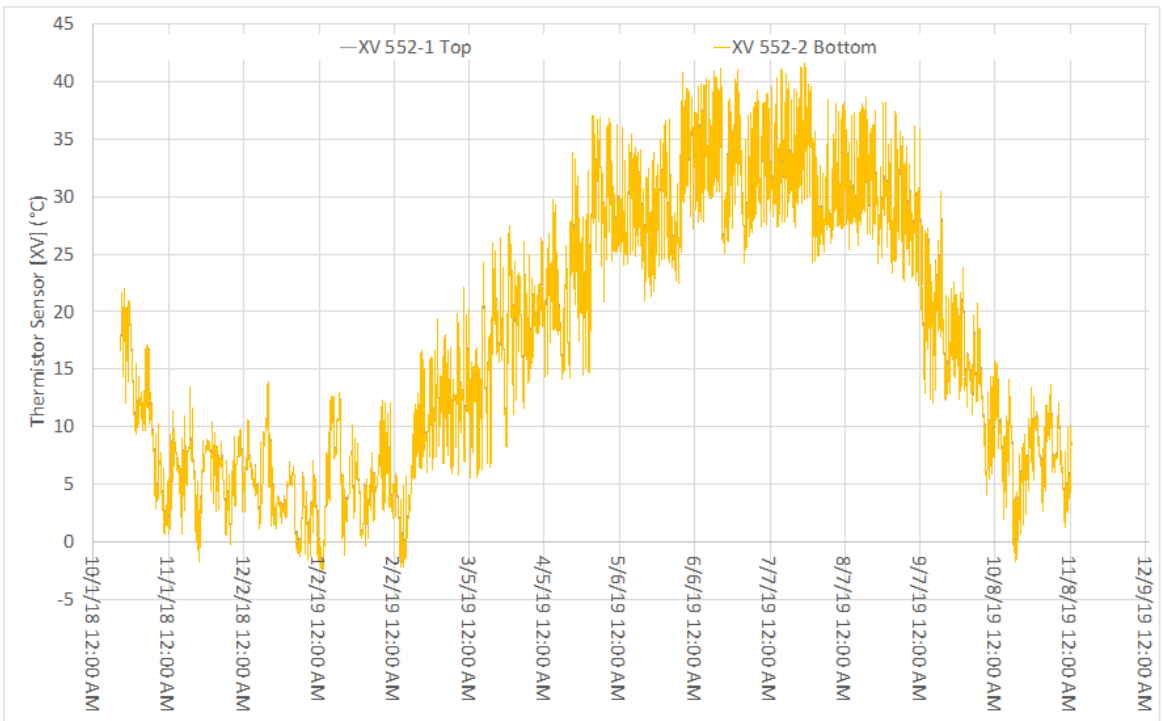
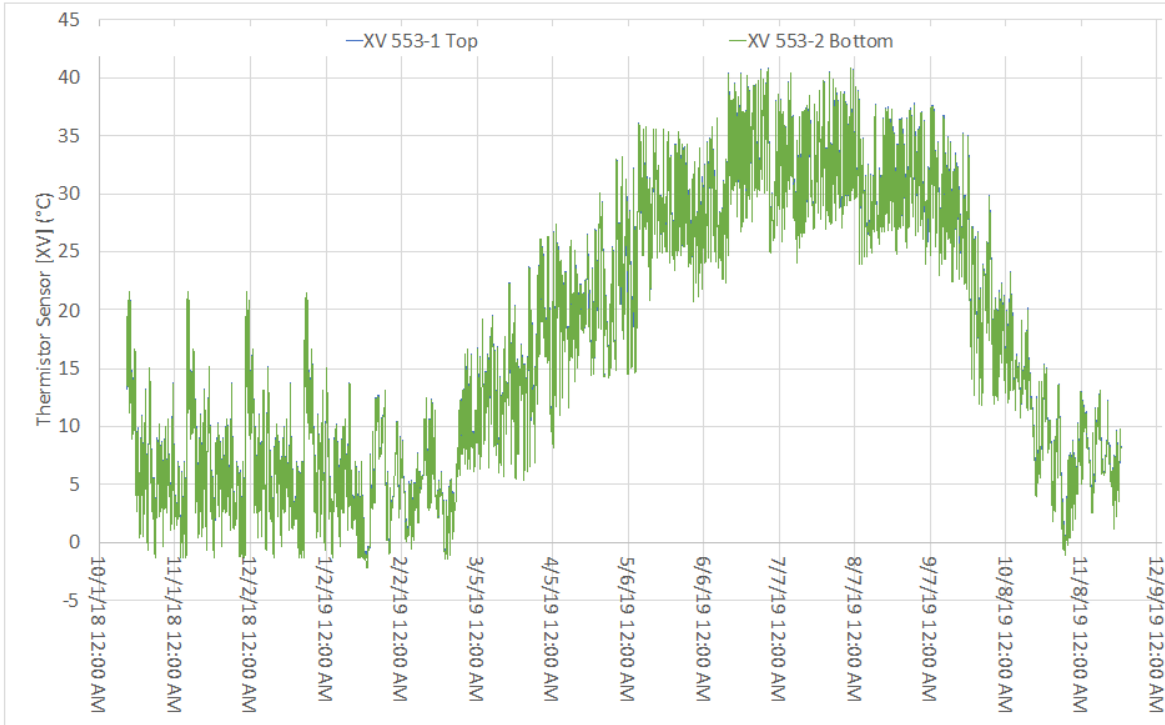
During the winter, the temperature varied between -2 and 22 °C (72 and 28 °F), where the temperature reached its maximum value after approximately 24 hours of concrete placement. During the summer, the temperature varied between 25 and 45 °C (77 and 113 °F), where the temperature reached its maximum value at the first week of August. The temperature variation between the top and the bottom of the slab was not significant, where a maximum temperature variation of 5 °C (41 °F) was recorded in August at station 551.

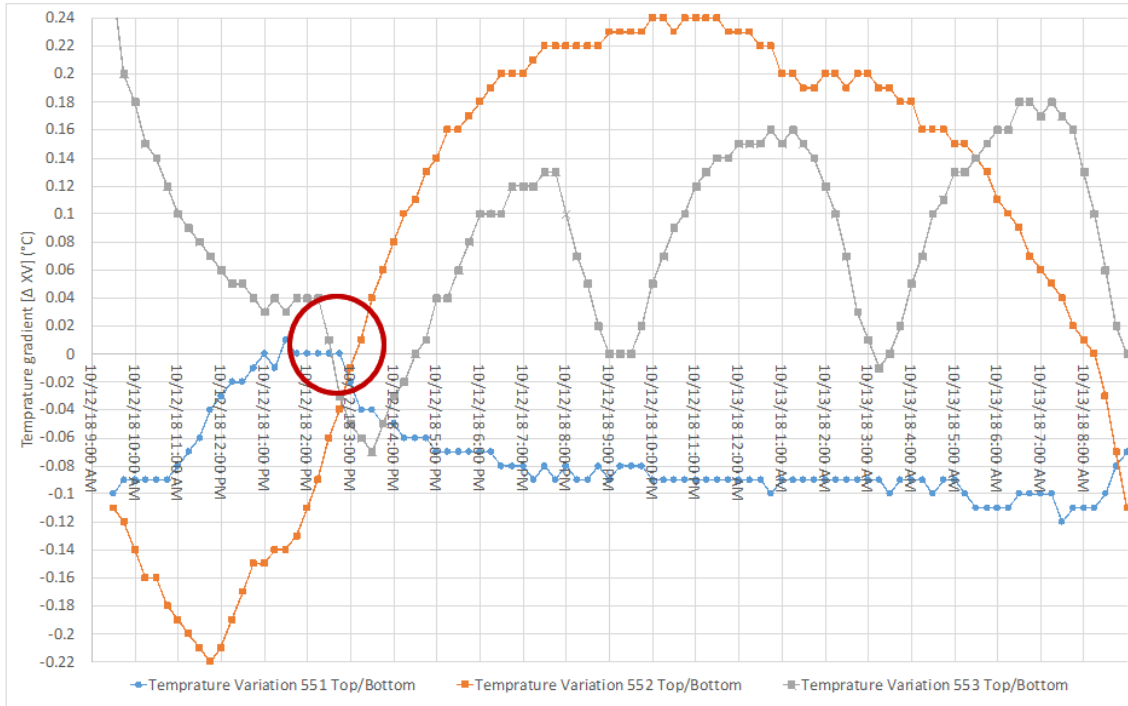
Figure 43: Temperature variations between the top and the bottom sections of the three investigated stations.

The temperature variations between the top and the bottom sections at the three investigated stations are plotted in Figure 43. The temperature variation at the three investigated stations was found to reach zero on 10/12/2018 between 2:00 pm and 3:00 pm, which indicated that the concrete had hardened sufficiently to fully engage the sensors and the initial vibrating wire strain gauge (VW) values were considered.

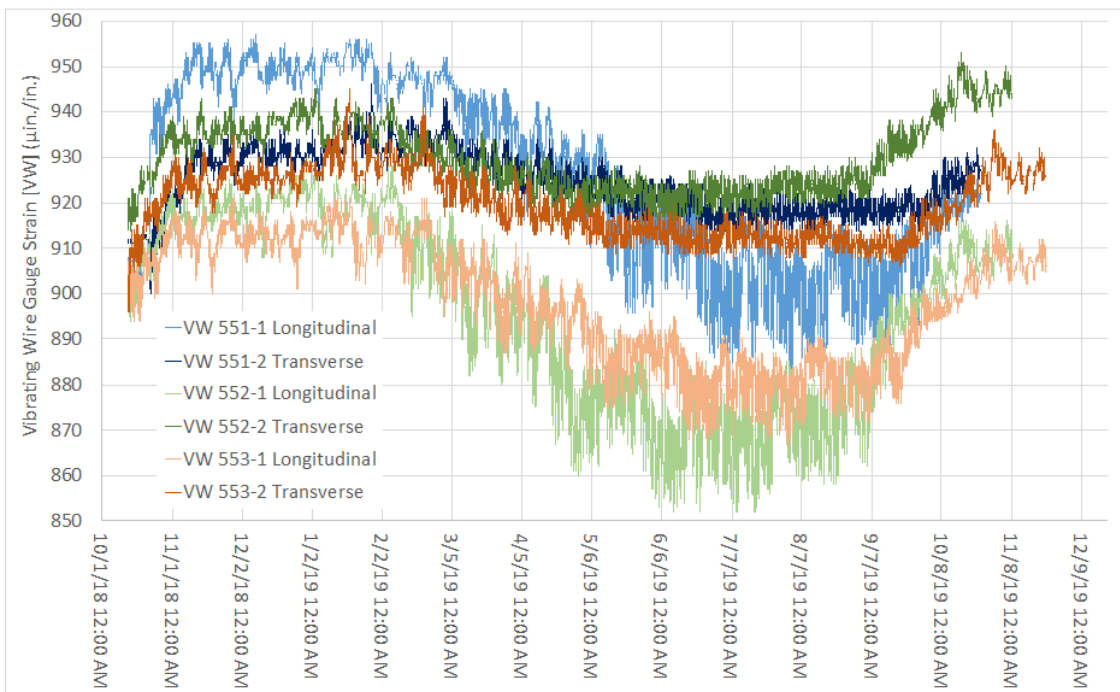
Figure 44: Strain variations at the longitudinal and the transverse directions of the three investigated stations.

Figure 44 shows the strain variations of the longitudinal and the transverse directions of the investigated three stations that were referred to as VW 551-1, VW 551-2, VW 552-1, VW 552-2, VW 553-1, and VW 553-2, respectively. After approximately seven weeks of concrete placement, the longitudinal and the transverse sections reached a maximum strain of 960 and 940 micro-strains, respectively. Generally, the strain varied between 850 and 960 micro-strains. Both longitudinal and transverse strains went down in summer, reaching lowest values first week of July. The strains after that started to go up. The rate of decrease of the transverse strain was much lower than the longitudinal strain. For example, at Station 551 the longitudinal strain was higher than the transverse strain up first week of May then the transverse strain started to be higher than the longitudinal one.
