SHRP 2 Project R21 (Composite Pavements)

Evaluation of MnROAD PCC-PCC Construction

**August 23, 2010
MnROAD Open House**

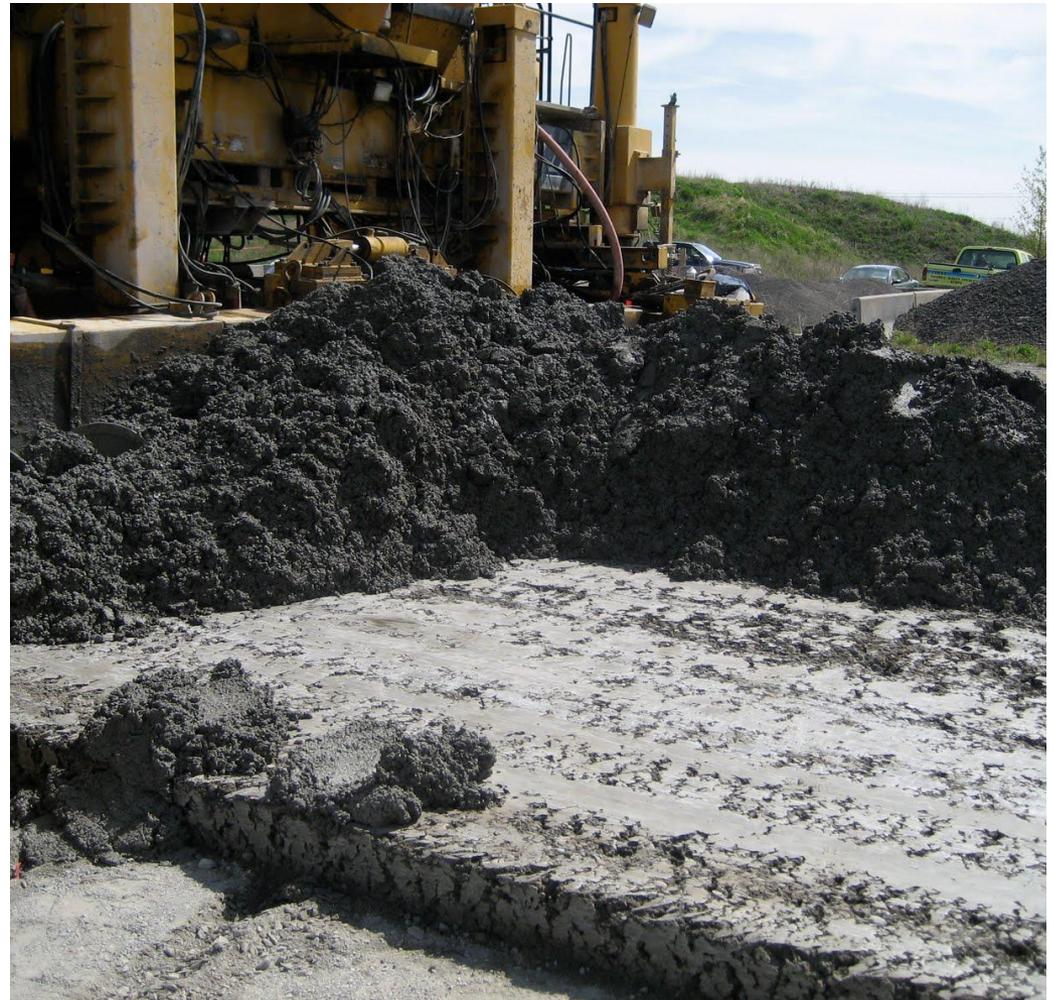
R21. Ultrasonic NDT and PCC-PCC interface

- In extreme circumstances (i.e. “worst case scenario”), interface may be compromised
- Use ultrasonic imaging to get quicker QA without sacrificing reliability

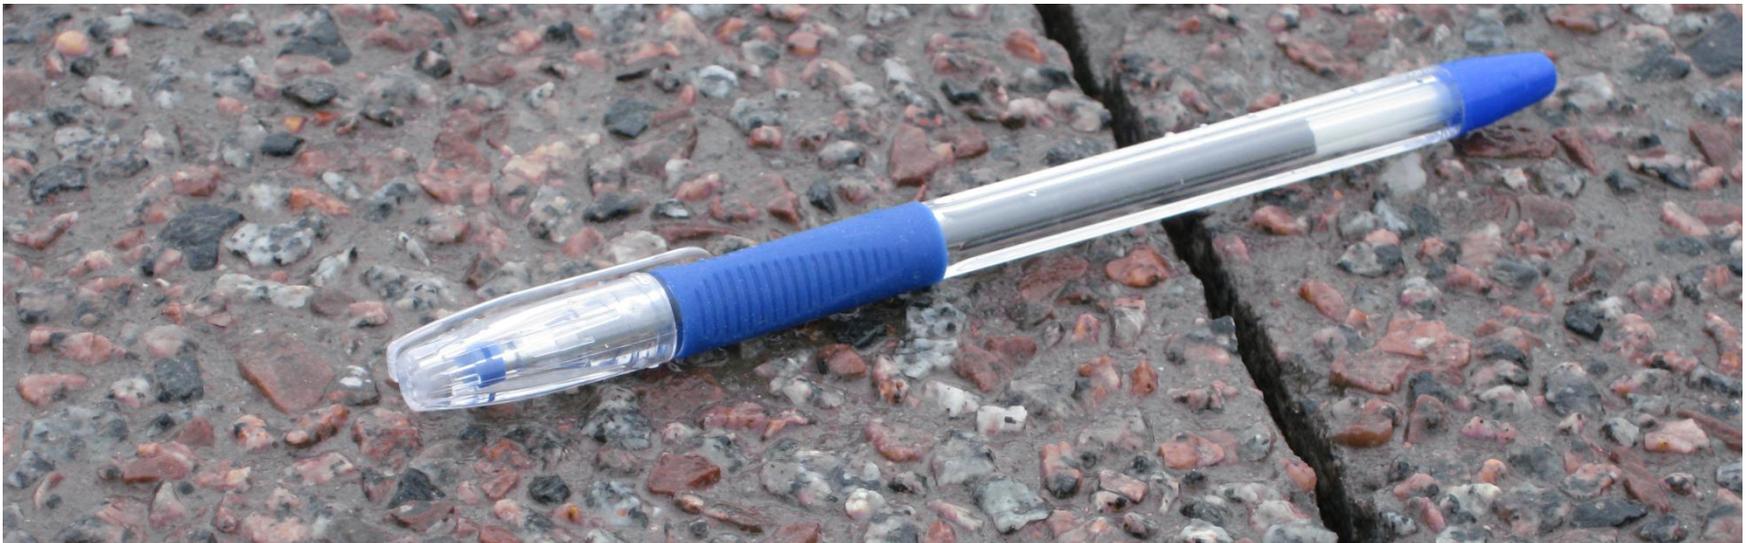
R21. EAC texture overview

- EAC gradation top-size was 12.7 mm (100% passing 1/2" sieve, 96% passing 3/8" sieve)
- Specified texture depth was 0.8 - 1.2 mm; final reported uniform texture depth was 0.76 mm
- QC measures used behind brush were aggregate peak picking and sand patch

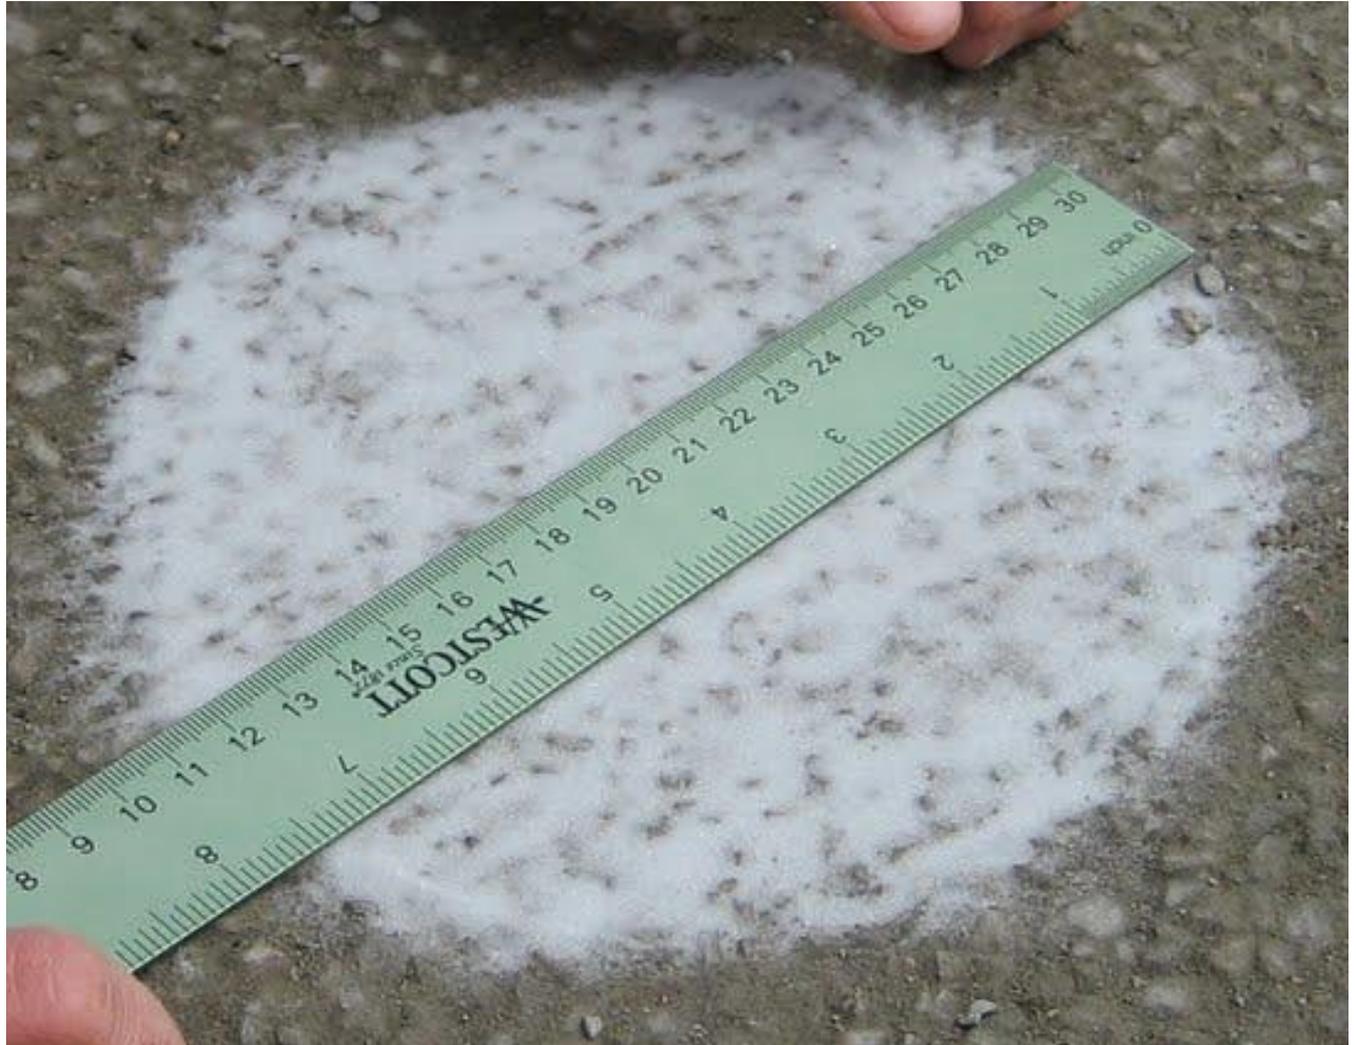
R21. EAC evaluation (2)

- Sand patch conducted regularly to achieve texture 0.8-1.2 mm according to spec
- Test protocol was ASTM E965

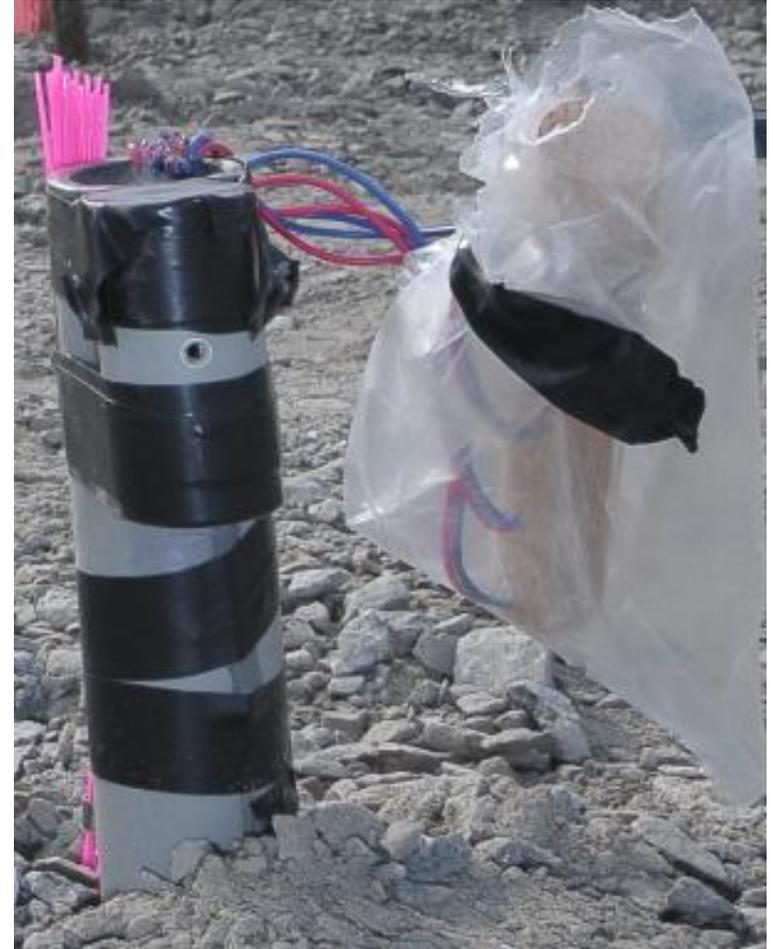
R21. PCC-PCC instrumentation (2)

- Instrumentation will provide strains, joint opening, temperature, and moisture data
- Will use this response data to validate MEPDG models for PCC-PCC
- Other useful data will be noise and surface friction data from EAC and diamond grind surfacing
