# Appendix K. Limited Phase I Environmental Site Assessment

Northern Lights Express Minneapolis to Duluth, Minnesota

# Limited Phase I Environmental Site Assessment

*Minnesota Department of Transportation  
Federal Railroad Administration*

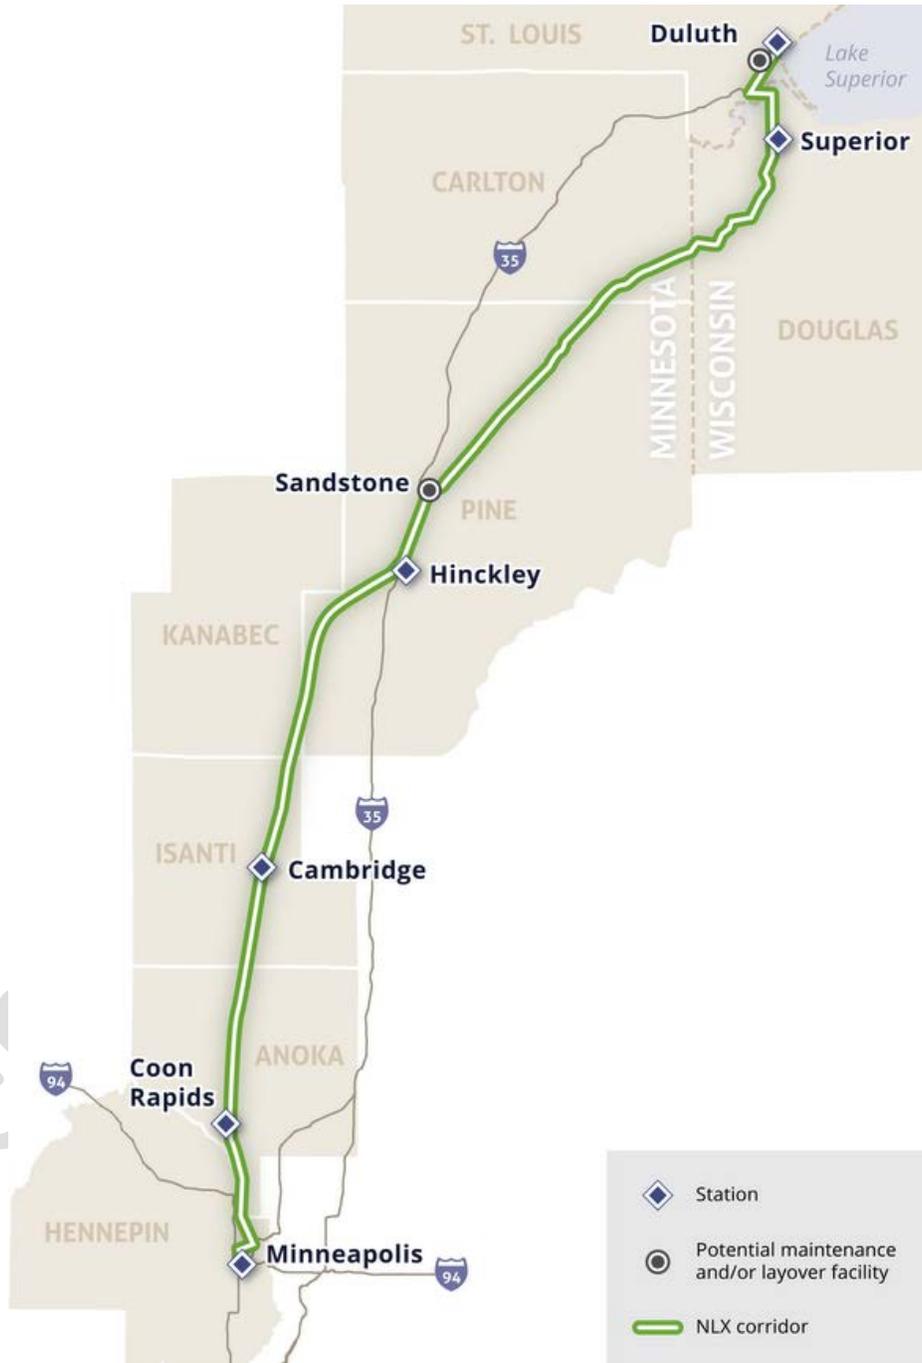
**Figure ES-1: Project Location**

Figure ES-1 provides an overview of the proposed NLX Project and facilities for the NLX Project.

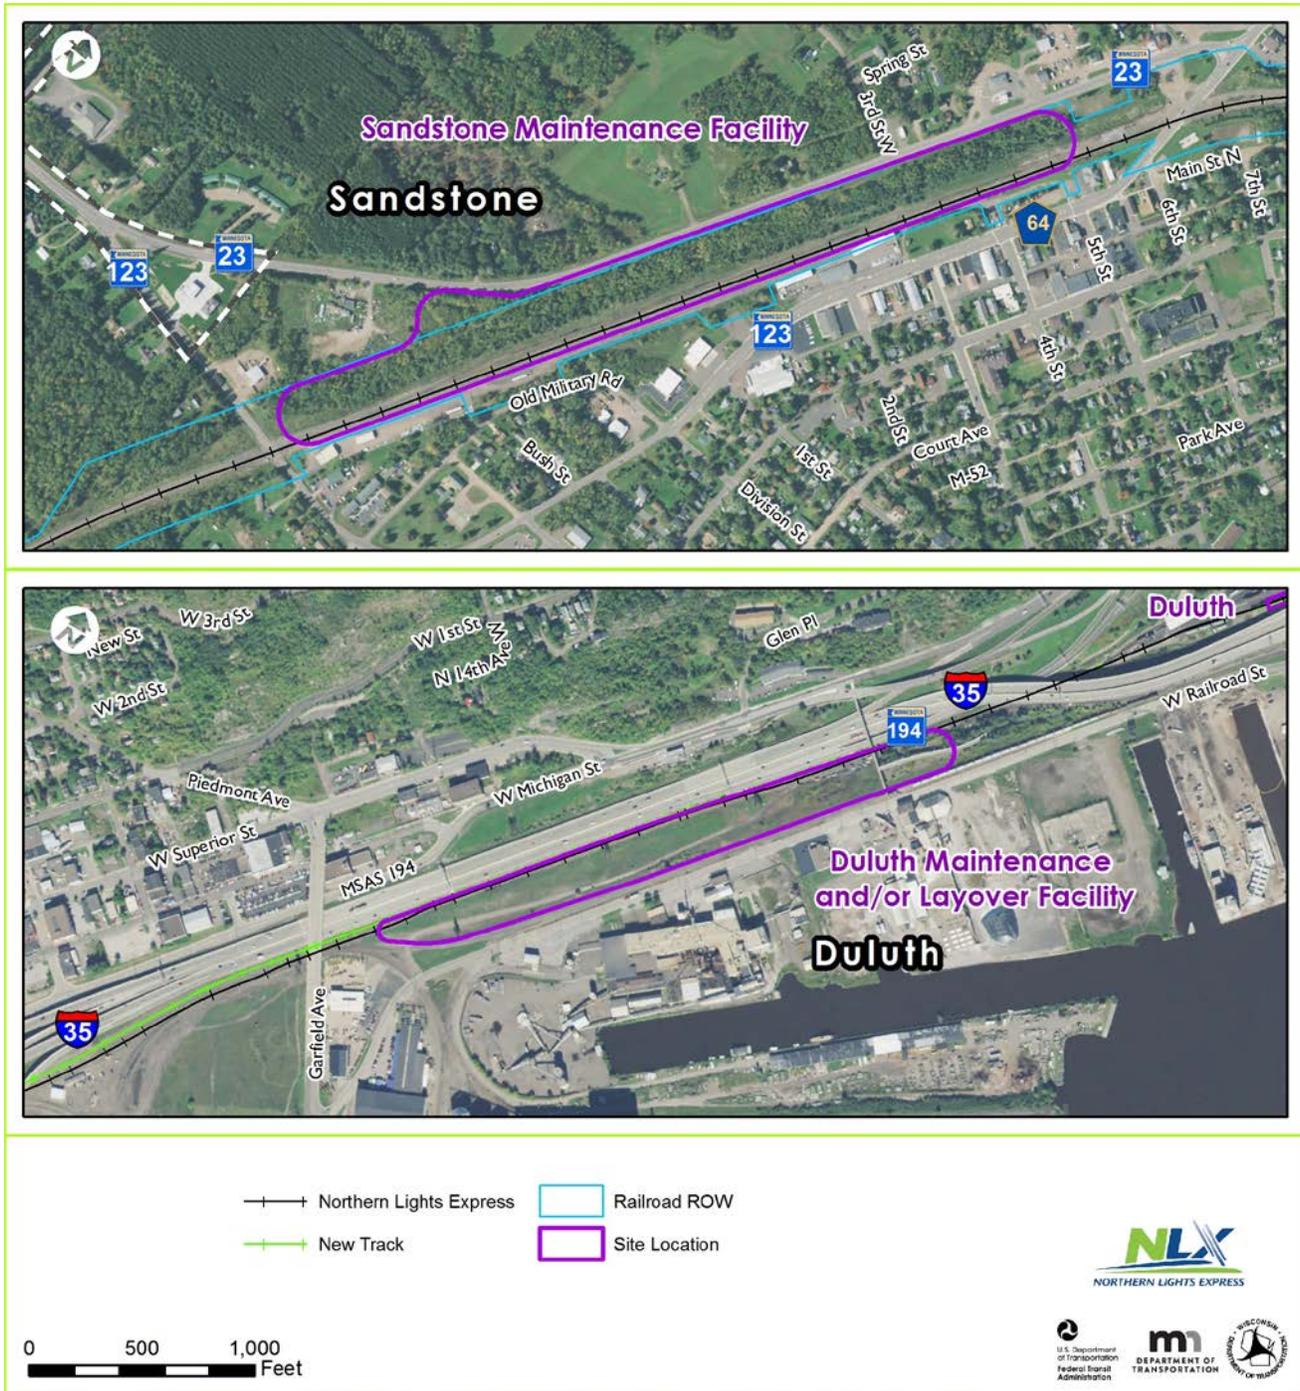
**Figure 1-2: Project Detail Schematic (Maintenance and/or Layover Facilities)**

Two maintenance facility sites and one layover facility site are being considered for the NLX Project. One of the proposed maintenance sites is in Sandstone, and the other maintenance site option is in Duluth approximately 1/3 mile to the southwest of the proposed Duluth Station. The layover facility would be located in Duluth as well, and would be co-located with the maintenance site if the Duluth option were selected. For this assessment, both facilities were reviewed. **Figure 1-2** depicts the proposed construction limits of each maintenance and/or layover facility.

The maintenance facility would be used for inspection, service, maintenance and repair activities required to keep NLX trains in service and incorporate train layover and storage needs. The maintenance building would accommodate a 650-foot-long train consist. Additional features of the maintenance facility include a train wash, office and shop space, yard and lead tracks, shop equipment, vehicular access, exterior lighting and signage and security systems. The maintenance facility would not be used for major rebuilds, main engine change-outs, wreck repairs or component rebuilds.

The layover facility would provide a location away from BNSF main tracks to store up to two complete trains. For NLX, the 650-foot-long train consist would include six 85-foot-long coaches, and two 70-foot-long push-pull locomotives. The layover facility would also provide a location to perform limited servicing, inspections and minor repairs. The layover facility would consist of yard and lead tracks, a support building, vehicle access, parking, exterior lighting and signage and security systems.
