Location Map – Project D3-2 Brainerd, Crow Wing County

Overall Weighted Score: **8.54**

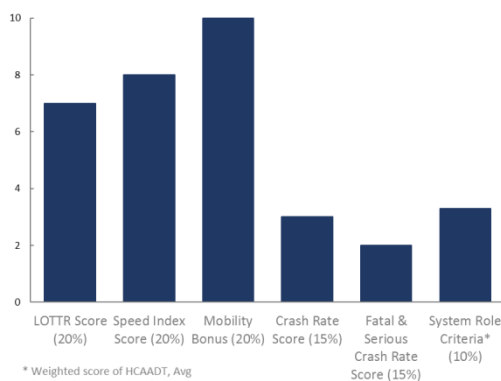
Figure 2: Evaluation Criteria Scores

* Weighted score of HCAADT, Avg Trip Length, RR Crossing, & Tourism
