TECHNICAL SUMMARY

Evaluating Iron-Enhanced Swale Ditch Checks for Phosphorus Removal

This Technical Summary pertains to Report 2019-27, “Iron-Enhanced Swale Ditch Checks for Phosphorus Retention,” published July 2019. The full report can be accessed at mndot.gov/research/reports/2019/201927.pdf.

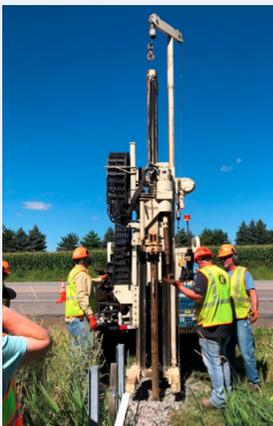
Near the end of the study, workers used a boring machine to take core samples of the ditch check and the filter insert.

In July 2018 researchers collected three core samples from the ditch check sides and the filter to test for retained phosphorus and signs of diminished performance.

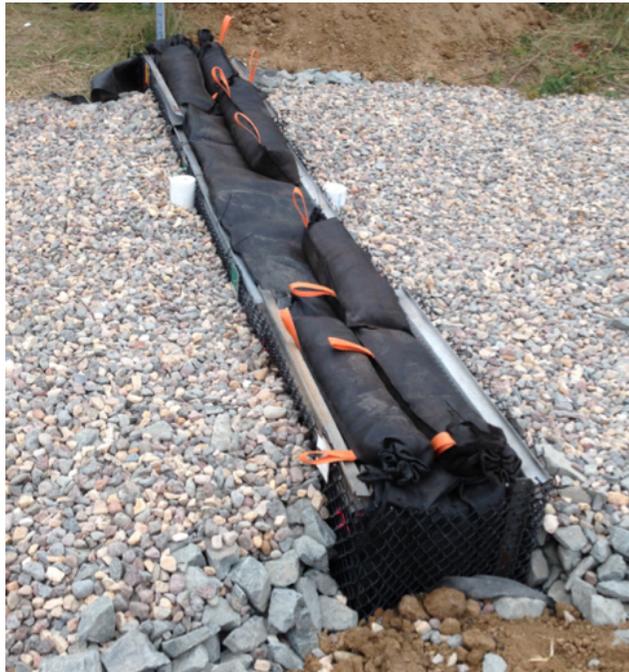
The iron-enhanced filter installed in this ditch check holds iron filings and sand in a geotextile fabric envelope and is supported by a metal filter cage extending across the swale. Topsoil and sod will cover the entire ditch check.
