TECHNICAL SUMMARY

Investigating Asphalt Pavement Stripping Under Seal Coats

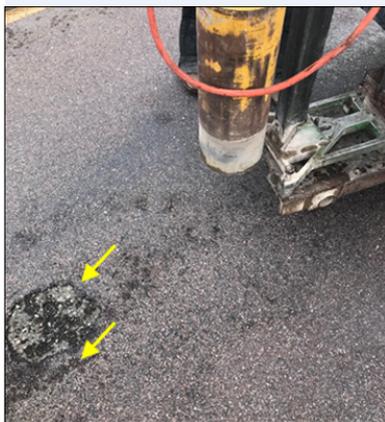
Researchers identified partial stripping of the seal coat on this asphalt pavement.

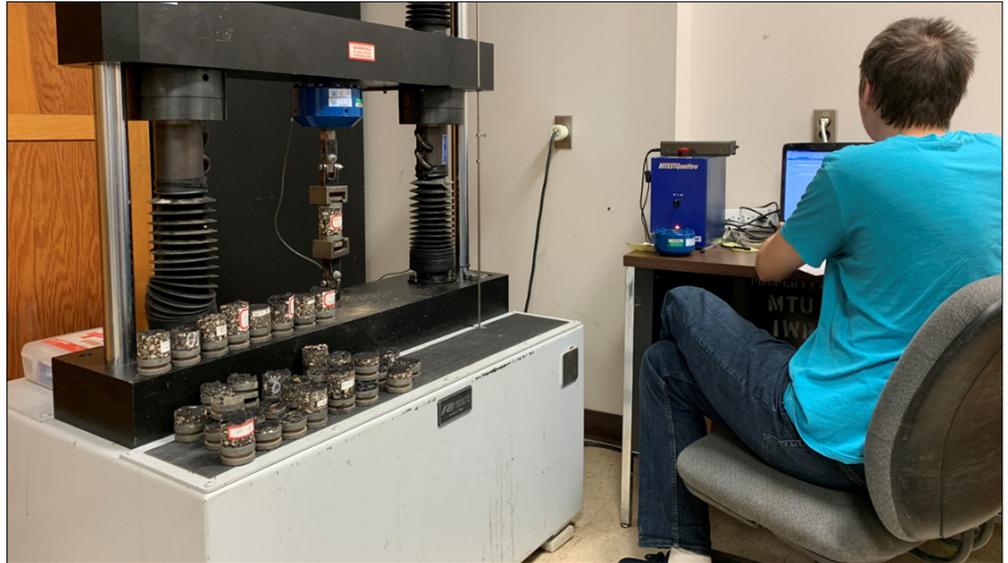
Investigators at Michigan Technological University developed new bond tests to determine the impact of freeze-thaw activity, temperature and moisture on pavement samples.

LRRB and MnDOT provided 48 8-inch cores from the sites for laboratory testing, which focused on bond strength in terms of shear and interface bond, as well as asphalt loss, at different temperatures and moisture levels, and over multiple freeze-thaw cycles. Cores were sorted according to degrees of damage; seal coat material; and pavement age (under five years, five to eight years and eight to 15 years). Aggregate chips and emulsions were also collected. From these materials researchers prepared almost 300 lab samples for bond testing.
