## TECHNICAL SUMMARY

# Evaluating Improved Specifications for Retightening Anchor Rods on Support Poles

*This Technical Summary pertains to Report 2021-23, “Re-Tightening the Large Anchor Bolts of Support Structures for Signs and Luminaires: Phase II,” published October 2021. The full report can be accessed at [mndot.gov/research/reports/2021/202123.pdf](http://mndot.gov/research/reports/2021/202123.pdf).*

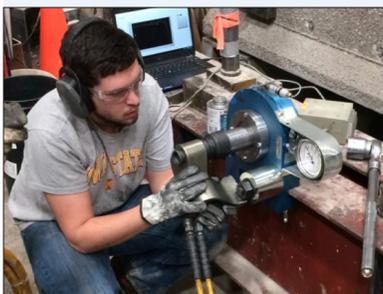
The Skidmore-Wilhelm test apparatus determines the tension of a tightened assembled sample.

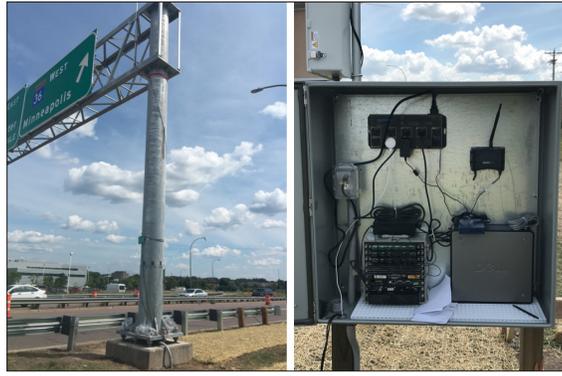
A large cantilevered highway sign on a tall post installation (far left) was instrumented to gather strain/wind-load data from the anchor rods in the base. A data logging box (left) contained and protected the data-collecting equipment.

In the lab, researchers evaluated different tightening aspects of the protocols by investigating metal strain and fatigue. They tested the behavior of single anchor rods under stresses and the laboratory post structure as a whole using data gathered from an instrumented overhead sign structure in the field. Researchers conducted numerous [Skidmore tests](#) to determine rod pretension levels versus different grip lengths for different rod sizes attained through the revised specifications. Using finite element modeling, researchers closely examined where stresses manifested in anchor rods under load.
