Is Seal Coating Counterproductive or Not?

Zhanping You, Principal Investigator

Department of Civil and Environmental Engineering
Michigan Technological University

Research Project
Final Report 2020-34

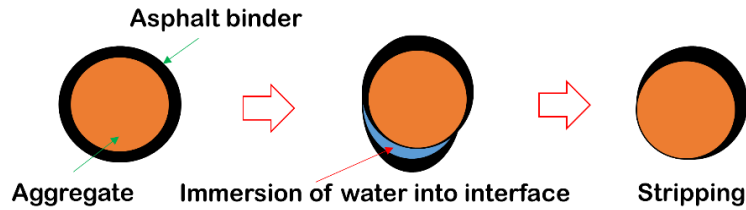
Figure 1-1. Conceptual diagram for stripping mechanism

Many asphalt pavements under seal coating suffer from premature stripping, and states are progressively specifying the use of antistripping agents. It has been reported by Fromm (Fromm 1974) that the stripping of aggregates from asphalt initiates at the bottom of the asphalt pavement and gradually moves up. This is most likely due to highly compacted pavement. Water may enter the asphalt pavement from the granular base, infiltrate through the seal coating surface cracks, or seep in from the sides (due to the hydraulic gradient) and deteriorate the pavement under the seal coating, which subsequently causes stripping. Figure 1-1 shows a conceptual diagram for the stripping mechanism. Normally, the moisture or water could migrate into the interface of asphalt and aggregate, and the potential osmotic difference causes diffusion across the asphalt film, wear and tear of asphalt binder film, seepage by air voids, and diffusion from the pores of the aggregate to the interface due to its partial coating (S.K. Das 2004). Some studies reported that the damage would be minimal if the stripping is restricted to coarse aggregates; however, if stripping occurs with fine aggregates, then the influence will be severe since these aggregates are major constituents in the asphalt mixtures (Kennedy, Roberts, and Lee 1982; Taylor and Khosla 1983). The relationship between stripping and how the seal coat was applied to the asphalt pavement needs to be analyzed.

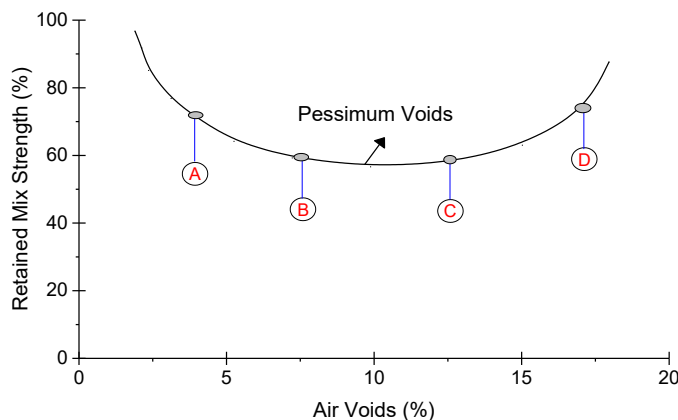
Figure 1-2. Air-void content vs. retained mix strength, the region of pessimum (Terrel and Shute 1989; Kaukuntla 2014)

Kandhal (Kandhal 1994) has described factors that can induce the premature stripping of asphalt pavement under seal coatings, such as inadequate pavement drainage, inadequate compaction degree of asphalt mixture, excessive dust coating on aggregate, and inadequate drying of aggregate. Kandhal et al. (Kandhal, Lubold, and Roberts 1989; Kaukuntla 2014) reported that if excessive water (or moisture) is present in the asphalt pavement, surface, or subsurface, then the asphalt pavement can strip prematurely. Stripping is a localized phenomenon that occurs in areas of pavement and is caused by inadequate subsurface drainage. Inadequate compaction of HMA material is probably the most common construction-related factor to cause premature stripping. Terrel et al. (Terrel and Shute 1989; Kaukuntla 2014) have developed the concept of pessimum voids percentage for stripping, as shown in Figure 1-2. Figure 1-2 shows that at less than 4.0% voids (region A), the asphalt mixture is virtually impermeable to water, but most asphalt pavements are constructed in regions B and C. The asphalt mixture strength becomes less affected by water when the voids increase to region D and beyond. The pessimum voids, shown in regions B and C, are the opposite of optimum (Kandhal 1994). Parker (Parker Jr 1989; Kaukuntla 2014) studied the influence of inadequate drying of aggregate on the stripping of asphalt pavement, and the results indicated that a high residual-moisture percentage in the aggregate before mixing with asphalt binder increases the potential for stripping.

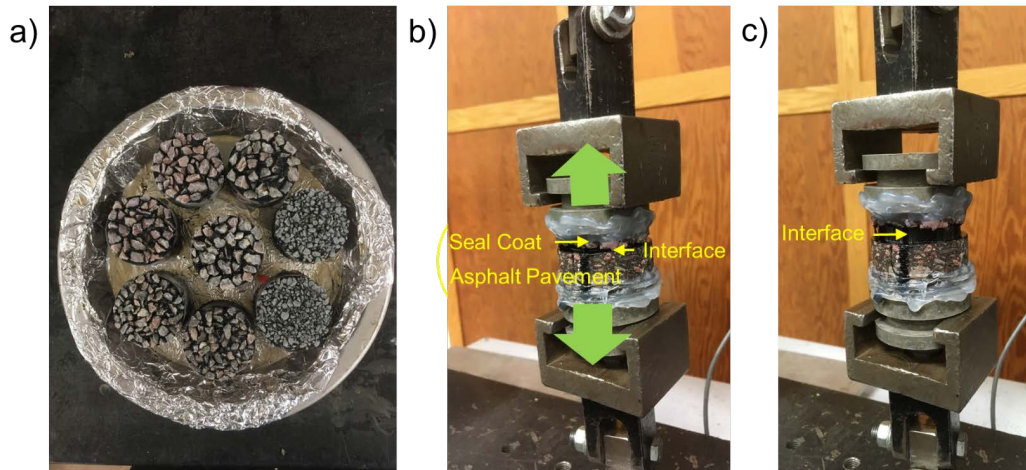
Figure 3-1. Cross-section and schematic of IBT test by material testing system (mts): a) laboratory IBT samples, b) before IBT test, and c) after IBT test

In addition, the aluminum caps/molds were hot glued to both faces of the cut sample. The sample was then set to cure for 24hrs. Given that the bond strength between the aluminum mold and hot glue was estimated to be over 2.2MPa, with the bond strength between the hot glue and asphalt pavement estimated to be about 1.4-1.5MPa, the interface bond strength between asphalt-emulsions at just 0.7-1.5MPa was found to be the least strong bond. The strength of hot glue is over 13.5MPa. Thus, when performing an interface bond strength test at different temperatures, the interface bond was expected to be the first to fail when the MTS used a loading of 0.83mm/sec., with the threshold value at 19.6N. The partial view and the schematic of the IBT test by MTS are presented in Figure 3-1. Furthermore, a typical IBT test (AE-1 with Trap-Rock at 25°C) loading curve by MTS is shown in Figure 3-2. The IBT specimen performs at the linear-elastic region before structural damage occurs. As such, the maximum load just before the specimen ruptured was selected to evaluate and express the interface bond strength between the seal coat and asphalt pavement at different test temperatures.

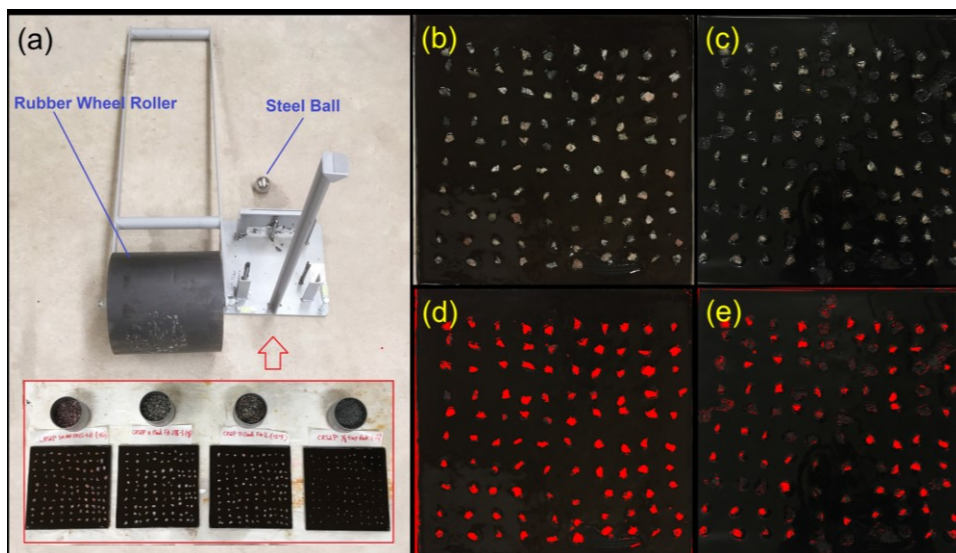
Figure 3-3. Vialit test set-up and typical Vialit test results (ae-1 with Trap-Rock): a) Vialit set-up, b) and d) samples before Vialit test, c) and e) samples after Vialit test

Samples were prepared with 79g (1.90 L/m²) of asphalt-emulsion on clean and dry stainless-steel plates (20cm×20cm). Exactly 100 washed and graded aggregate particles were placed in 10×10 rows onto the emulsion. After 15 minutes of curing, the sample was compressed with a rubber roller. The sample was then allowed to cure at room temperature (25°C) for a minimum of 12hrs. Once cured, the individual plates were conditioned at three different temperatures for 30 minutes. Plates were assembled in the Vialit apparatus individually and faced down. A 500g steel ball was dropped from a distance of 50cm onto each stainless-steel plate for three hits. After each drop, the plate was examined, and the remaining aggregate particles were counted (Gheni and ElGawady 2017). For example, Figure 3-3 illustrates the test sample before and after the Vialit test, where the final retained aggregate number out of 100 aggregate in the asphalt-emulsion is 56; thus, the final retention ratio of this specimen is 56%. The test apparatus used in the Vialit test can be seen in Figure 3-3(a). Figures 3-3(b) and 3-3(c) illustrate the test sample before and after the Vialit test, respectively. In addition, in order to highlight the aggregate distribution pre and posttest, Figures 3-3(b) and 3-3(c) were adjusted to Figures 3-3(d) and 3-3 (e) by ImageJ, respectively. In the manipulated image, the color red denotes the position of aggregate retained in the asphalt emulsion.

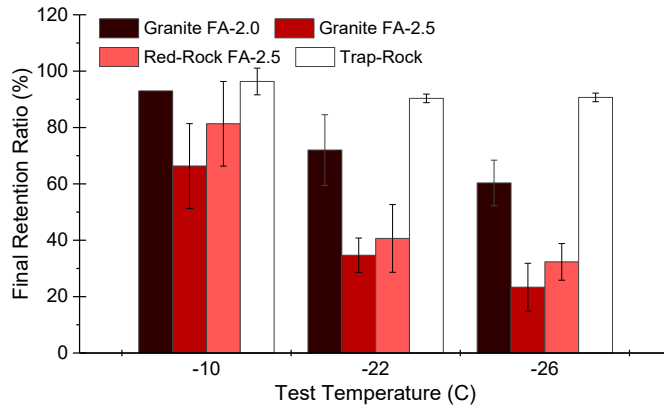
(a) Final retention ratio of ae-1 with four aggregates

aggregate type can be found at one of three temperatures. The error bars demonstrate the ± 1 standard deviation from the average value. Figure 3-4 (a) presents the final retention ratio of the aggregates tested within the AE-1 emulsion at different temperatures, while Figure 3-4 (b) illustrates the final retention ratio of the aggregates embedded in AE-2 at different temperatures. It can be observed that, in general, the final retention ratio of aggregate decreased proportionally with a decrease in temperature for both emulsion types. It must be noted, however, that the AE-1 samples using trap rock slightly increased in retention ratio from -22°C to -26°C . This result indicates that lower temperatures result in weaker adhesive performance, or durability, between the aggregate and the asphalt-emulsions. Mostly this is because the asphalt-emulsion became fragile and glassy after freezing and thus subject to brittle behavior upon impact. The testing also revealed that AE-1 had a better low-temperature adhesive performance for all aggregate types than that of AE-2. The trials also revealed the performance of different combinations of asphalt-emulsion and aggregate, concluding that aggregate type and binder both had a significant impact on the final retention ratio of aggregates.

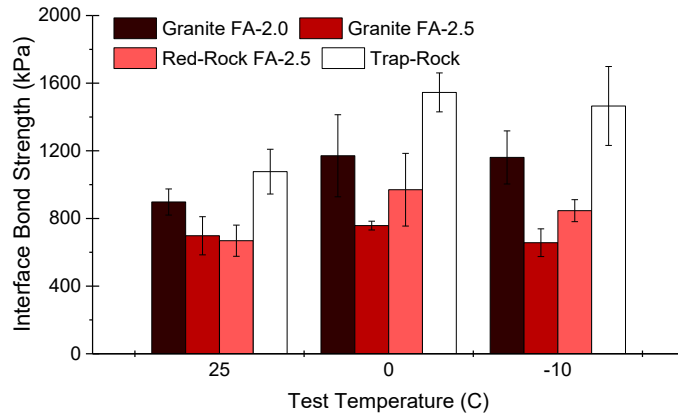
(a) AE-1 seal coats

The durability of seal coats on asphalt pavement is partially determined by the interface bond strength between the seal coat layer and the asphalt pavement. Therefore, a weak interface bond strength between the seal coat layer and the asphalt pavement may contribute to the failure of asphalt pavement under seal coat with premature stripping. In consideration of the possible cold service conditions for the seal coat in the field, the interface bond strength of the seal coats at 25°C, 0°C, and -10°C was tested. Figure 3-5 illustrates the laboratory interface bond strength of AE-1 and AE-2 seal coats at different temperatures. Each bar in this figure represents the average interface bond strength value of three replicates, and the error bars demonstrate ± 1 standard deviation from the average value. In this figure, the effect of the asphalt-aggregate combinations on the interface bond strength at different test temperatures is displayed. From Figure 3-5 (a) and (b), it can be seen that at 25°C, the interface bond strength was higher for AE-2 than for AE-1. For instance, for the aggregate Red-Rock FA-2.5, the average bond strength was found to be 668kPa and 842kPa. However, while AE-2 displayed a greater average strength for all of the aggregate types, both Granite FA-2.5 and 2.0 aggregates displayed very similar strengths. In particular, Granite FA-2.0 was found to have a strength of 867kPa for AE-1 and 861kPa for AE-2. Trap-Rock performed the best for the asphalt-emulsion with 1.63 L/m² application rate, with a bonded strength of 1077kPa for AE-1 and 1193kPa for AE-2. This could be caused by the higher percentage of fine aggregate particles in the employed Trap-Rock, as well as by the interactions between the aggregate particles and asphalt. For instance, the higher calcium ion content on the surface of Trap-Rock may have developed more ionic bonds with the carbonyl group in the asphalt-emulsion.

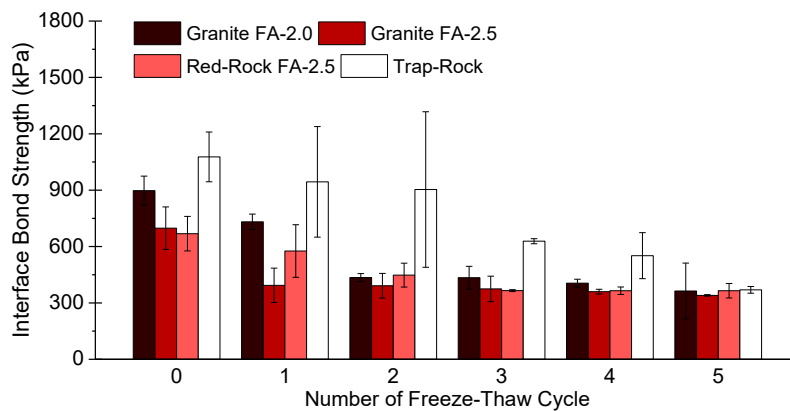
Figure 3-6. Interface bond strength for AE-1 seal coat with multiple freeze-thaw cycles

Furthermore, after the fifth freeze-thaw cycle, the interface bond strength decreased to a total of 58.13%, 51.22%, 45.36%, and 65.69% for Granite FA-2.0, Granite FA-2.5, Red-Rock FA-2.5, and Trap-Rock, respectively. It can be seen that after the fifth freeze-thaw cycle, the Trap Rock seal coat displayed the most considerable total loss in interface bond strength at 65.69%. Since the loss of interface bond strength was greater than 40% for all aggregate emulsion combinations, the effect of the freeze-thaw cycle can be considered significant. Moreover, the freeze-thaw cycle may be seen as a critical external factor in the premature stripping of pavement under the seal coat.

The seal coat tested with Trap-Rock displayed the best resistance to the freeze-thaw cycles despite displaying the most significant percentage decrease in strength. The surface properties and the smaller aggregate size range of the Trap-Rock may be concluded to have had a positive impact on the resistance to the freeze-thaw cycle of seal coat. As mentioned in the Reference (Wood, Janisch, and Gaillard 2006), the asphalt-emulsion application rate used in this study (0.36 gal/yd²) for the Trap-Rock and Granite FA-2.0 was higher than the recommended application rate. Therefore, a lower air void composition was present in the seal coat layer with the Granite FA-2.0 and Trap-Rock when compared with the seal coat layers of Granite FA-2.5 and Red-Rock FA-2.5. The presence of fewer voids reduced the microstructural damage due to ice expansion of voids during the freeze-thaw cycles, and thus the larger aggregates produced an increase in microstructural damage. This may be the reason that the smaller aggregate particles resulted in higher resistance to the freeze-thaw cycles. For example, after the first freeze-thaw cycle, the interface bond strength loss rate of the seal coat with Granite FA-2.0 and FA-2.5 was 14.36% and 43.19%, respectively.

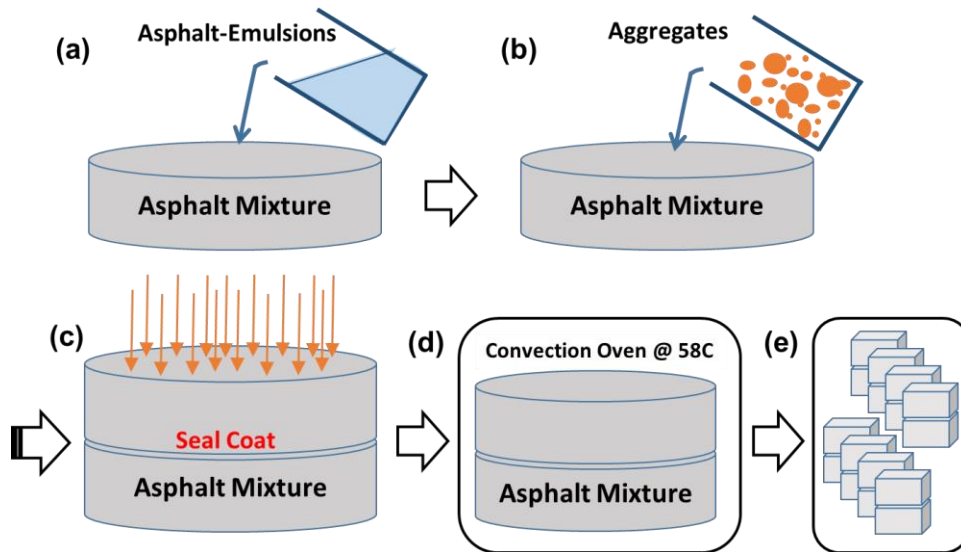
Figure 4-1. Laboratory sample preparation steps: a) spraying asphalt-emulsions, b) spraying aggregates, c) compressing sample by using rubber wheel roller, d) oven curing, and e) cutting sample to square shape (2×2 inches)

In order to investigate the shear bond strength of the laboratory seal coats, the laboratory SBT samples were prepared according to the preparation steps in Figure 4-1. Here, laboratory seal coat samples for the SBT were prepared based on the seal coat design method used in Minnesota (Wood, Janisch, and Gaillard 2006). First, the large core samples (150mm diameter) were cut and allowed to dry. Samples were then

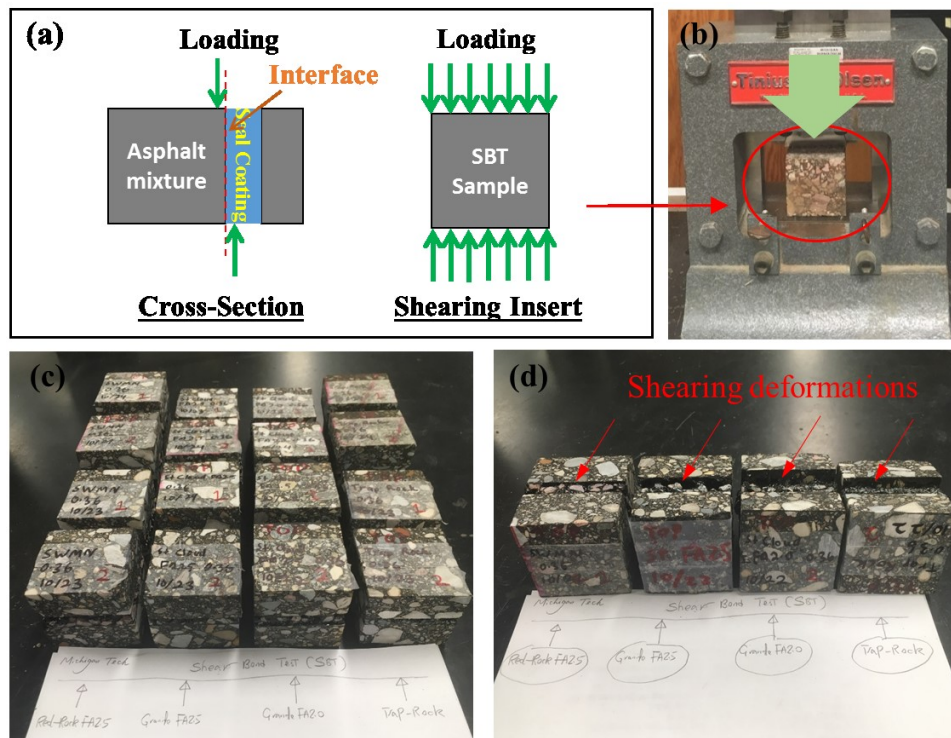
Figure 4-2. Cross-section and schematic of SBT by material testing system (MTS): a) schematic of SBT, b) laboratory SBT, c) sample before SBT, and d) sample after SBT

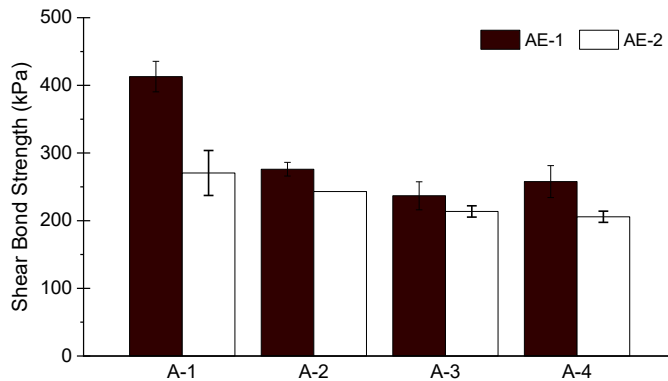
Figure 4-3. Shear bond strength for AE-1 and AE-2 seal coat with the aggregate of (a-1) Trap-Rock, (a-2) Granite FA-2.0, (a-3) Granite FA-2.5, and (a-4) Red-Rock FA-2.5

larger aggregates produced a diminished contact interface (Leng et al. 2008; Reitzel et al. 2000). This might explain why the smaller sized aggregates resulted in a more muscular shear bond strength between the seal coat and asphalt pavement when the same asphalt-emulsion application rate was administered.

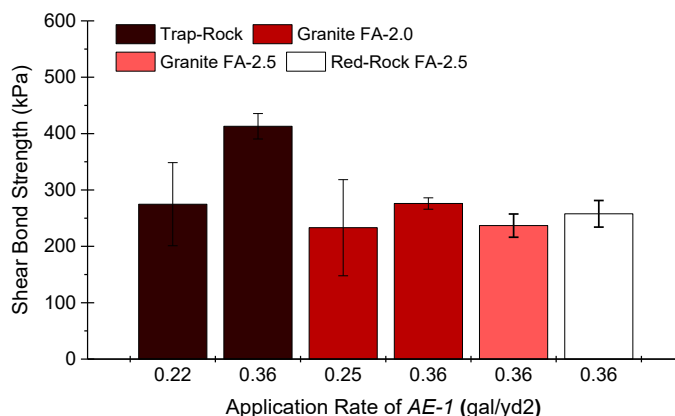
Figure 4-4. Shear bond strength for AE-1 seal coat at different asphalt application rates

optimum asphalt-emulsion application rate for each aggregate type, and then the test results were compared with the results from the samples with the same asphalt-emulsion application of 1.63 L/m² (0.36 gal/yd²).

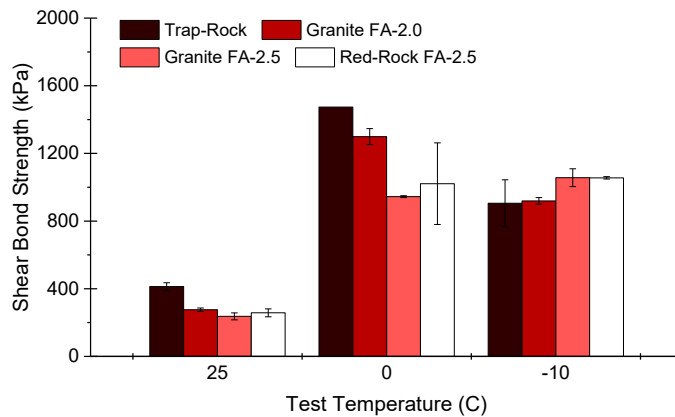
Figure 4-5. Shear bond strength for AE-1 seal coat at different SBT temperatures

was higher with lower test temperatures, which may be caused by the asphalt's tendency to become more brittle and harder at low temperatures. The test data shown in Figure 4-5 confirms this assumption. For instance, from 25°C to 0°C, the increased rate in shear bond strength of the Trap-Rock seal coat with asphalt pavement was 258%, which is the smallest increase in all the combinations.

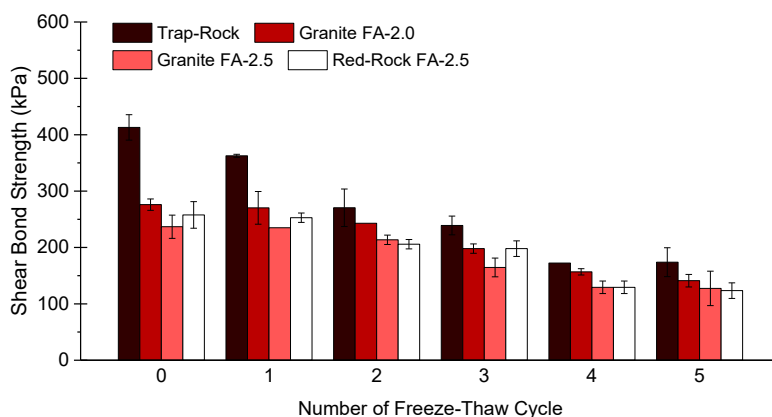
Figure 4-6. Shear bond strength for ae-1 seal coat with multiple freeze-thaw cycles

Figure 4-6 demonstrates that the shear bond strength of seal coat with asphalt pavement decreased with the increase of freeze-thaw cycles. After the first freeze-thaw cycle, the decrease rate for the shear bond strength of Trap-Rock, Granite FA-2.0, Granite FA-2.5, and Red-Rock FA-2.5 seal coats were 12%, 2%, 0.8%, and 2%, respectively. Under freeze-thaw cycle conditions, the Trap-Rock seal coat had the highest rate of shear bond strength loss for the first freeze-thaw cycle. Therefore, it can be concluded that although the performance of Trap-Rock is the best overall, its ability to resist the freeze-thaw cycle is arguably the worst (most temperature-sensitive). This trend was also reflected in the performance of the next repetitive freeze-thaw cycles. After the fifth freeze-thaw cycle, the shear bond strength of the Trap-Rock seal coat with asphalt pavement was reduced by 58%, which is the greatest reduction of all the combinations. In addition, it was found that the larger sized aggregate provided better durability of seal coat for multiple freeze-thaw cycles. For instance, the Granite FA-2.5 seal coat had better resistance to multiple freeze-thaw cycles compared with Granite FA-2.0; the shear bond strength loss ratios were 46% and 48%, respectively, after five freeze-thaw cycles. Nevertheless, after five freeze-thaw cycles, the shear bond strength loss of the Red-Rock FA-2.5 seal coat was higher than that of the Granite FA-2.5 seal coat, falling 52% and 46% for Red-Rock FA-2.5 and Granite FA-2.5 seal coats, respectively. According to the information from section 2.1, it can be seen that both Granite FA-2.5 and Red-Rock FA-2.5 have mostly the same aggregate gradation/aggregate size assignment. The difference between the resistances of multiple freeze-thaw cycles of seal coats also may be the micro-interactions due to mineral composition. Therefore, the aggregate size range and mineral compositions can be said to have a significant effect on the resistance of the seal coat to the multiple freeze-thaw cycles.

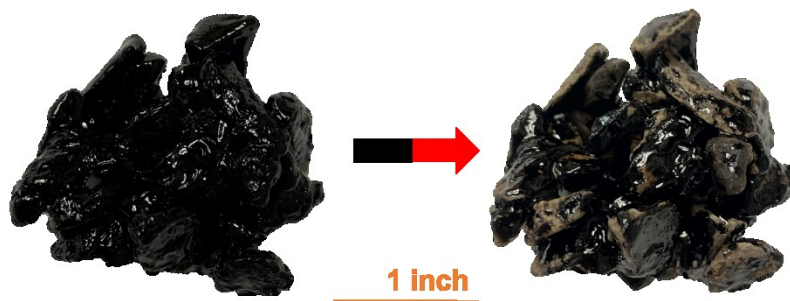
Figure 5-1. Comparison between asphalt mixtures before and after stripping: initial asphalt mixtures (left image) and partial asphalt loss from aggregate surface (right image). Both images are from Michigan Tech Asphalt Lab

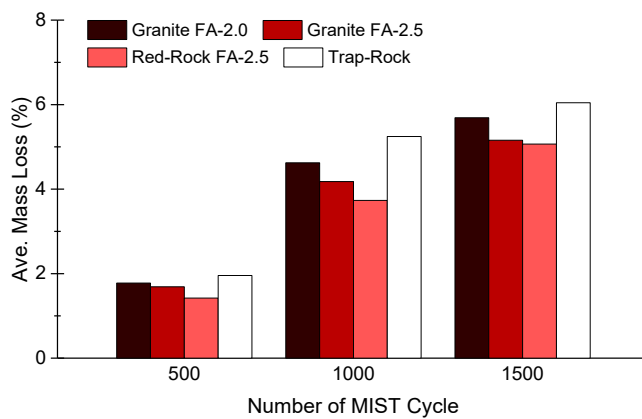
Figure 5-3. Average mass loss of asphalt from seal coat samples after mist tests

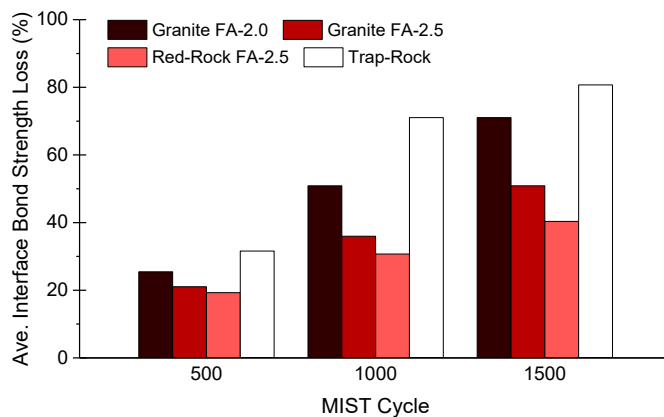
Figure 5-4. Average interface bond strength loss of seal coat samples after mist tests

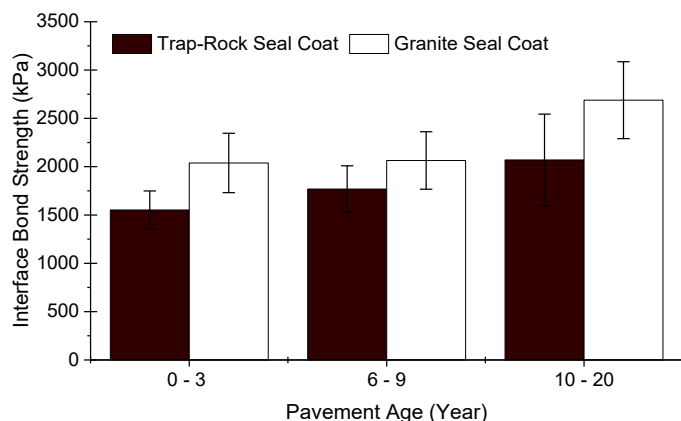
Figure 5-6. IBT testing results of good performance seal coating pavement cores: interface bond strength of seal coat with asphalt pavement. Note that the fracture occurs between asphalt pavement and seal coats during IBT testing, which indicates that the direct tensile strength of asphalt pavement is higher than the interface bond strength of seal coat

Figure 5-6 depicts the IBT testing results of the good performance seal coating pavement cores; the fracture occurs between the seal coat and the asphalt pavement, which indicates that the direct tensile strength of asphalt pavement is higher than the interface bond strength of seal coat. Also, it can be observed that the interface bond strength between the seal coat and asphalt pavement increased with the pavement age increase. This may be caused by the tendency of asphalt in seal coats to become more brittle and harder after long-term aging. Meanwhile, it can be observed that the Granite seal coats performed better in bonding with the asphalt pavement compared with the Trap-Rock seal coats.

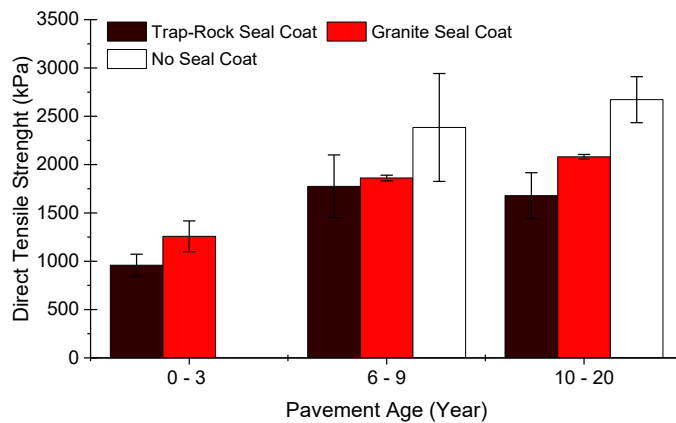
Figure 5-7. IBT testing on partially damaged seal coating pavement cores: direct tensile strength of asphalt pavement under seal coating. note that fractures occur in asphalt pavement during IBT testing, which indicates that the interface bond strength of the seal coat is higher than the direct tensile strength of asphalt pavement in the partially damaged pavements

Figure 5-7 shows the IBT testing results of the partially damaged seal coating pavement cores, revealing the direct tensile strength of asphalt pavement underlying different types of seal coats. It should be noted that the direct tensile strength of the asphalt pavement was evaluated via the testing set-up of IBT, while the fractures occurred in the asphalt pavement. The results indicate that for the partially damaged seal coating asphalt pavement, the interface bond strength of seal coat is higher than the direct tensile strength of asphalt pavement because fractures occur in the asphalt pavement in IBT. In addition, the non-seal coating asphalt pavement (from Deer Hill in Minnetonka) has the highest direct tensile strength, followed by the Granite seal coating pavement and the Trap-Rock seal coating pavement. Also, except for the pavement cores with the Trap-Rock seal coat, the direct tensile strength of asphalt pavement increased with the increase of pavement age. Similarly, this may be caused by the tendency of asphalt in the pavement to become more brittle and harder after long-term aging. From 6-9 to 10-20 years, the slight decrease of the direct tensile strength of the pavement with the Trap-Rock seal coat may be due to the strength loss caused by moisture damage being more massive than the strength improvement caused by the asphalt aging in pavements.

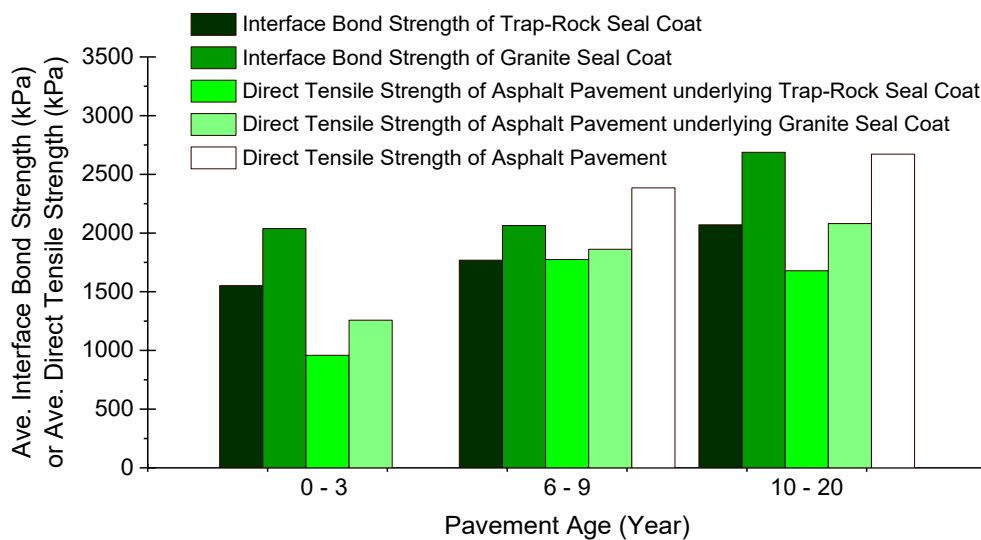
Figure 5-8. Comparisons of the interface bond strength of seal coats and the direct tensile strength of asphalt pavements in good performance and partially damaged pavement underlying various seal coats. Note that for the IBT testing on good performance pavement cores, fractures occur between the asphalt pavement and seal coats, while for the IBT testing on partially damaged pavement cores, fractures occur in the asphalt pavement

By comparing the results in Figure 5-8, it is suggested that if partial damage occurs in the seal coat, this will accelerate the moisture damage in the pavement because environmental moisture (such as rainfall and humidity) seeps into the pavement via the damaged part of the seal coat of the pavement.

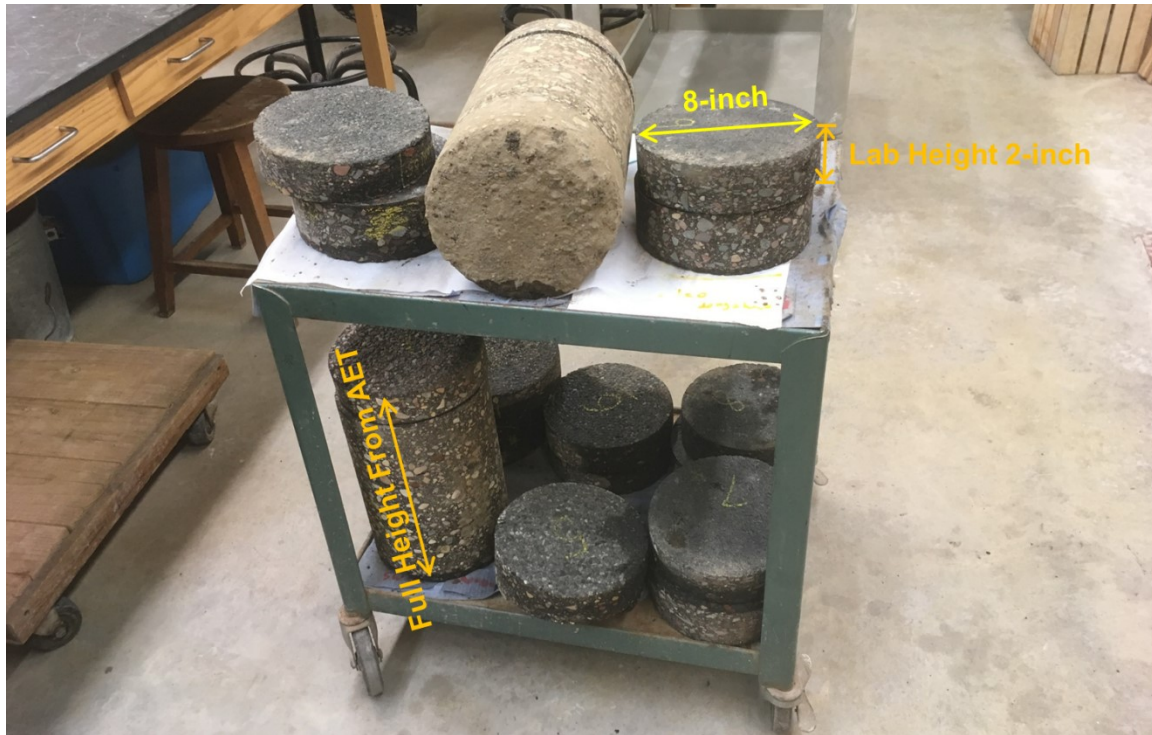
Appendix Figure 44. Height-treated pavement cores

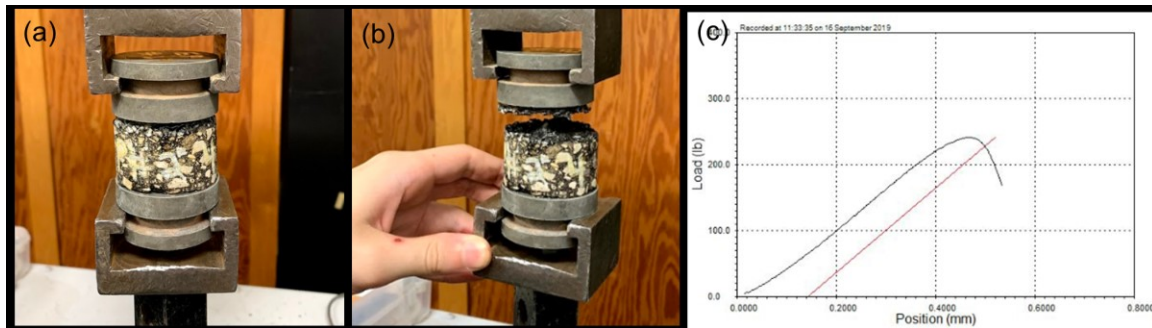
Appendix Figure 47. IBT testing on good performance pavement core with granite seal coat: (a) Before IBT, (b) After IBT, and (c) Loading Curve (Load-Position). Note that the average interface bond strength between the Granite seal coat and asphalt pavement was from at least three replicates for various pavement age conditions, i.e. 0-3, 6-9, and 10-20 years. Thus, the successful IBT testing sample amount about $3 \times 3 = 9$

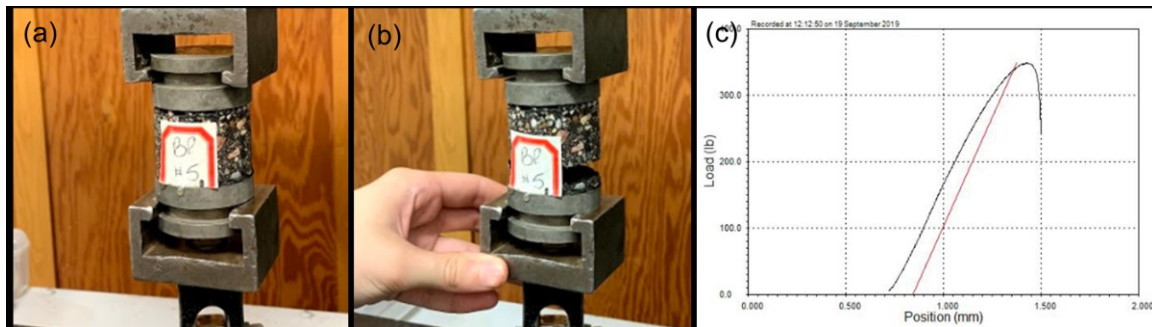
Appendix Figure 48. IBT testing on partially damaged pavement core with granite seal coat: (a) Before IBT, (b) After IBT, and (c) Loading Curve (Load-Position). Note that the average direct tensile strength of partially damaged pavement with Granite seal coat was from at least three replicates for various pavement age conditions, i.e. 0-3, 6-9, and 10-20 years. Thus, the successful IBT testing sample amount about $3 \times 3 = 9$

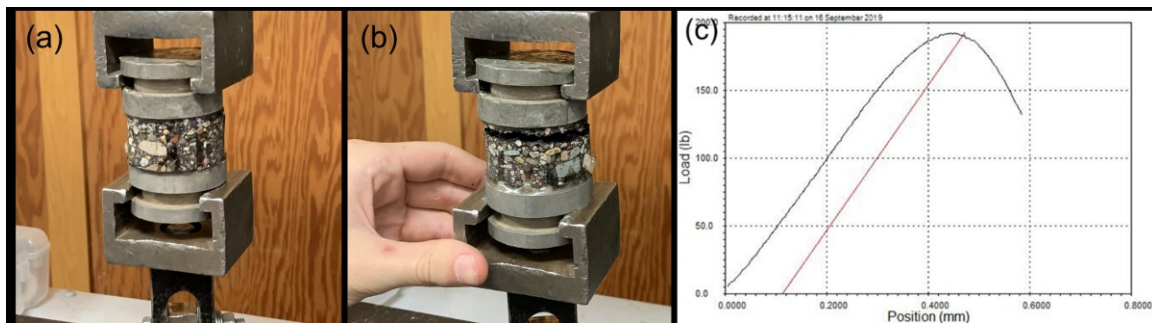
Appendix Figure 49. IBT testing on good performance pavement core with trap-rock seal coat: (a) Before IBT, (b) After IBT, and (c) Loading Curve (Load-Position). Note that the average interface bond strength between the Trap-Rock seal coat and asphalt pavement was from at least three replicates for various pavement age conditions, i.e. 0-3, 6-9, and 10-20 years. Thus, the successful IBT testing sample amount about $3 \times 3 = 9$

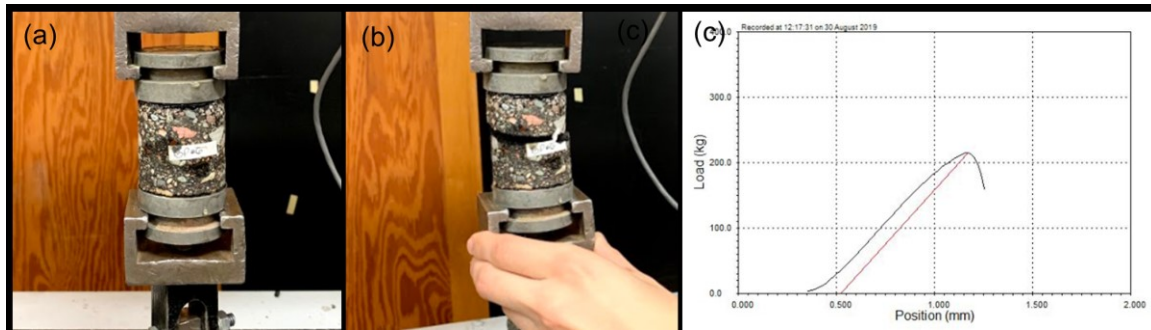
Appendix Figure 50. IBT testing on partially damaged pavement core with trap-rock seal coat: (a) Before IBT, (b) After IBT, and (c) Loading Curve (Load-Position). Note that the average direct tensile strength of partially damaged pavement with Trap-Rock seal coat was from at least three replicates for various pavement age conditions, i.e. 0-3, 6-9, and 10-20 years. Thus, the successful IBT testing sample amount about $3 \times 3 = 9$

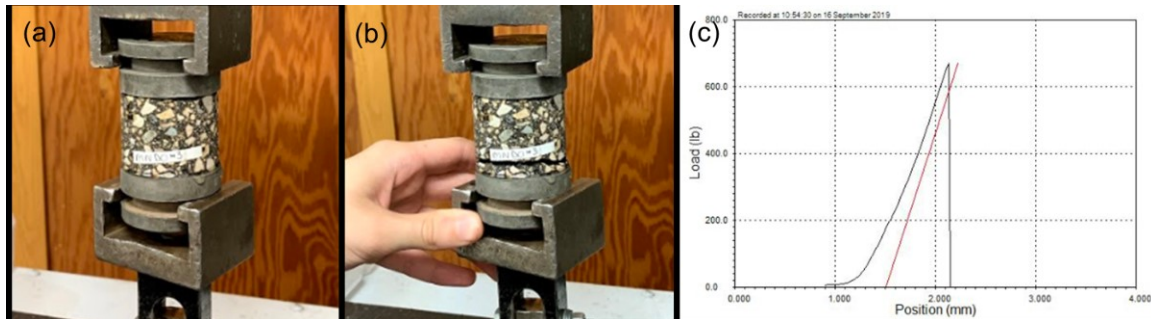
Appendix Figure 51. IBT testing on pavement core with non-seal coat: (a) Before IBT, (b) After IBT, and (c) Loading Curve (Load-Position). Note that the average direct tensile strength of non-seal coating pavement cores was from at least three replicates for various pavement age conditions, i.e. 6-9 and 10-20 years. Thus, the successful IBT testing sample amount about $2 \times 3 = 6$
