Performance Benefits of Fiber-reinforced Thin Concrete Pavement and Overlays

FINAL REPORT

June 2021

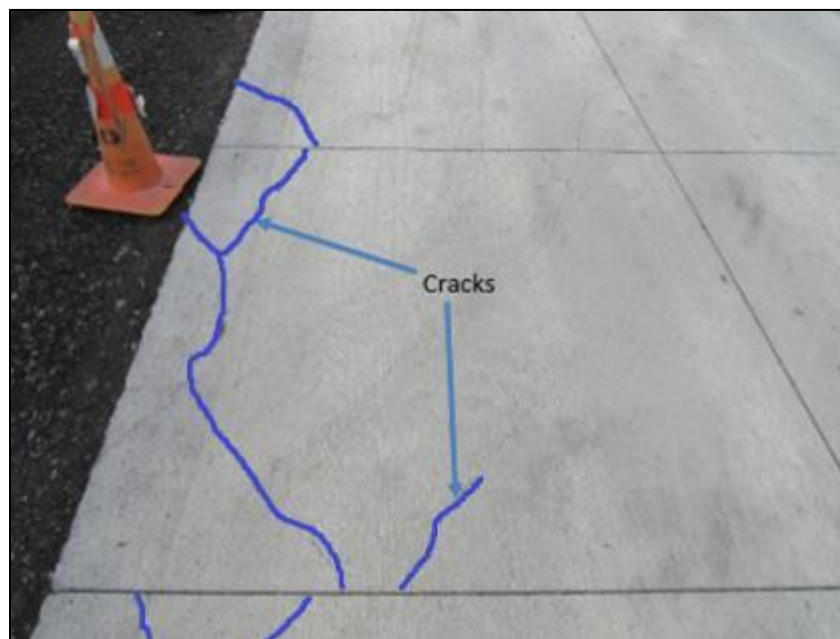
Figure 3-1. Cell 139 after exposure to construction trucks.

Cell 139 was inadvertently exposed to early loads from construction trucks that were using the crossover segment to access other cells under construction, resulting in many early-age cracks. Placement of shoulder materials with heavy equipment may have also caused some of these early cracks to form. Figure 3-1 shows a picture of a couple of such early-age cracks in this cell. These cracks continued to develop and propagated with age and MnROAD truck loadings, which eventually led to the shattering of many slabs by the end of the summer of 2018, as shown in Figure 3-2. Besides that, there was a considerable amount of depression along the outer wheel path at some locations; this distress looked like rutting that occurs in asphalt pavements. Because of this cell's significantly different distress pattern compared to other cells (slab shattering vs fatigue cracking), Cell 139's crack data was not included in studying fibers' influence on the development of fatigue cracks. The distress survey sheet for this Cell is provided in the Appendix.

Due to the occurrence of the high severity distresses (slab shattering and depression along the wheel path), 14 of the 44 slabs in the inside lane of Cell 139 were replaced on September 27, 2018. The replacement slabs were 4-inch thick, with eight of them containing fiber reinforced concrete and the other six with plain concrete. The fibers used in the replacement slabs were different and laterally stiffer than those used in 2017, as shown in Figure 3-3. The dosage of the fiber was 5.5 lbs./cy, which corresponds to a 30% residual strength ratio. The replacement slabs have performed well, with only one crack noticed in the spring 2020 distress survey.

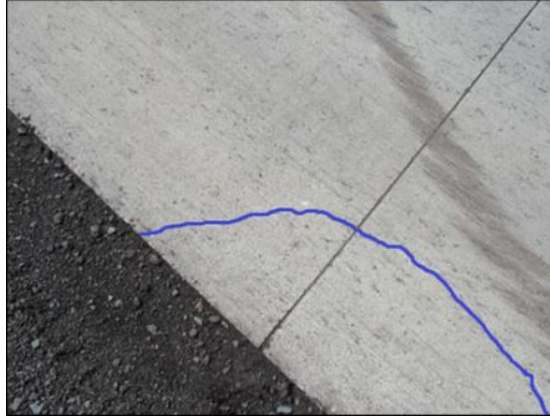
Cell 239 also experienced longitudinal and corner cracks, as shown in Figure 3-5 and Figure 3-6, respectively. Figure 3-7 shows the consolidated distress map indicating the cracks measured at different seasons and years. Some of the corner cracks along the shoulder were thought to be caused by the placement of the shouldering material. This cell performed significantly better than Cell 139 throughout the three years of observation. Based on the distress survey data until March 2020, 35 panels have cracked in this cell, with 27 in the inside lane. A total of 20% of slabs had cracked after 145,000 ESALs in this cell compared to more than 75% cracked slabs in Cell 139 with a similar traffic load.

Figure 3-5. Corner cracks in Cell 239 (2018).

Figure 3-6. Longitudinal cracks in Cell 239 (April 2019)

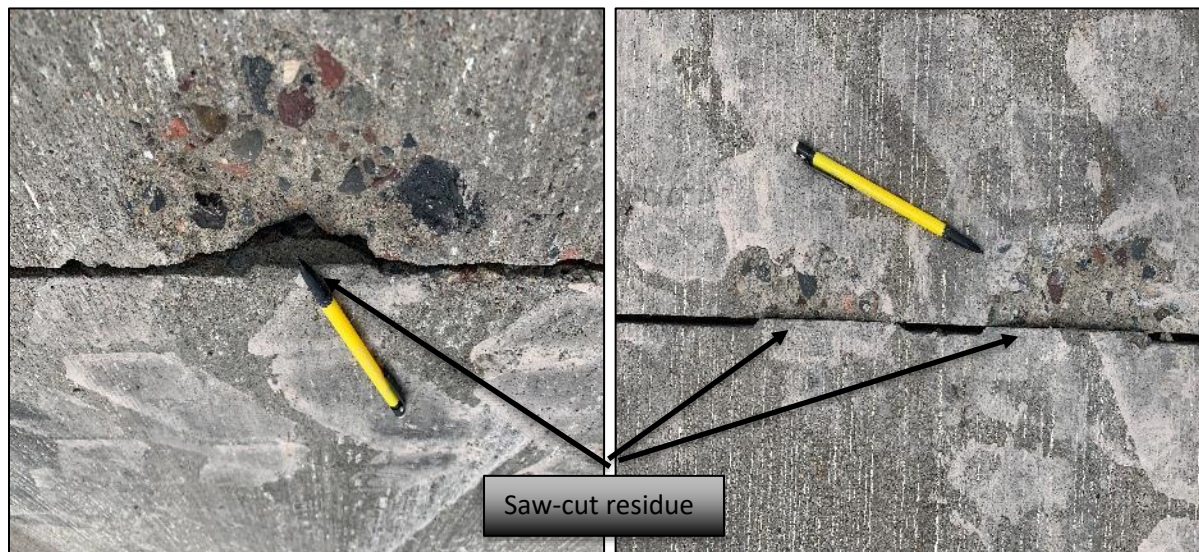
Figure 3-12. Hardened saw-cut residue found at the spalled joints of Cell 506.

Regarding the spalling in Cell 506, upon looking closer at multiple spalling locations, it was found that joint gaps were filled with hardened saw-cut residue; it is assumed that concrete residues were not cleaned out of the joints after sawing. There was a clear correlation between the spalling and the presence of the residue. It was up to ¼" deep and completely spanned the saw cut. Thus, when the joints closed in the summer, the spalls formed in these locations. Figure 3-12 shows two photographs of hardened saw-cut residue found at the spalled joints of Cell 506. No visible saw-cut residue was noticed in the joints of other cells.

Saw-cut residue

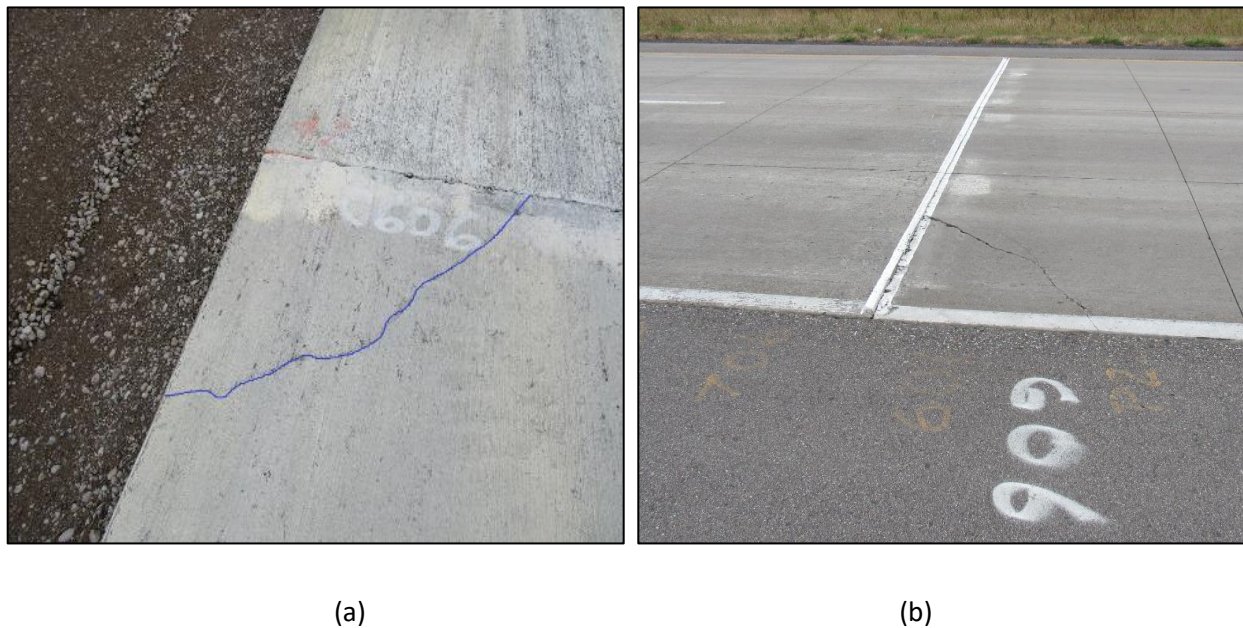
Cell 606, which was constructed with 5 lbs. /cy (20% residual strength) of synthetic structural fibers, experienced one corner crack prior to April 2018. This corner crack was the only crack observed during the 2019 distress survey as well. Figure 3-13 shows photographs of the crack in April 2018 and October 2019. It can be seen that the severity of this crack did not change much as compared to what has happened for the cracks in Cell 506 (Figure 3-8 vs. Figure 3-10). As this crack is located in the last panel next to a cell transition joint, it can be assumed that this crack is not a typical fatigue-related crack; it occurred because of a construction issue. The distress survey conducted in March 2020 found one joint with spalling and two additional low severity corner cracks. Figure 3-14 shows the color-coded distress map for Cells 506 and 606, where the locations of the crack in Cell 506 can be seen.

Figure 3-13. Corner crack (construction issue) in the last panel of Cell 606 observed (a) in the year 2018 and (b) 2019.

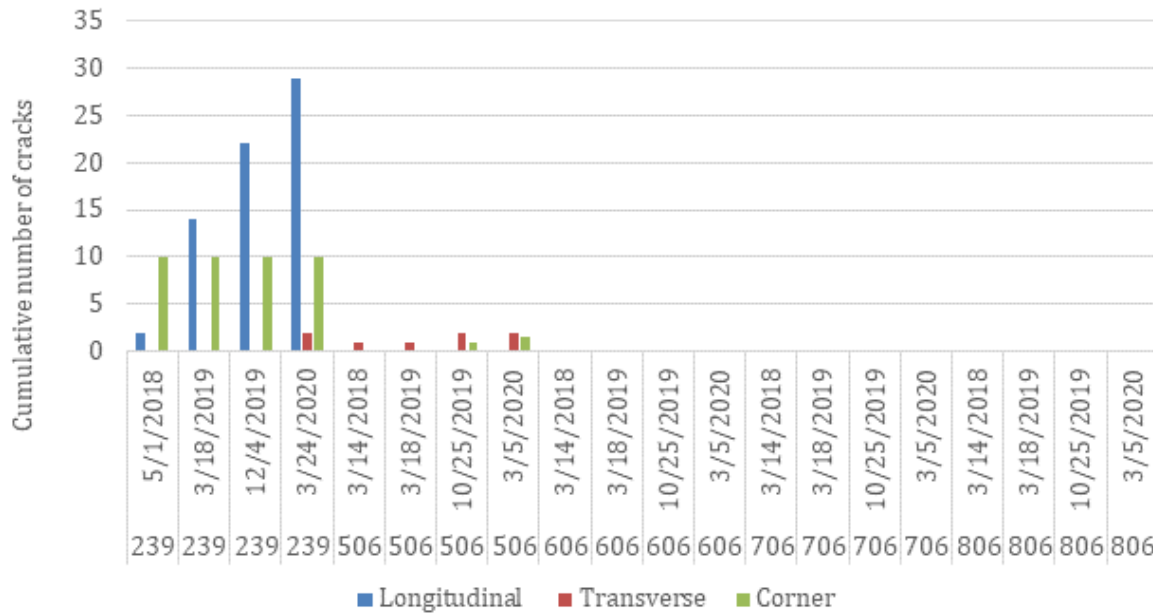
Figure 3-16: Summary of fatigue cracks of cells on gravel base until March 2020 (Cell 139 not shown).

A summary of the fatigue cracks documented in Cells 239 and 506 through 806 until March 2020 is provided in Figure 3-16. This figure does not include the unique distresses that developed in Cell 139. A close looking of Figure 3-7, Figure 3-14, and Figure 3-16 confirm that 4-inch thick Cell 239 (with 8 lbs./cy fibers) has more visible cracks than 5-inch thick 506 and 6-inch thick 606 (with 5 lbs./cy fibers), despite significantly fewer traffic loadings in the low volume test track.

The fatigue crack data of the thin pavement Cells 506-806 confirms that fatigue cracks may not be the dominant distresses for such pavement designs, especially when slabs are constructed on thicker and more stable bases.

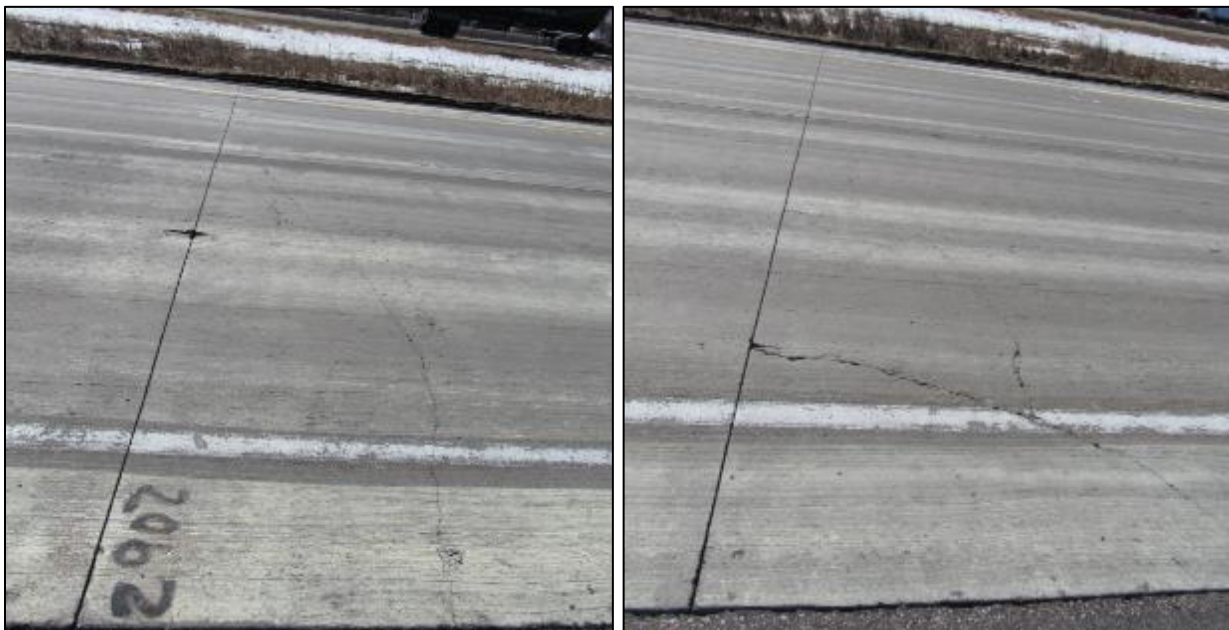
Figure 3-20. Photographs of transverse and corner cracks in Cell 705 as observed during April 2019.

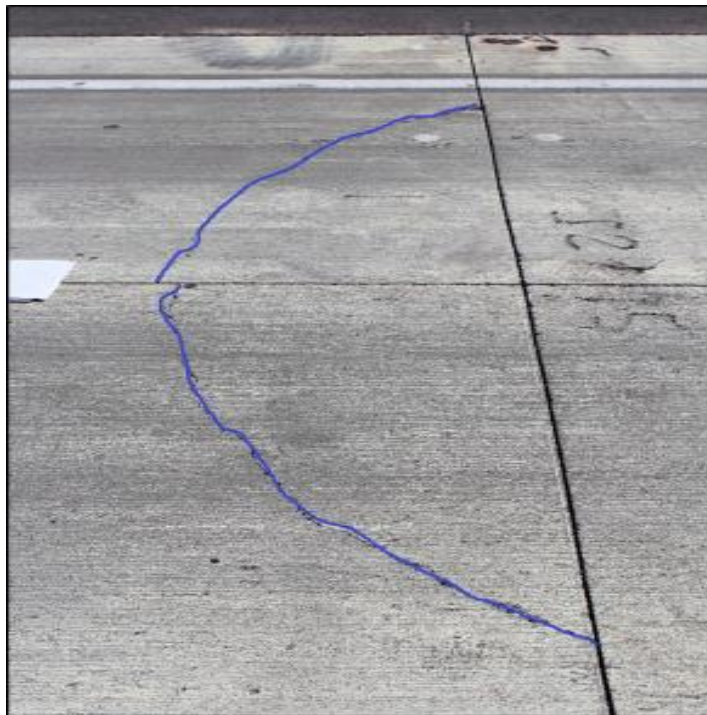
Figure 3-24. Corner crack in Cell 805 (2018)

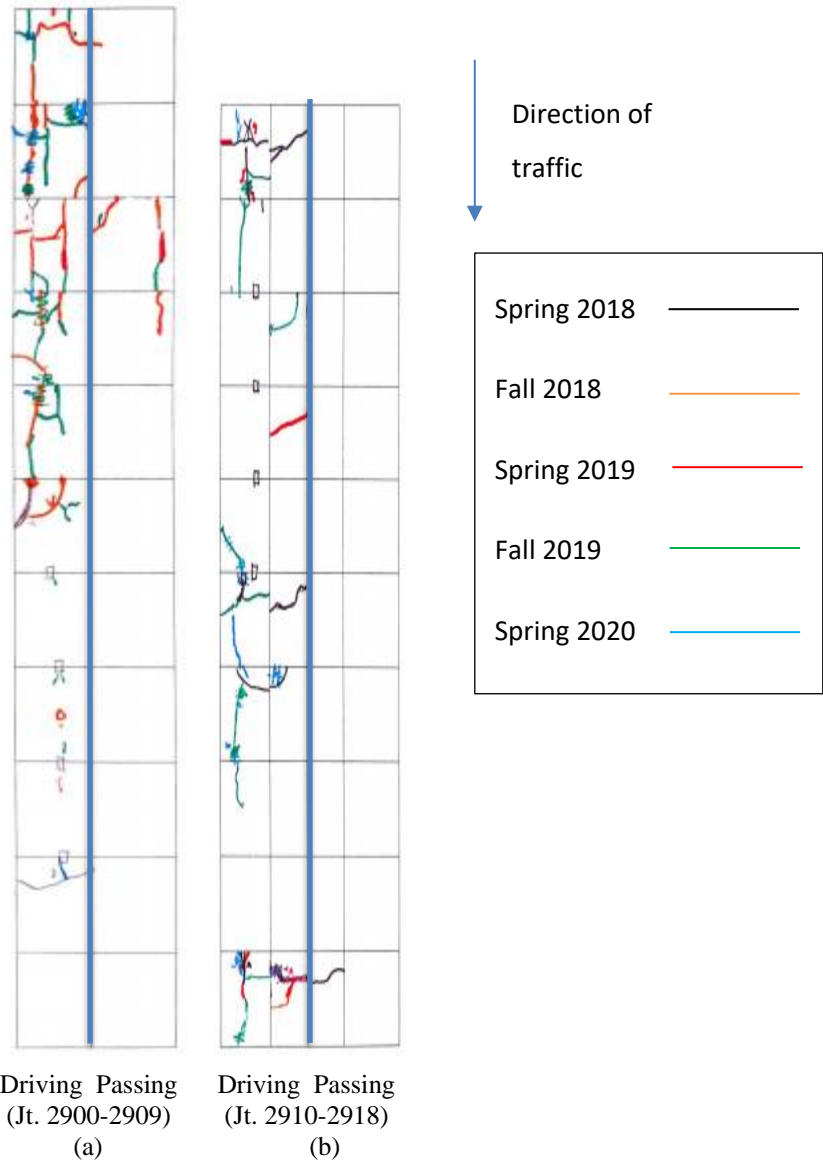
Figure 3-27: Distress Survey Maps (a) Cell 705 (b) Cell 805.

3) Regarding the unbonded concrete overlays placed on a fabric interlayer (Cells 705 and 805), it was seen that Cell 805 with narrow panels resulted in less percentage of cracked slabs (35%) than the wide panels in Cell 705 (50% cracked) after three years of traffic and climate (~ 3 million ESALs). Cell 705 experienced more longitudinal cracks compared to Cell 805, which experienced more transverse cracks. The transverse and corner cracks of Cell 805 and 705 were comparable. It seems the higher slab curvature for thin overlays can create more longitudinal cracks. Faulting and IRI values were also more prominent for Cell 705.

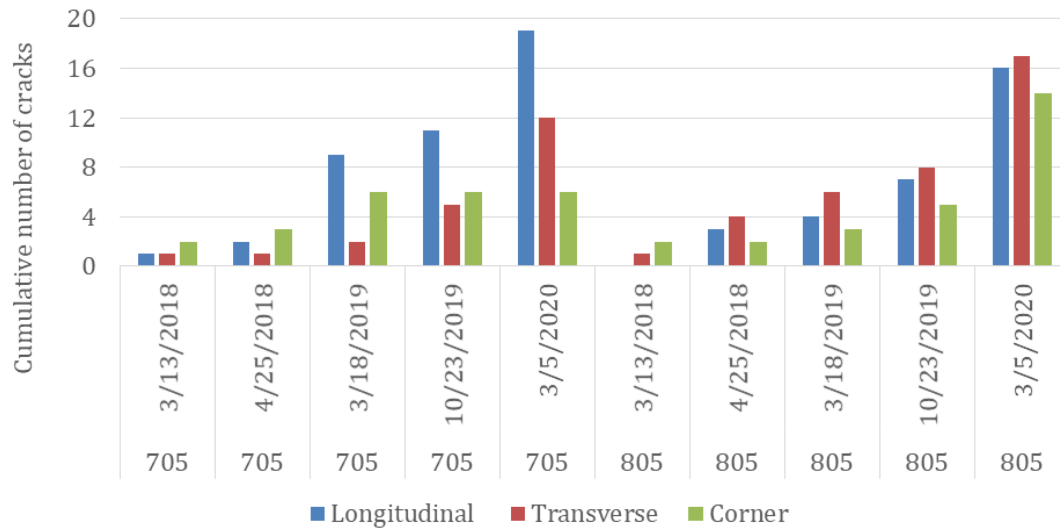
Figure 3-28. Cumulative number of various cracks in Cell 705 and 805.

Color-coded distress maps for Cell 705 and 805 are provided in Figure 3-27, where the locations of the cracks in the cell can be seen. Figure 3-28 presents the cumulative numbers of cracks on different dates for the two cells. Based on the distress survey data available until March 2020, 11 out of 22 panels were

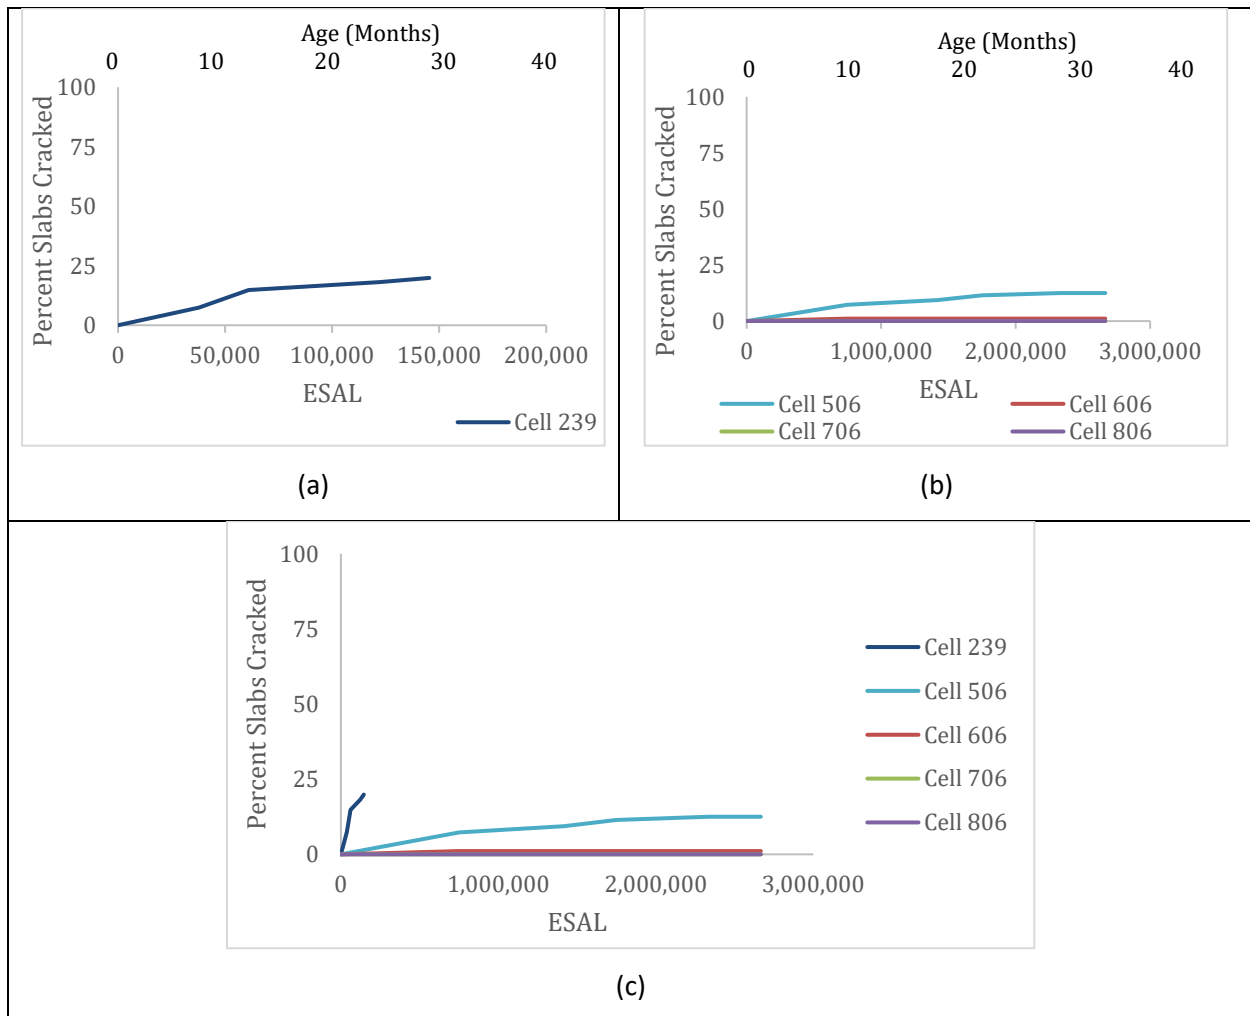
Figure 3-29: Percentage Crack vs. ESAL for both lanes (a) 239 (b) 506,606,706, and 806 (c) 239, 506, 606, 706, and 806.

Figure 3-29 shows the percentage of cracked slabs with respect to age (months) and ESAL for both lanes (combined) of Cells 239 and 506 through 806. Compared to the thin cells (on 11 inches thick unstabilized base), the ultrathin Cell 239 (4 inches panel on 6 inches thick unstabilized base) resulted in significantly higher cracks. Approximately 20% of the slabs of Cell 239 had cracked by 150,000 ESALs; neither of the thin fiber-reinforced cells experienced that many cracked slabs even after 2.8 million ESALs. Figure 3-30 shows the percentage of cracked slabs only on the driving lanes. As much as 30% of the slabs in the driving lanes cracked after 2.8 million ESALs. It may be noted that the reason for the increased amount of fatigue cracks in Cell 239 compared to Cells 506 through 806 is the less structure in Cell 239; thicknesses of both surface and base layers are lower for Cell 239.

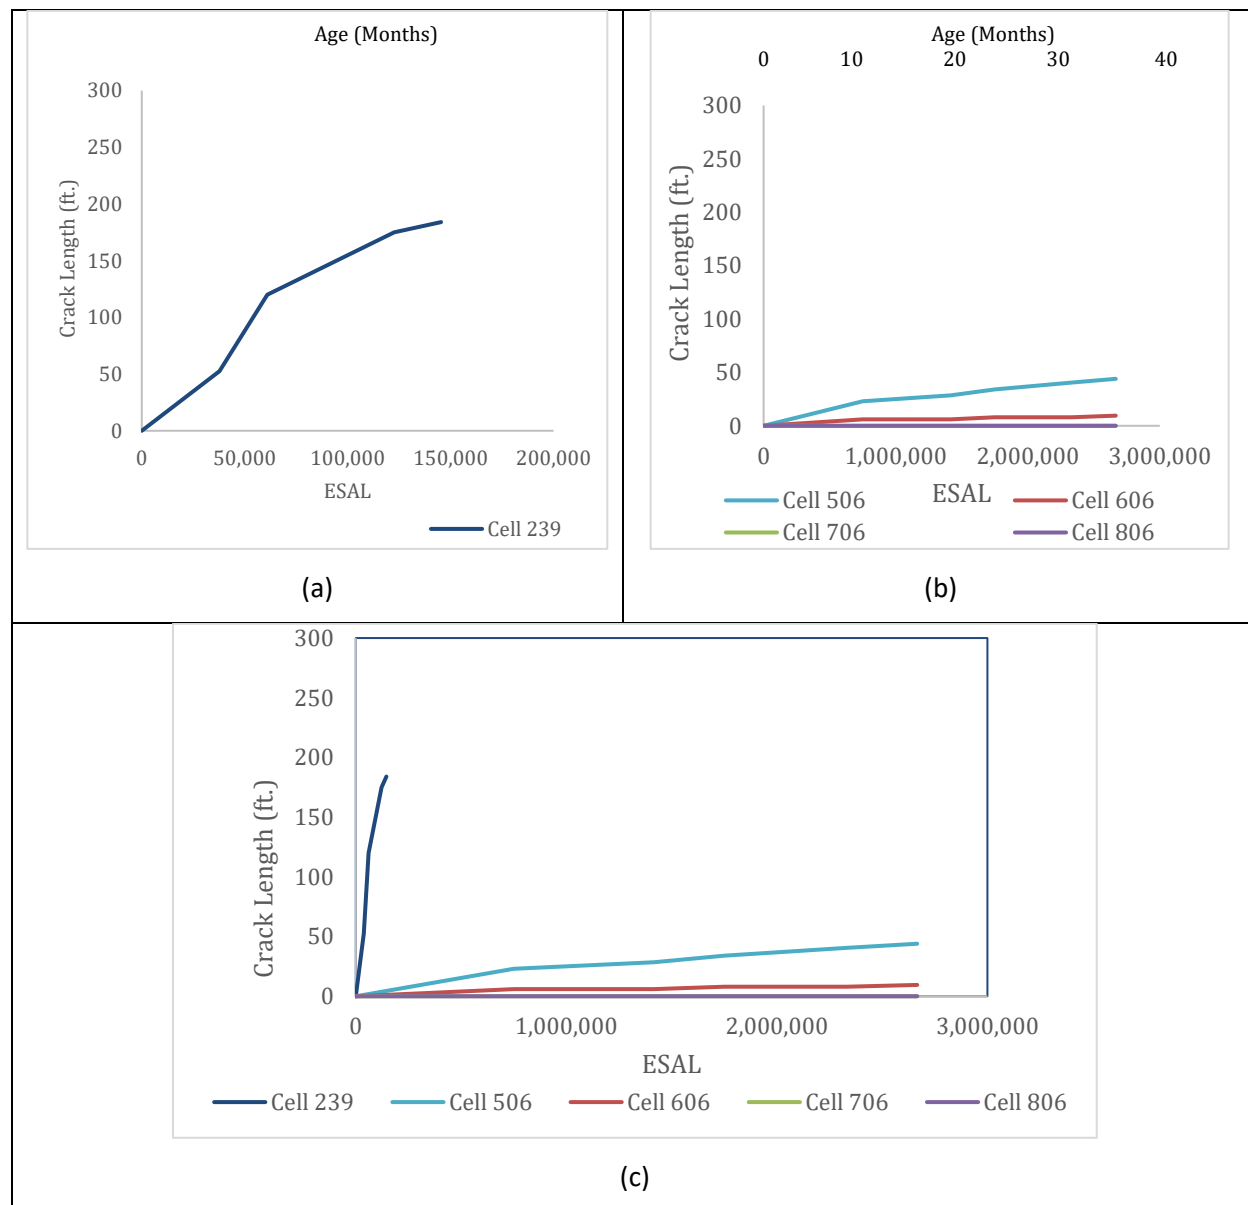
Figure 3-31: Crack Length vs. ESAL for both lanes (a) 239 (b) 506,606,706, and 806 (c) 239, 506, 606, 706, and 806

length between the cells for both lanes and the driving lane (only), respectively. The total crack length for ultrathin Cell 239 was 184 feet compared to 44 feet for Cell 506 after three years of service. Only around 150,000 ESALs were enough to create a total of 184 feet in Cell 239, while the same level of ESALs only created around 10 feet cracks in the thin cells (only in Cell 506, which did not have any fiber).

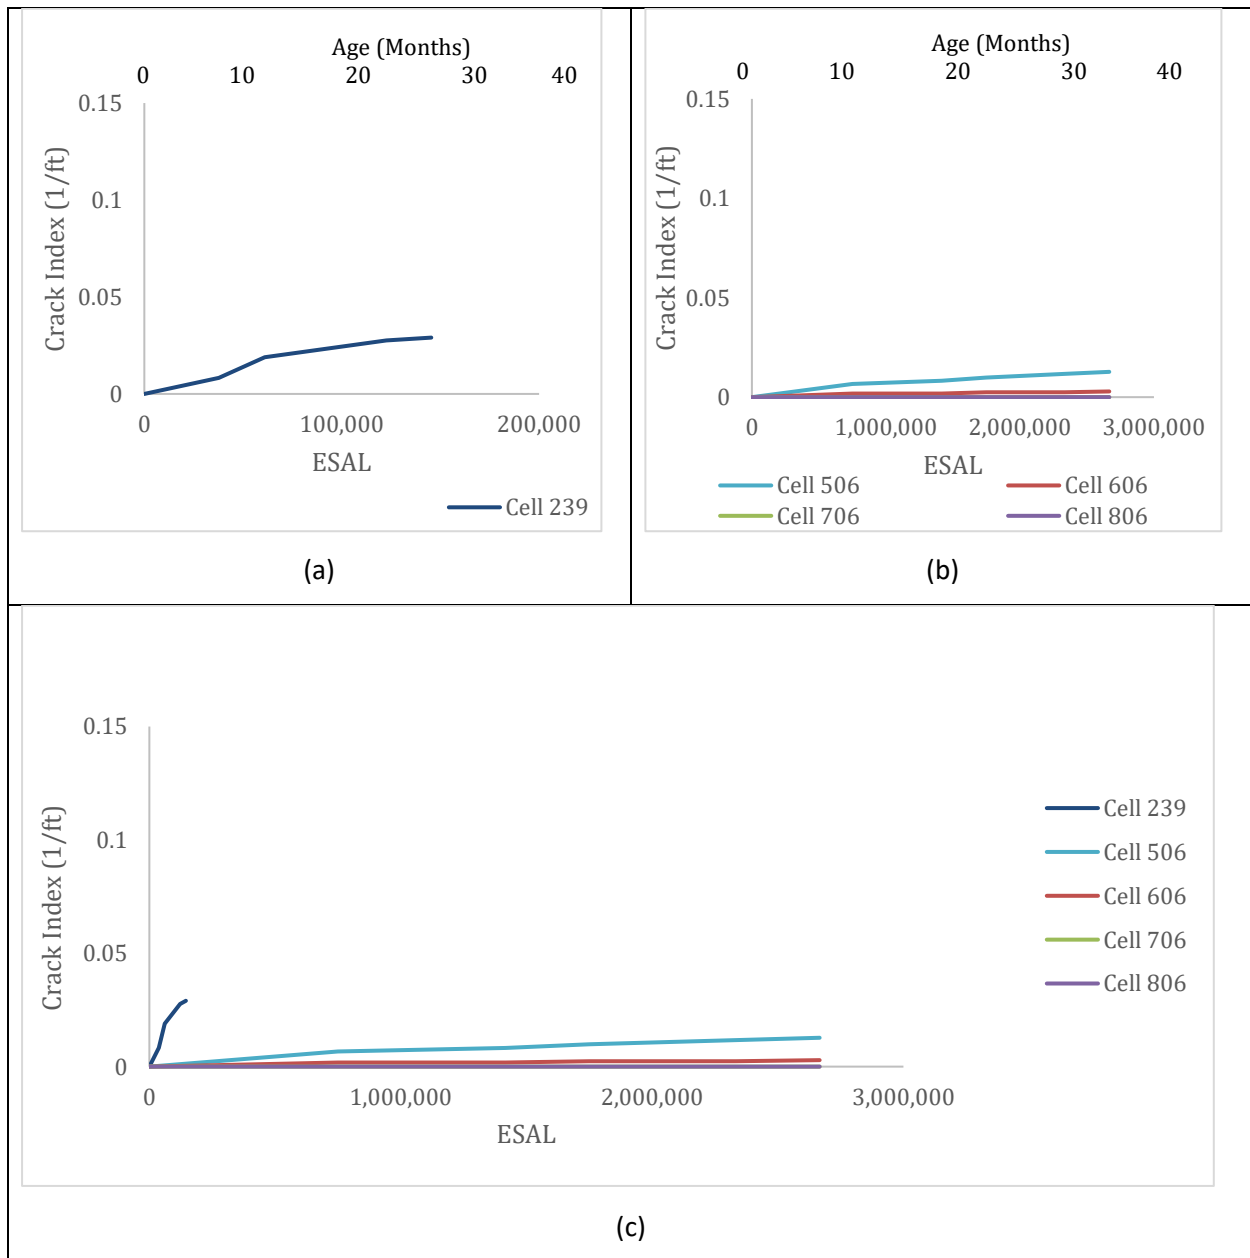
Figure 3-33: Crack Index vs. ESAL for both lanes (a) 239 (b) 506,606,706, and 806 (c) 239, 506, 606, 706, and 806.

However, as the number of slabs and total pavement surface of the cells are different, a factor termed as the 'crack index' has been introduced in this study to include the pavement surface area in the comparison. The crack index (unit = 1/ft) is the ratio of the crack length in ft and the total area of the cell in ft^2. Figure 3-33 and Figure 3-34 compare the crack index between the cells. Based on the crack index, Cell 239 had experienced almost twice the cracks (per unit area) than Cell 506.

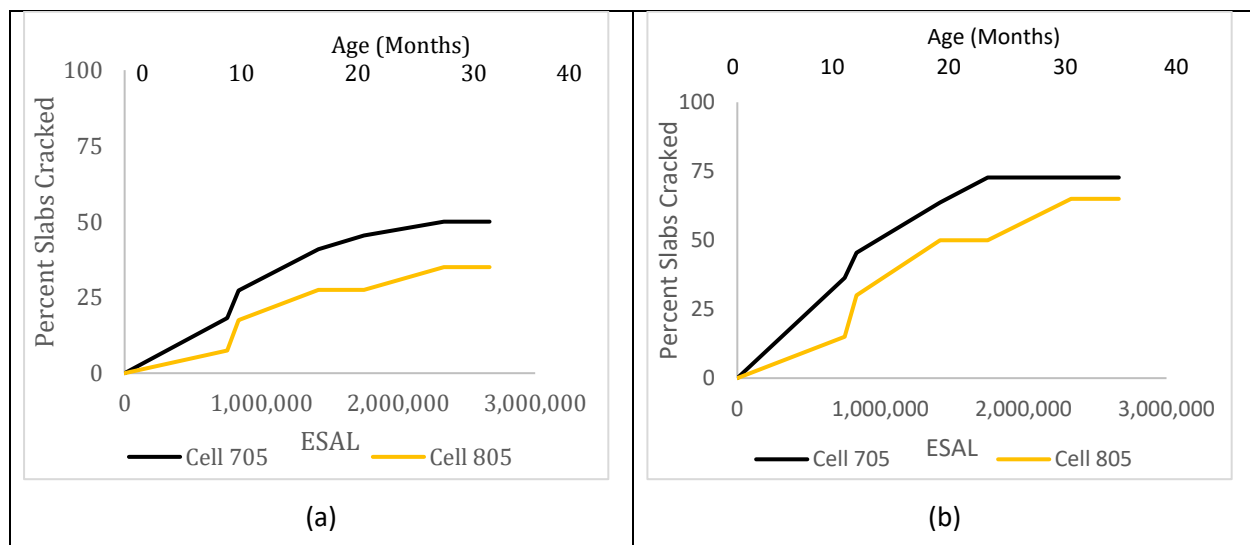
Figure 3-35. Percent slabs cracked vs ESAL for Cells 705 and 805 (a) Driving and Passing lane combined (b) Driving lane only.

Regarding the concrete overlays (Cells 705 and 805), as mentioned in Section 3.1.3, it was seen that Cell 805 with smaller slabs resulted in less percentage of cracked slabs (35%) than Cell 705 (50%) after three years of traffic and climate. Figure 3-35 through Figure 3-37 compare fatigue crack parameters between Cells 705 and 805. When the comparison was made with respect to the crack length, it was found that

the total length of the cracks (both lanes) in Cell 705 was 30% more than Cell 805 after 2.7 million ESALs, as shown in Figure 3-35. However, when the comparison was made with respect to crack index, the difference between the two cells has minimized; the driving lanes of both the cells experienced almost the same crack index, which indicates the crack length on the unit pavement area is similar for both the cells. The above finding suggests that construction of wider panels with synthetic fibers (at least for the dosages and type used in Cells 705 and 805) may not be a better design than using narrower panels in terms of performance.

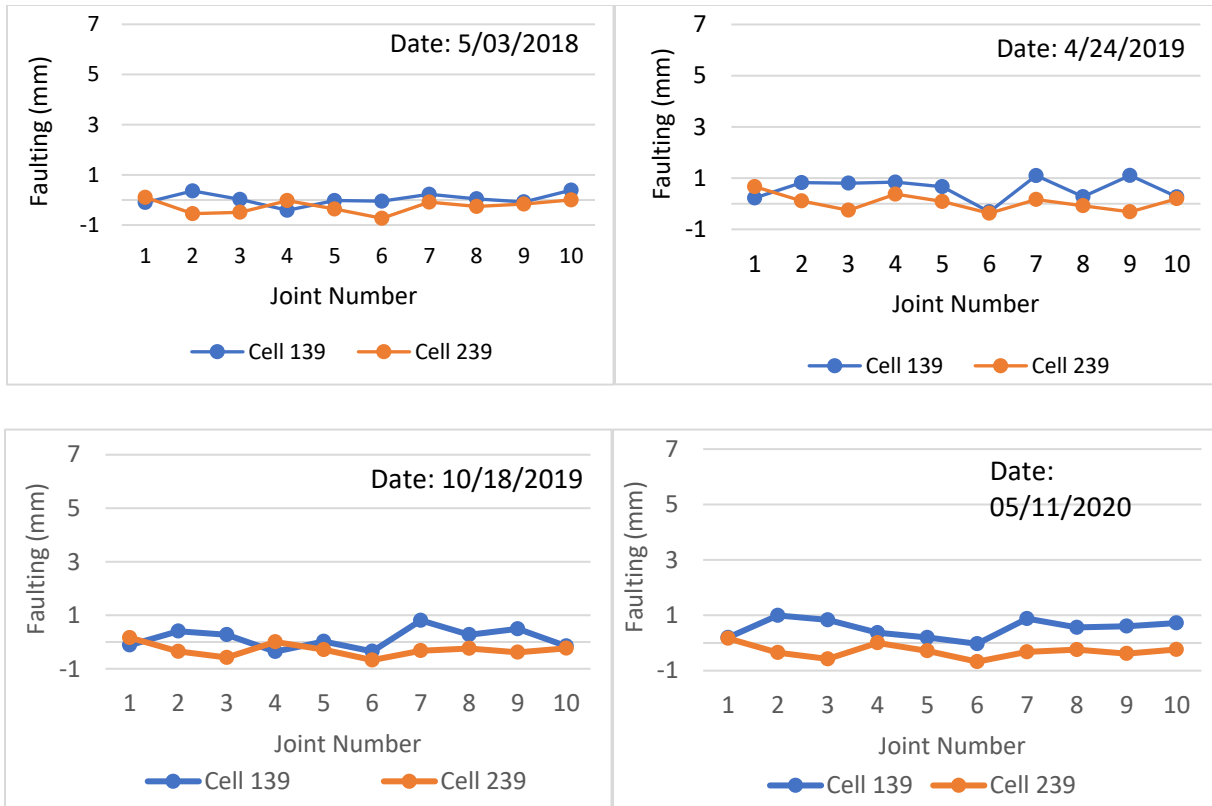
Figure 4-1 shows the faulting measured at ten various transverse joints of Cells 139 and 239, marked as Joint 1 through 10. It shall be noted that the joint numbers in these plots for Cells 139 and 239 and for all other cells are just serial numbers of joints where faulting was measured, which are different from MnDOT's assigned numbers for each transverse joint.

As previously mentioned, a portion of Cell 139 in the inside lane had developed significant depression along the wheel path, so it may not be appropriate to compare the faulting results between Cells 139 and 239. Interestingly, faulting results for Cell 239 mainly showed negative values. Negative faulting is usually not typical (Selezneva et al., 2000), but since the magnitude of the faulting in Cell 239 is below -1 mm until the third year of service, it can be stated that there was not any notable faulting that developed at least at the joints where the faulting values were recorded. This shows that only three years of data (approximately 150,000 ESALs) is not enough to comment on the joint faulting trends of Cells 139 and 239. Additionally, it can be stated that the joint faulting was not the dominant distress for Cells 139 and 239; the fatigue cracking was the dominant distress by far, as discussed in the previous chapter.

Figure 4-1. Faulting summary of Cells 139 and 239 at four different dates until May 11, 2020.

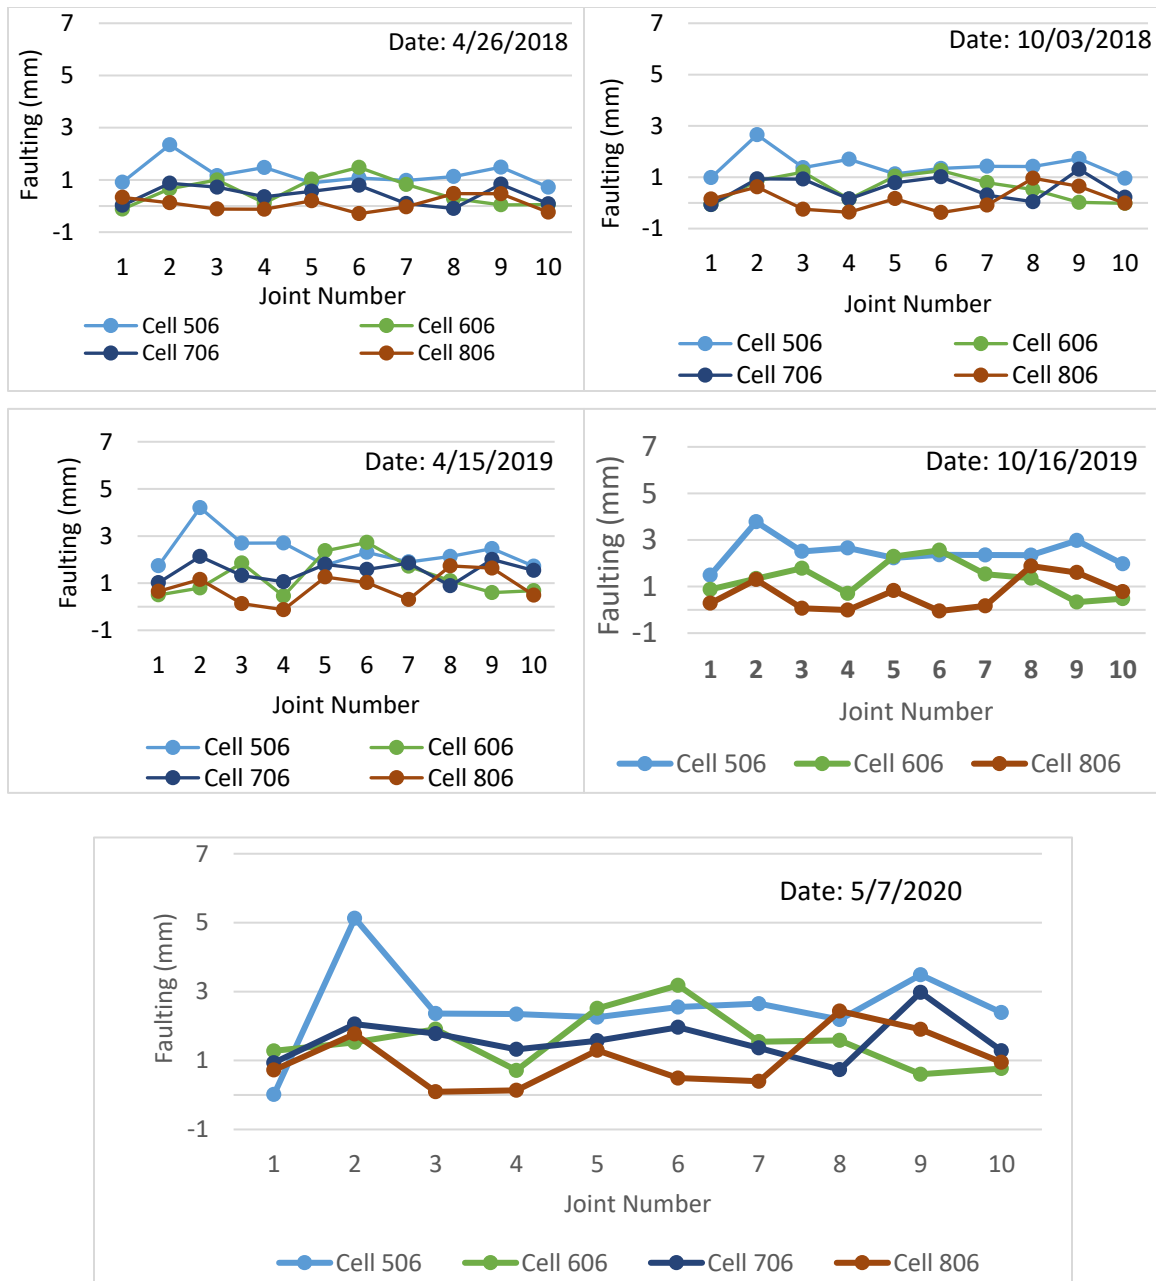
Figure 4-2 shows the faulting measured in Cells 506, 606, 706, and 806 until May 2020. Cell 506, which was constructed with plain concrete, experienced the highest faulting (up to 5 mm) among the four cells. Figure 4-3 shows a photograph of noticeable faulting in Cell 506 (note that there is a sunken corner crack in the leave slab, which exaggerated the faulting in the photo). Figure 4-4 shows the trend of average faulting versus fiber dosage. Cell 606, which was 6-inch thick (higher aggregate interlock) and constructed with a fiber dosage of 5 lbs/cy experienced approximately 82% less faulting than Cell 506 until May 2020. Cell 706, with a fiber dosage of 8 lbs./cy, also underwent less faulting than Cell 506. Cell 806, which had the highest fiber dosage at 11.7 lbs./cy, experienced significantly lower faulting compared to any other FRC cell.

Figure 4-2. Faulting summary of Cells 506 through 806 until May 2020.

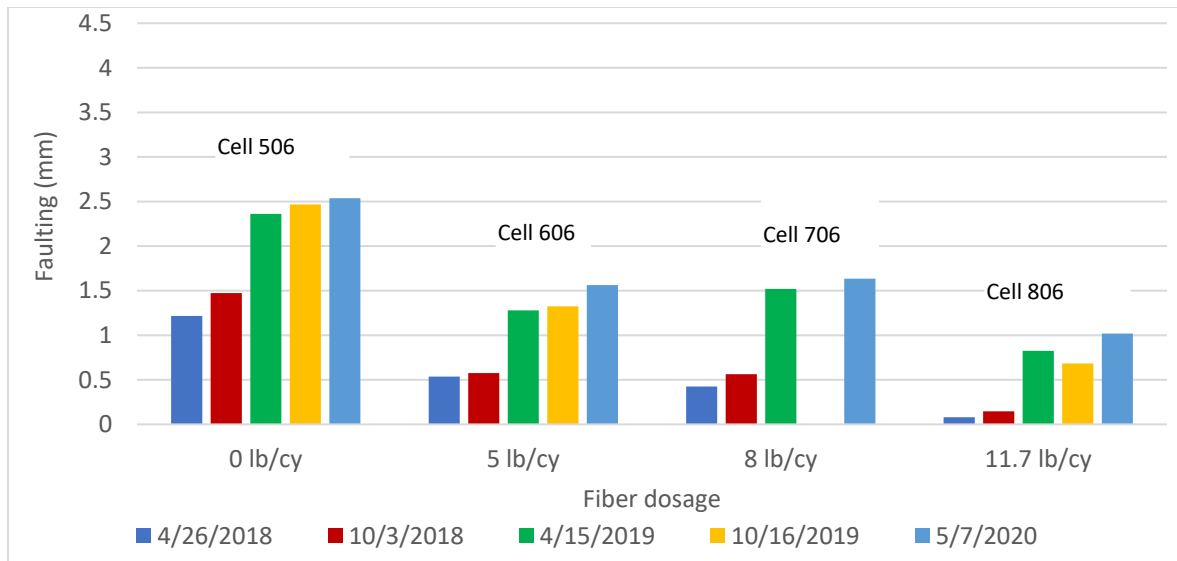
Figure 4-4. Faulting for Cells 506 through 806 with respect to fiber dosage (a) Only driving lane joints (b) average of the driving and passing lane joints.

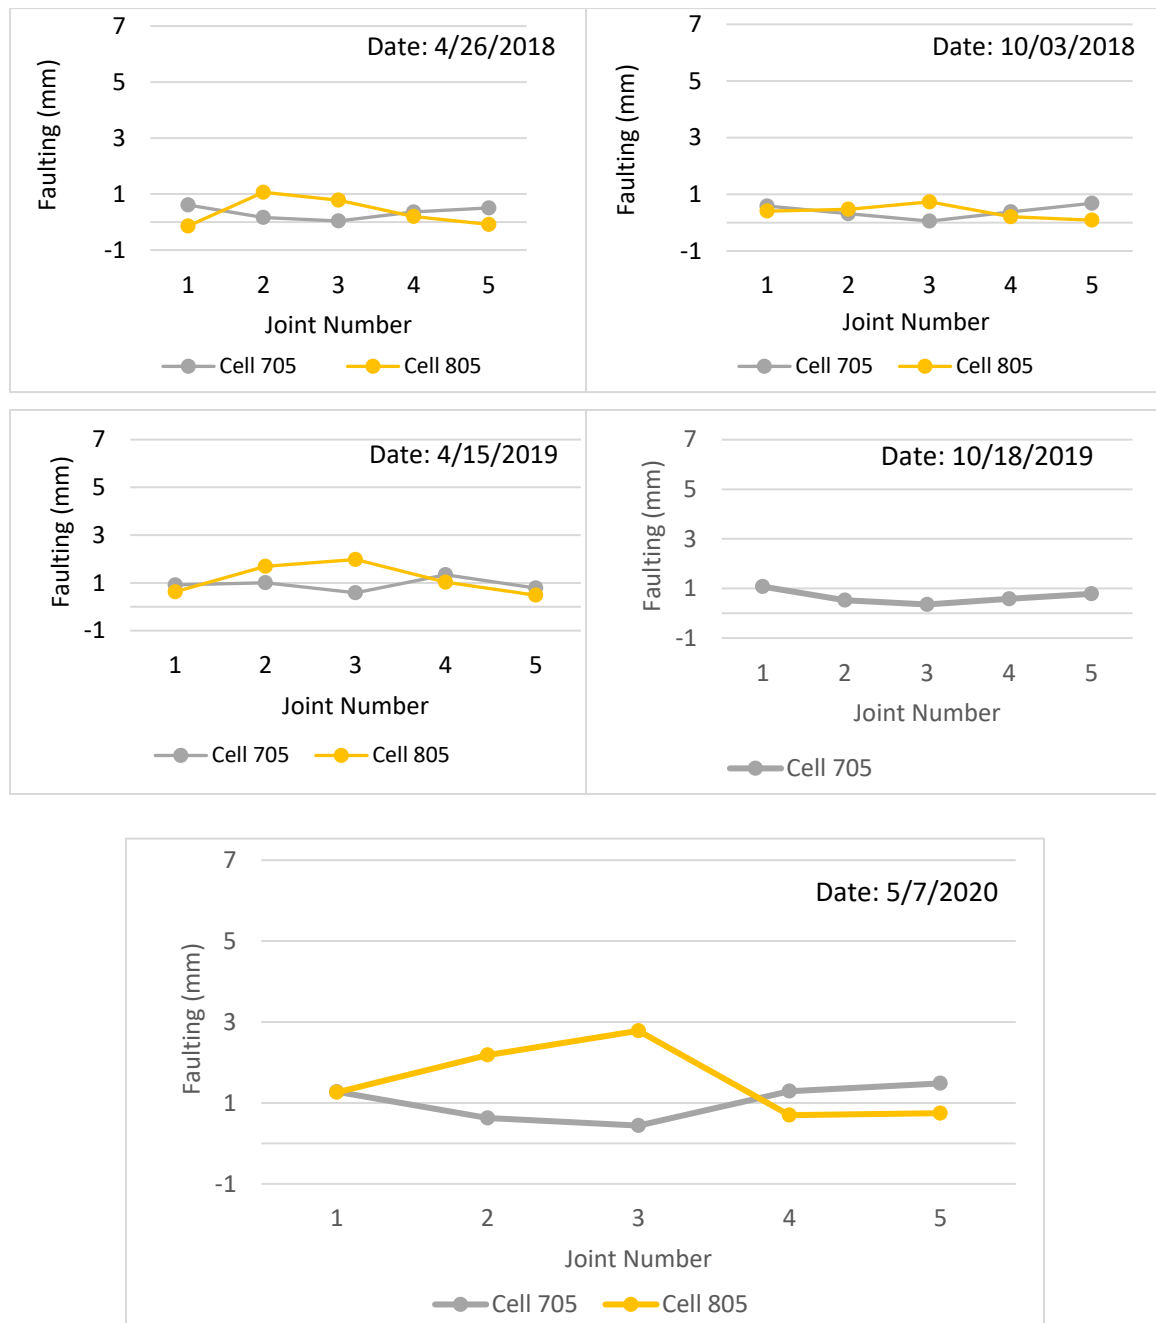
Figure 4-5 shows the faulting for Cells 705 and 805 until May 2020. Both Cells 705 and 805 had shown mostly positive faulting. One noticeable observation was that the faulting at Joint numbers 2 and 4 of Cell 705 was higher in April 2019 (spring) than what was measured in October 2019. May 2020 data showed Joint 4 having more faulting than the previous year's measurement, but Joint number 2 surprisingly reported the exact faulting measurement as in October 2019. Even though the faulting values in these cells were around 1 to 2 mm, Cell 805 experienced a slightly higher amount of faulting. It may happen that the narrower and lighter slabs in Cell 805 compared to Cell 705 move relatively more under the wheel load.

due to the limited compression of the fabric. Some of the faulting might be caused by broken panels that shift and settle.

Figure 4-5. Faulting summary of Cells 705 and 805 until May 2020.

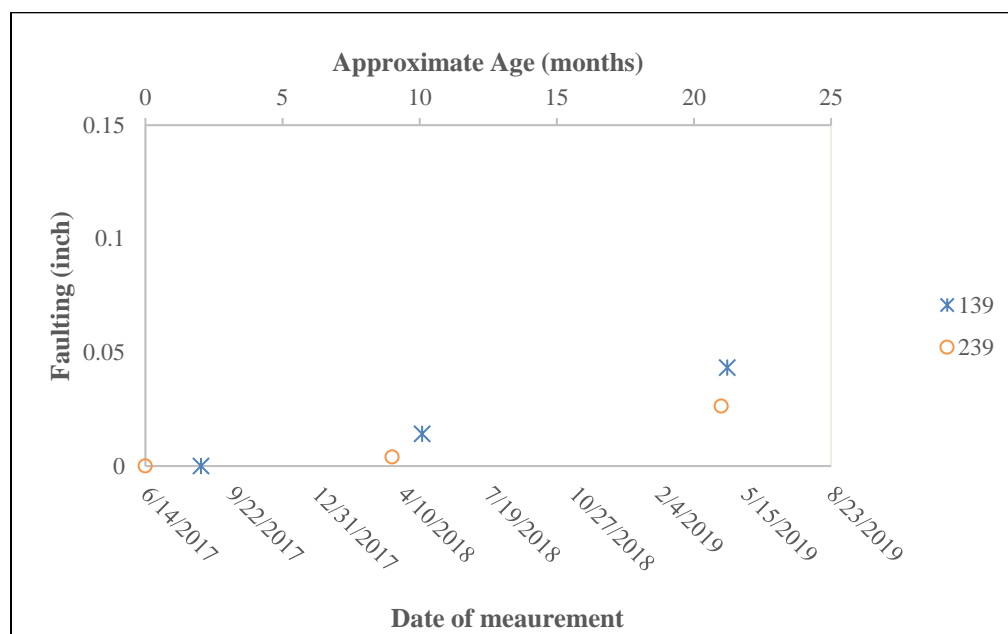
Figure 4-6 shows the trend of faulting with respect to age for Cells 139 and 239. It is evident from the plot that faulting increased with age, and Cell 239 (4-inch thick) compared to Cell 139 (3-inch thick) experienced slightly less faulting. However, as the measured faulting for these two cells was around 1 mm (0.04 inch) until May 2019, this minor difference in the faulting magnitudes between the two cells shall not be underscored.

Figure 4-6. Faulting vs. Age for Cells 139 & 239.

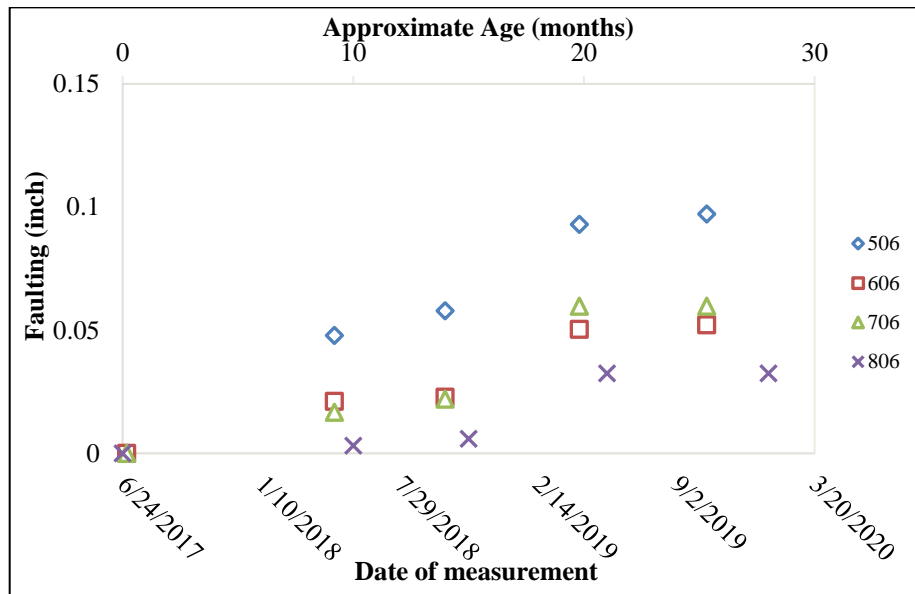
Figure 4-7 shows the faulting for the Cells 506 to 806 with respect to age, where fiber dosage varied between the cells. Faulting increased with the age as anticipated. The development of faulting decreased with the increase in fiber dosage. Cell 506, which did not have any fiber, experienced the largest magnitude of faulting among the four thin pavement cells; whereas, Cell 806, which had the maximum fiber dosage, experienced the lowest magnitude of faulting (3 times less than Cell 506).

Figure 4-7: Faulting vs. Age for Cells 506,606,706 & 806.

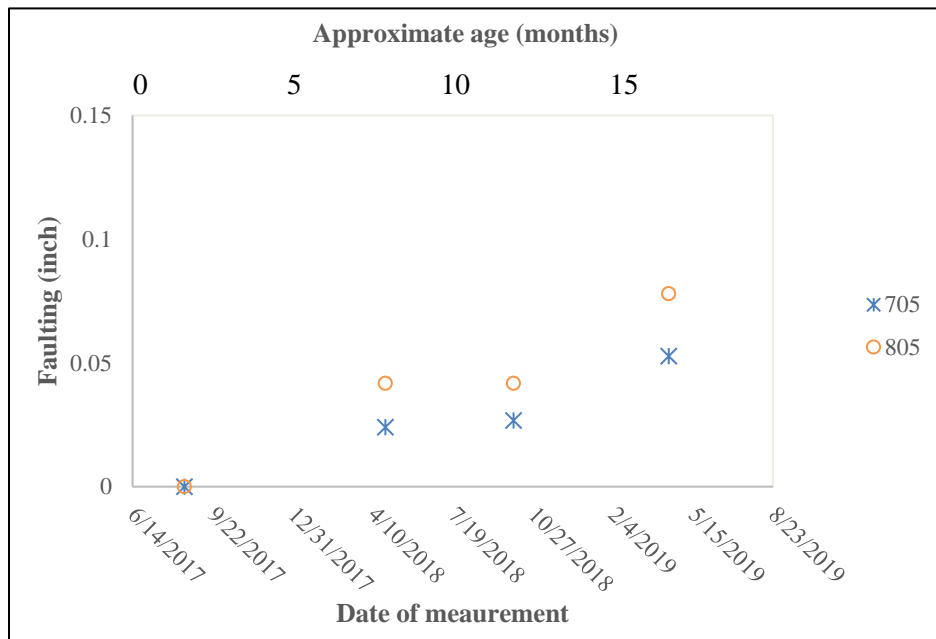
Figure 4-8 shows that for thin unbonded concrete pavement overlays, faulting was slightly affected by slab size and increased with age. Cell 705 with larger slabs (driving lane 14 ft X 12 ft, passing lane 12 ft X 12 ft) experienced slightly less faulting as compared to Cell 805 with smaller slabs (driving lane 8 ft X 12 ft, passing lane 6 ft X 12 ft).

Figure 4-8: Faulting vs. Age for Cells 705 & 805.

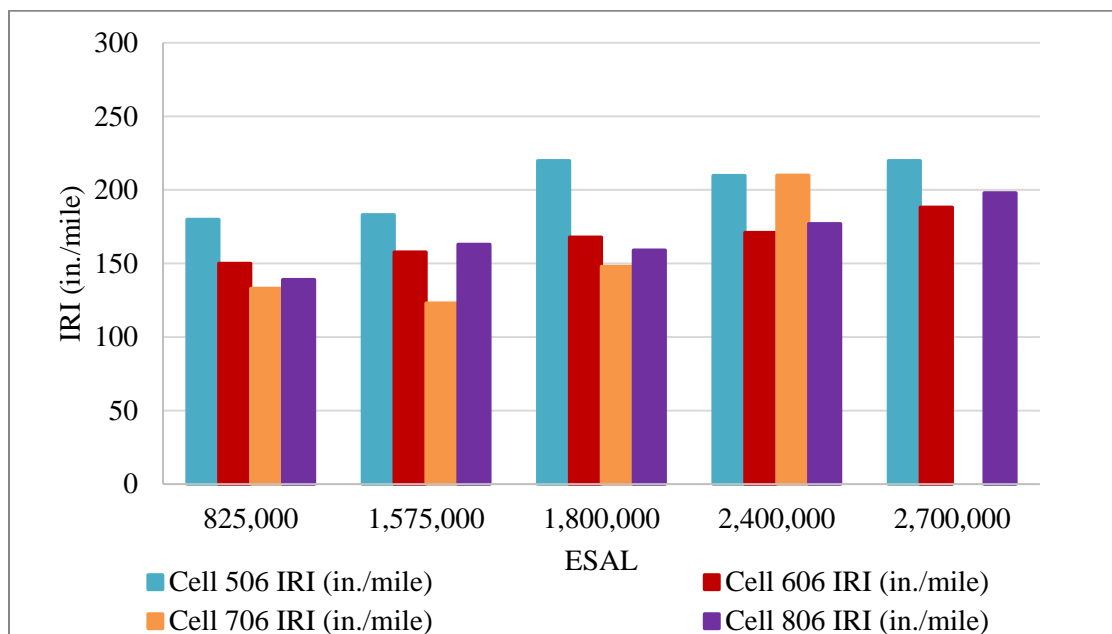
International roughness index data was collected on various cells to study the pavement surface ride quality and verify the fibers' influence on the same. Figure 4-15 shows the variation of IRI with respect to ESAL for the four thin pavement cells. Cell 506, having no fibers, showed higher IRI values consistently. Cell 606, 706, and 806, which have fibers, showed lower IRI values compared to Cell 506. In the year 2018, at 825,000 ESALs, the IRI value for Cell 506 was 180 inches/mile, which was already in the range of poor ride quality index (RQI) (Table 2-6). At the same time and same ESAL, Cell 806, having maximum fiber dosage, had an IRI value of 139 inches /mile, which is within the fair RQI rating. However, after 2.4 million ESALs, Cell 806 also reported a poor RQI rating (IRI>173 inches/mile). This suggests that thin concrete pavements with fiber reinforcement can keep the pavement roughness within an admittable range for up to the approximately 2 million ESALs, which is probably the anticipated design life for such thin pavements, then fibers' influence keeps decreasing. It may be noted that due to the short length of each test cell, higher initial IRI values are common at MnROAD; therefore one should look at the change in IRI relative to the initial IRI. Since these cells were exposed to much higher levels of traffic than would typically be placed on these thin designs, the rate of IRI development would likely be far less on typical projects in the network.

Figure 4-15: Variation of International Roughness Index (IRI) with respect to ESALs for Cells 506-806.
