Performance Benefits of Fiber-reinforced Thin Concrete Pavement and Overlays

FINAL REPORT

June 2021

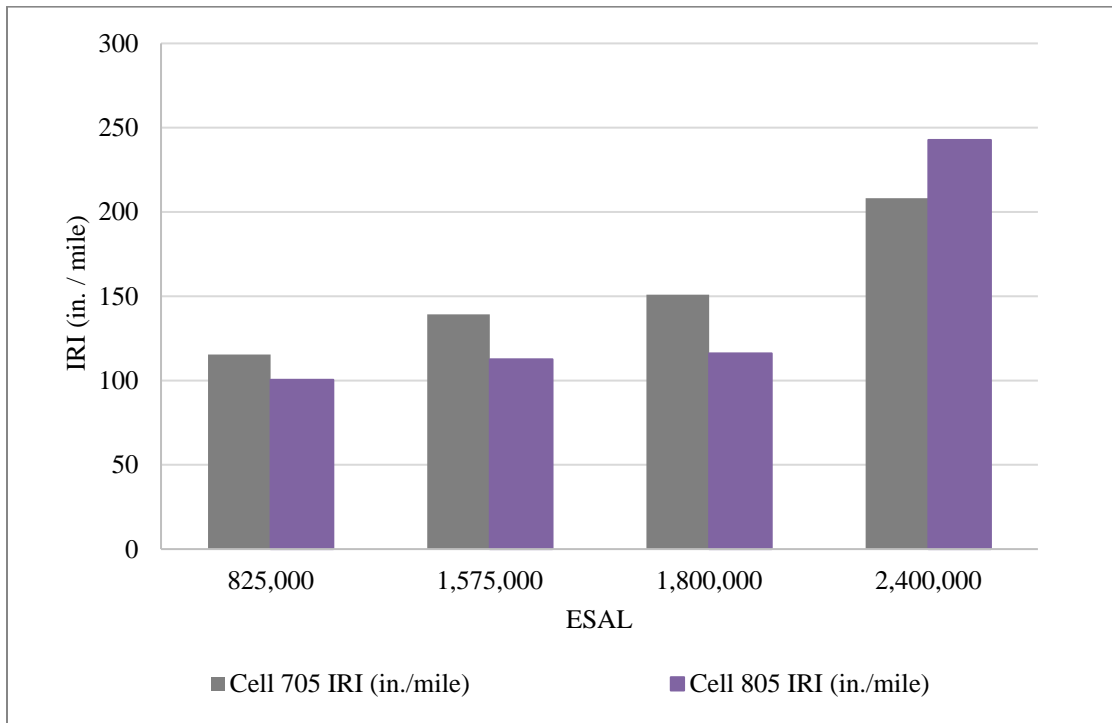
Figure 4-16 presents the IRI results of Cells 705 and 805. Recall that the percentage of cracked slabs for Cell 705 was 15% more than Cell 805 even though the crack index (length of cracks/ unit surface area) for both the cells were comparable. The IRI for both the cells was within the admittable range until approximately 2 million ESALs, with slightly less value for the Cell 805. At 2.4 million ESALs, both cells deteriorated, and the IRI significantly increased, more for the Cell 805 (narrower slabs).

Figure 4-16: Variation of International Roughness Index (IRI) with respect to ESALs for Cells 705 and 805.

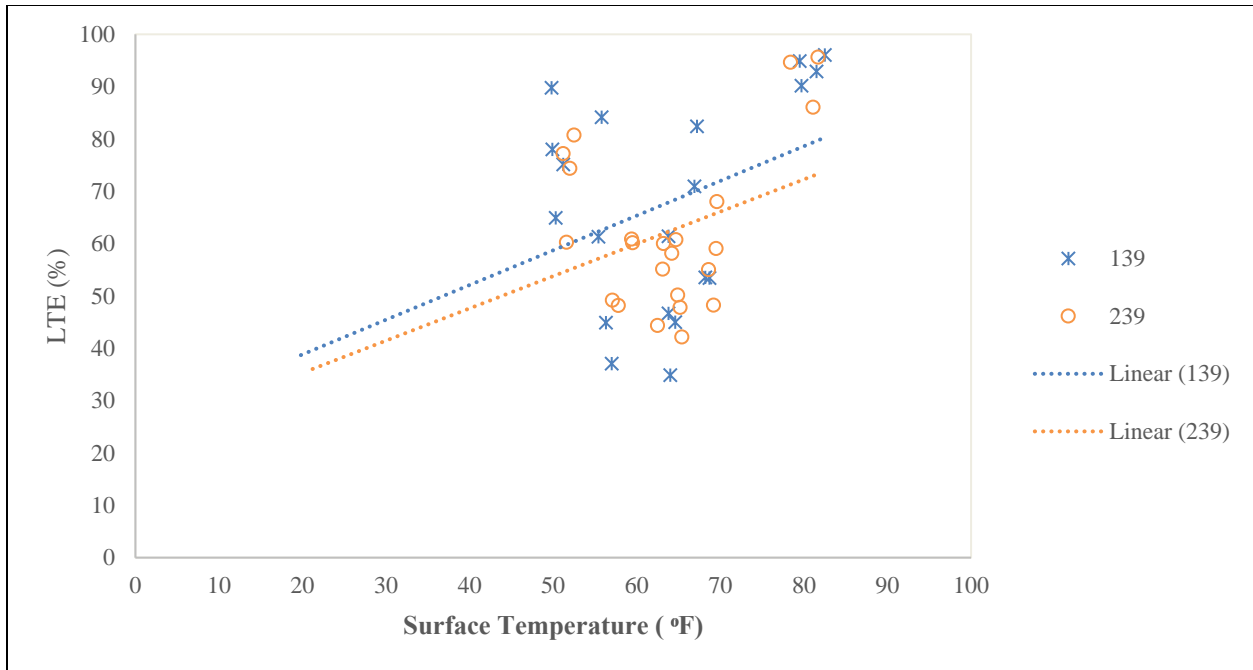
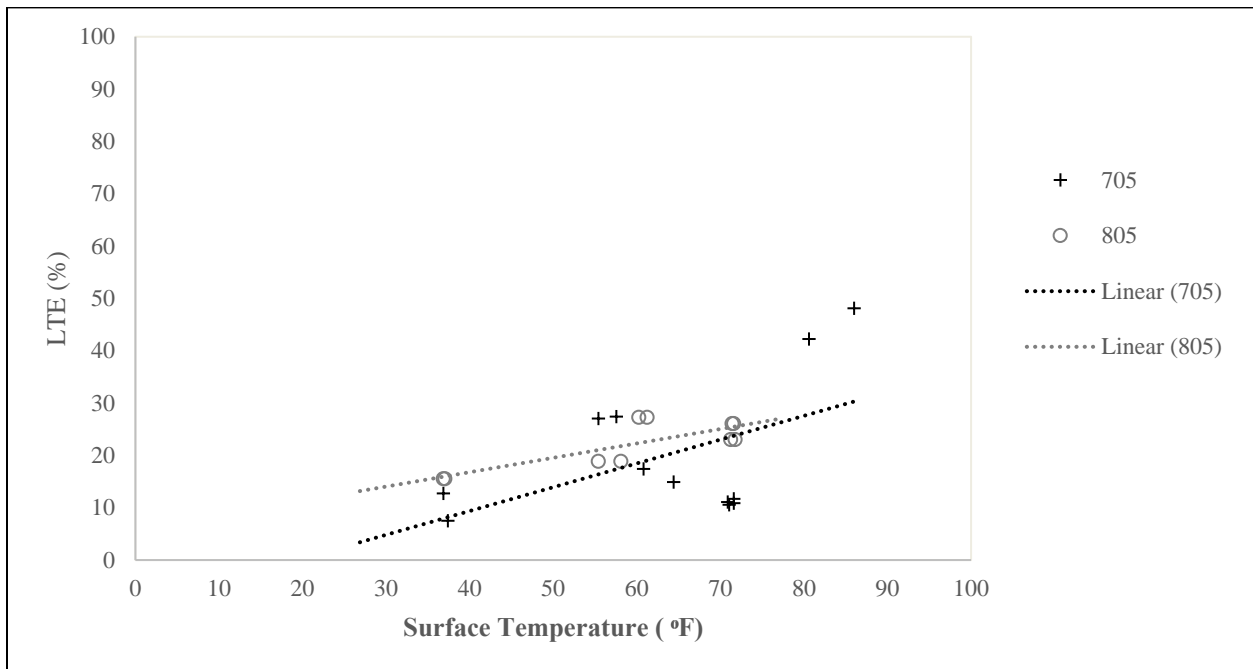
**Figure 5-94: LTE vs. Pavement surface temperature for Cells 139 and 239.**

Figure 5-94 to Figure 5-96 shows that the LTE for almost all the cells increases when the pavement surface temperature increases. Figure 5-94 shows that Cell 139 and 239 have almost similar characteristics when it comes to variation of LTE with pavement surface temperature. Cell 705 and 805, as shown in Figure 5-95, had the least reported LTE of all the eight cells, but they did not vary much with the temperature. It was observed that the variation of LTE with temperature was more sensitive in 705 compared to 805 (narrower slabs).

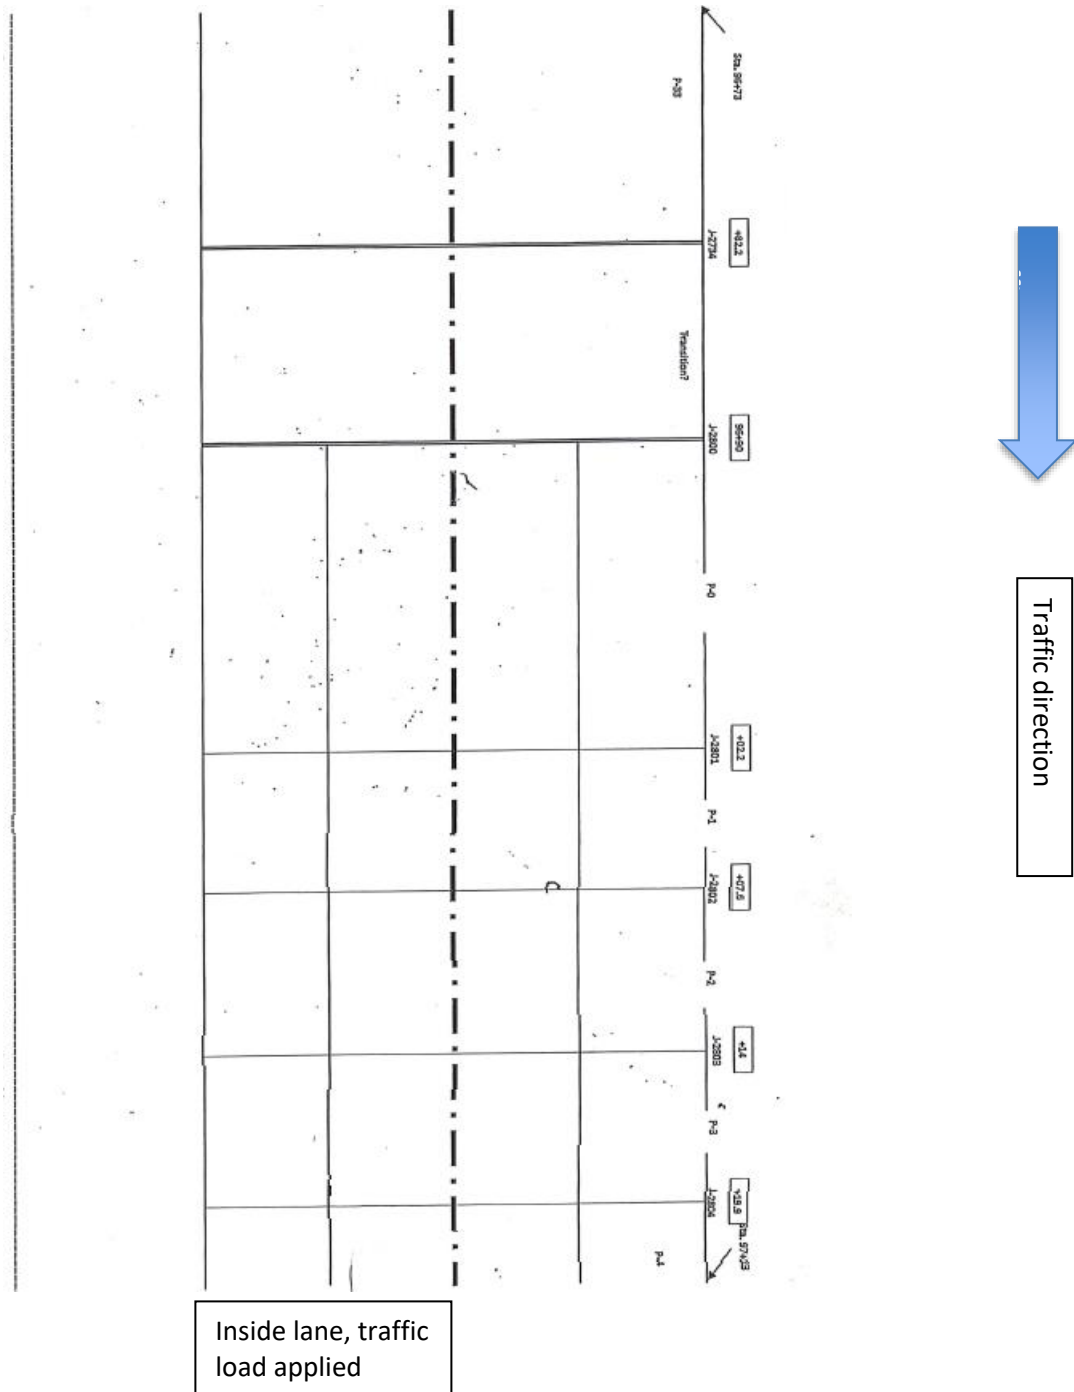
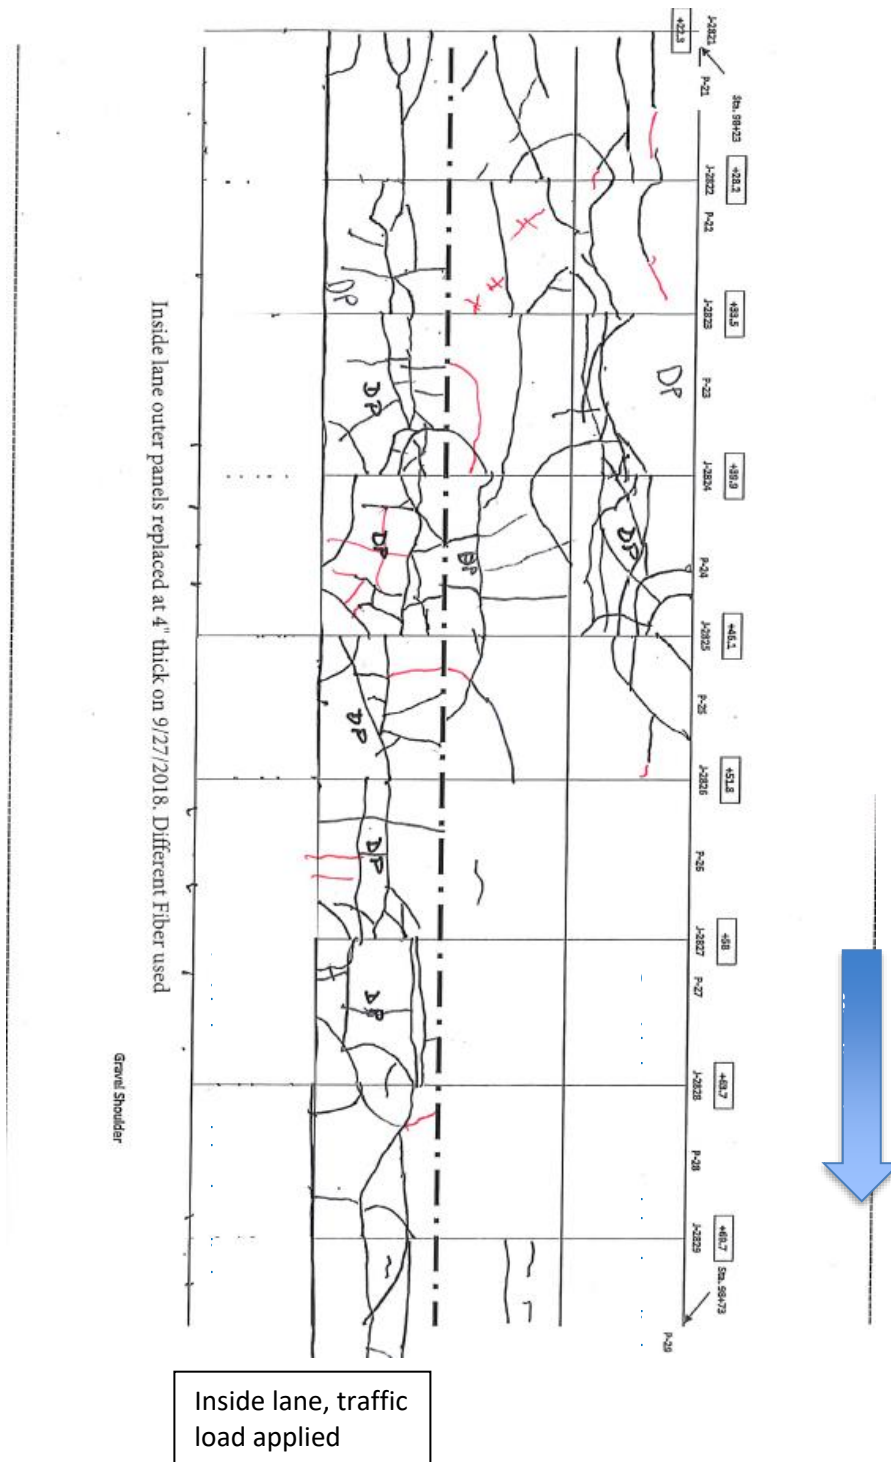
Figure A- 9: Distress map for Cell 139

On the other hand, unrepaired (original) slabs continued to develop distress with traffic load and age, with primary longitudinal and secondary transverse and diagonal cracks. Based on the December 2019 distress survey data, it was found that as much as 75% of the slabs had cracked in Cell 139 after 114,000 ESALs were applied to them. Figure 3-4 shows four photographs of Cell 139 taken in October 2019. The unrepaired slabs eventually failed and became undrivable in the middle of the third year of service (2020).

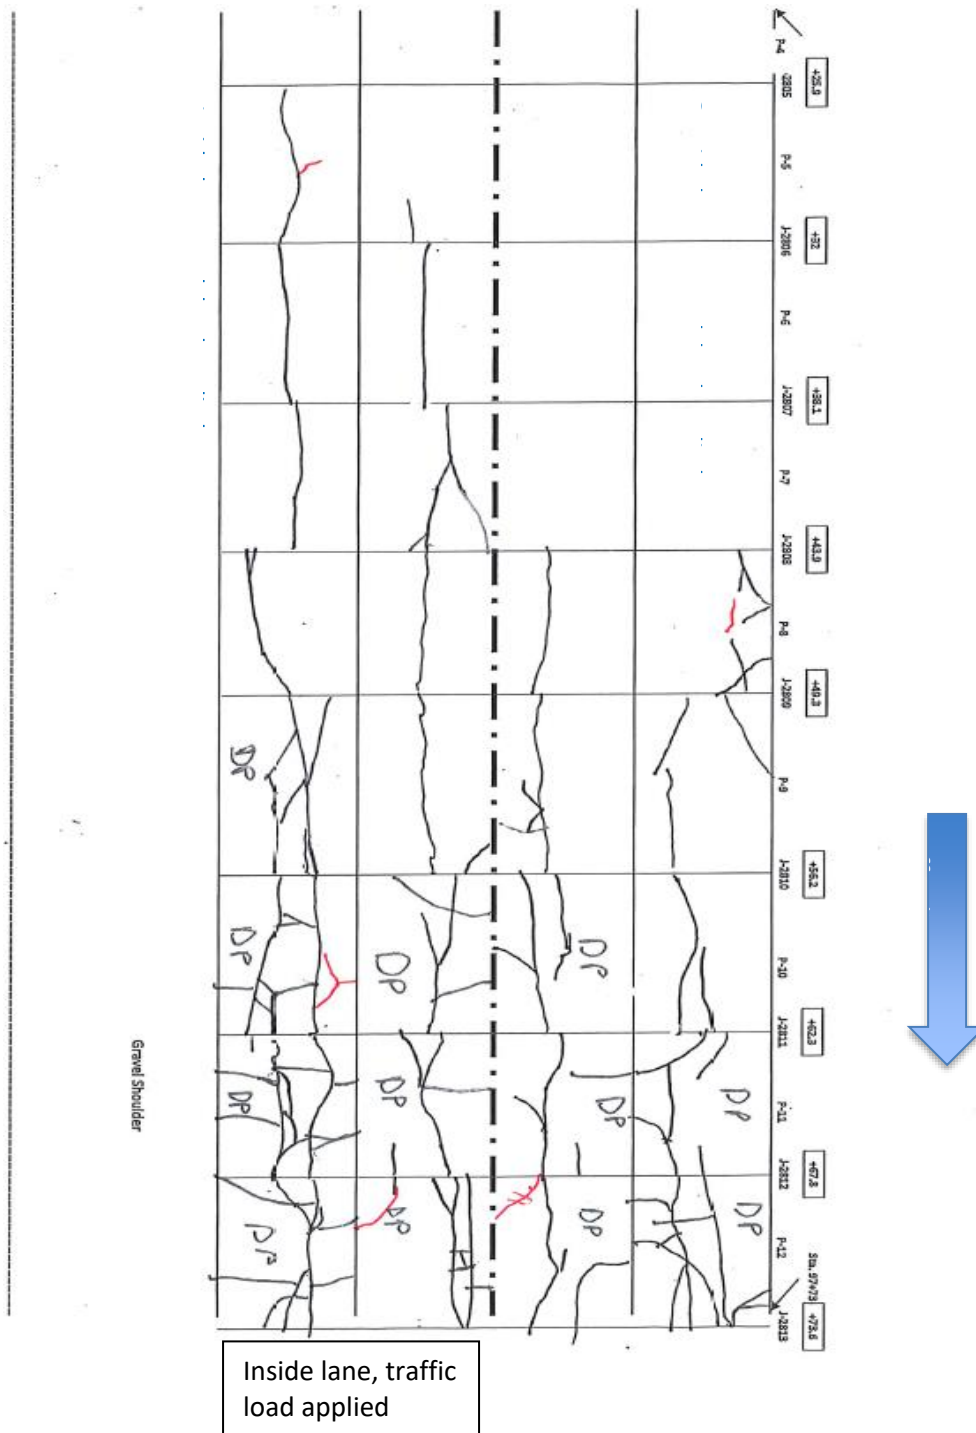
- In Cell 139, 75% of slabs cracked after approximately ~80,000 ESALs. Given the 3-inch thickness of the slabs, and the fact that fibers contribute most after cracking has occurred, it can be stated that the overall pavement structure in this test cell was too weak for this particular type of fiber and dosage (@8lb/cy fiber, 30% RSR) to significantly benefit performance. At the same time, however, the fibers in this cell clearly contributed to extending pavement life by the fact that although permanent deflections were extremely high, the individual pieces of shattered concrete remained interconnected via the fibers for a short time.

Cracks until March 2020; cracks colored red were documented on March 24, 2020.

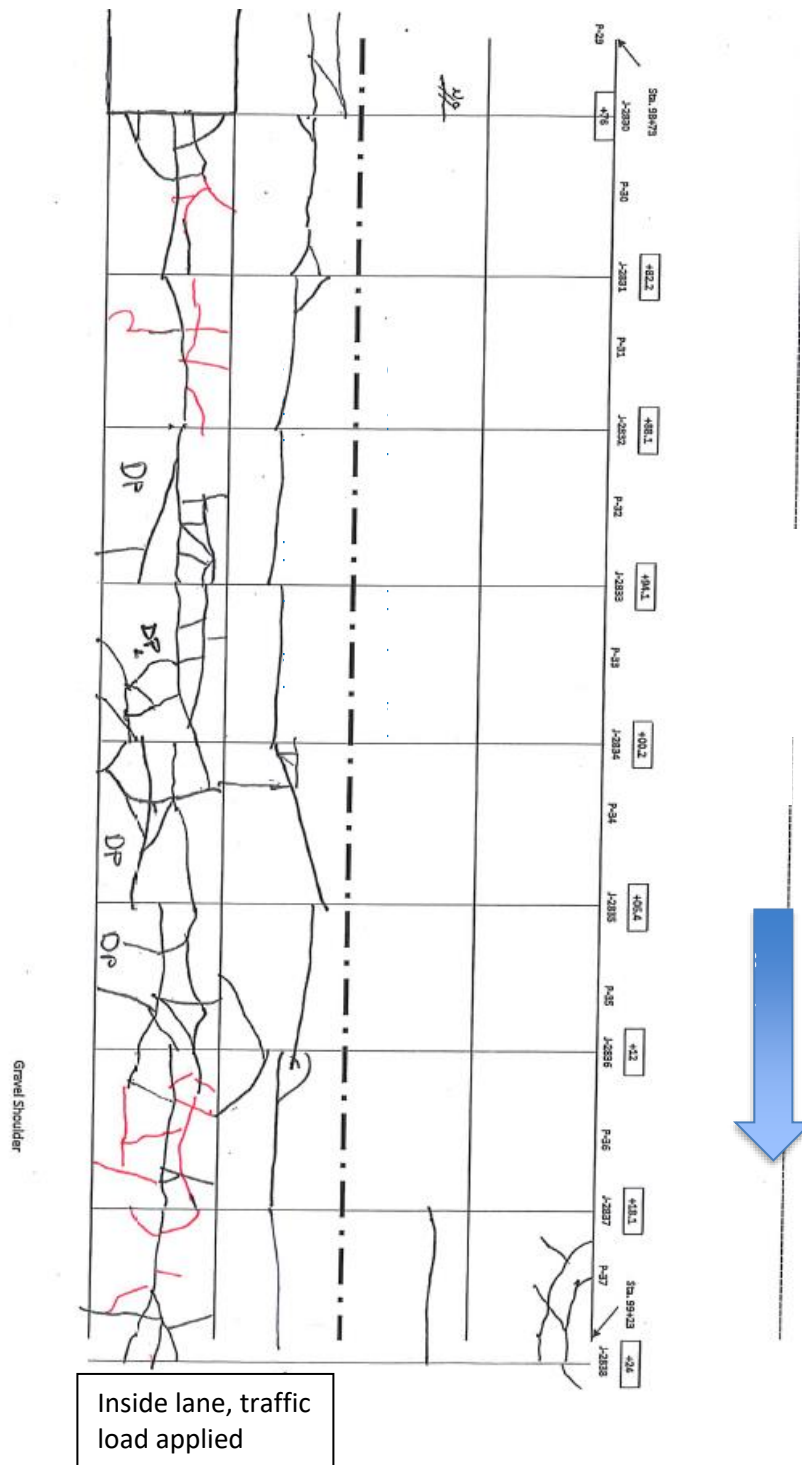
Figure A- 10: Distress map for Cell 139 contd.

Cracks until March 2020; cracks colored red were documented on March 24, 2020.

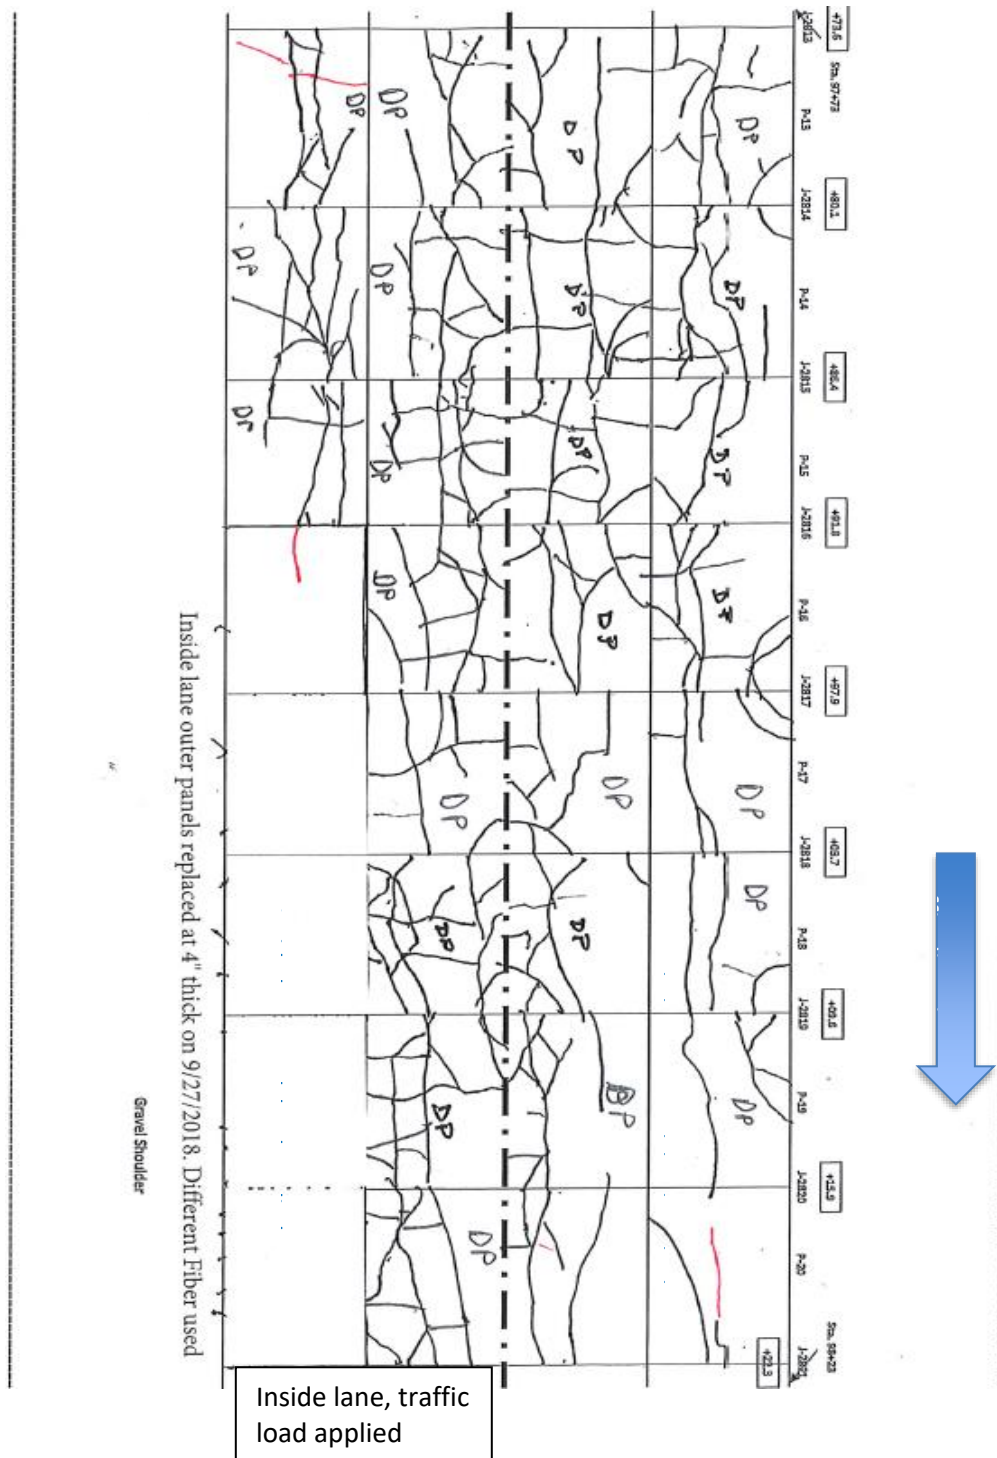
Figure A- 11: Distress map for Cell 139 contd.

Cracks until March 2020; cracks colored red were documented on March 24, 2020.

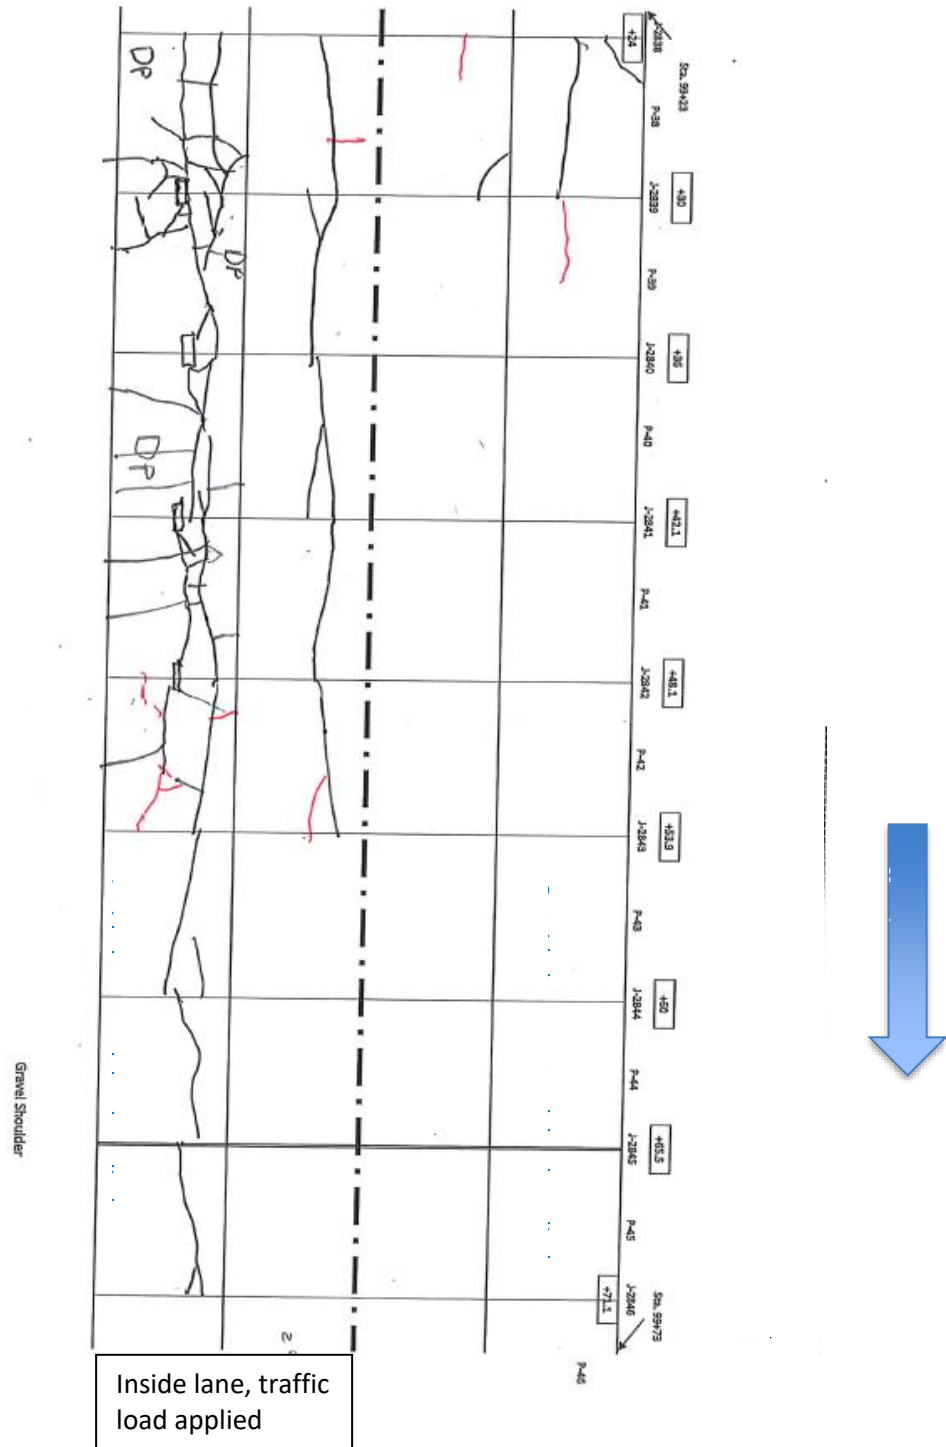
Figure A- 12: Distress map for Cell 139 contd.

Cracks until March 2020; cracks colored red was documented on March 24, 2020.
