Pavement Condition Report

Eveleth-Virginia Municipal Airport (EVM)

December 2018

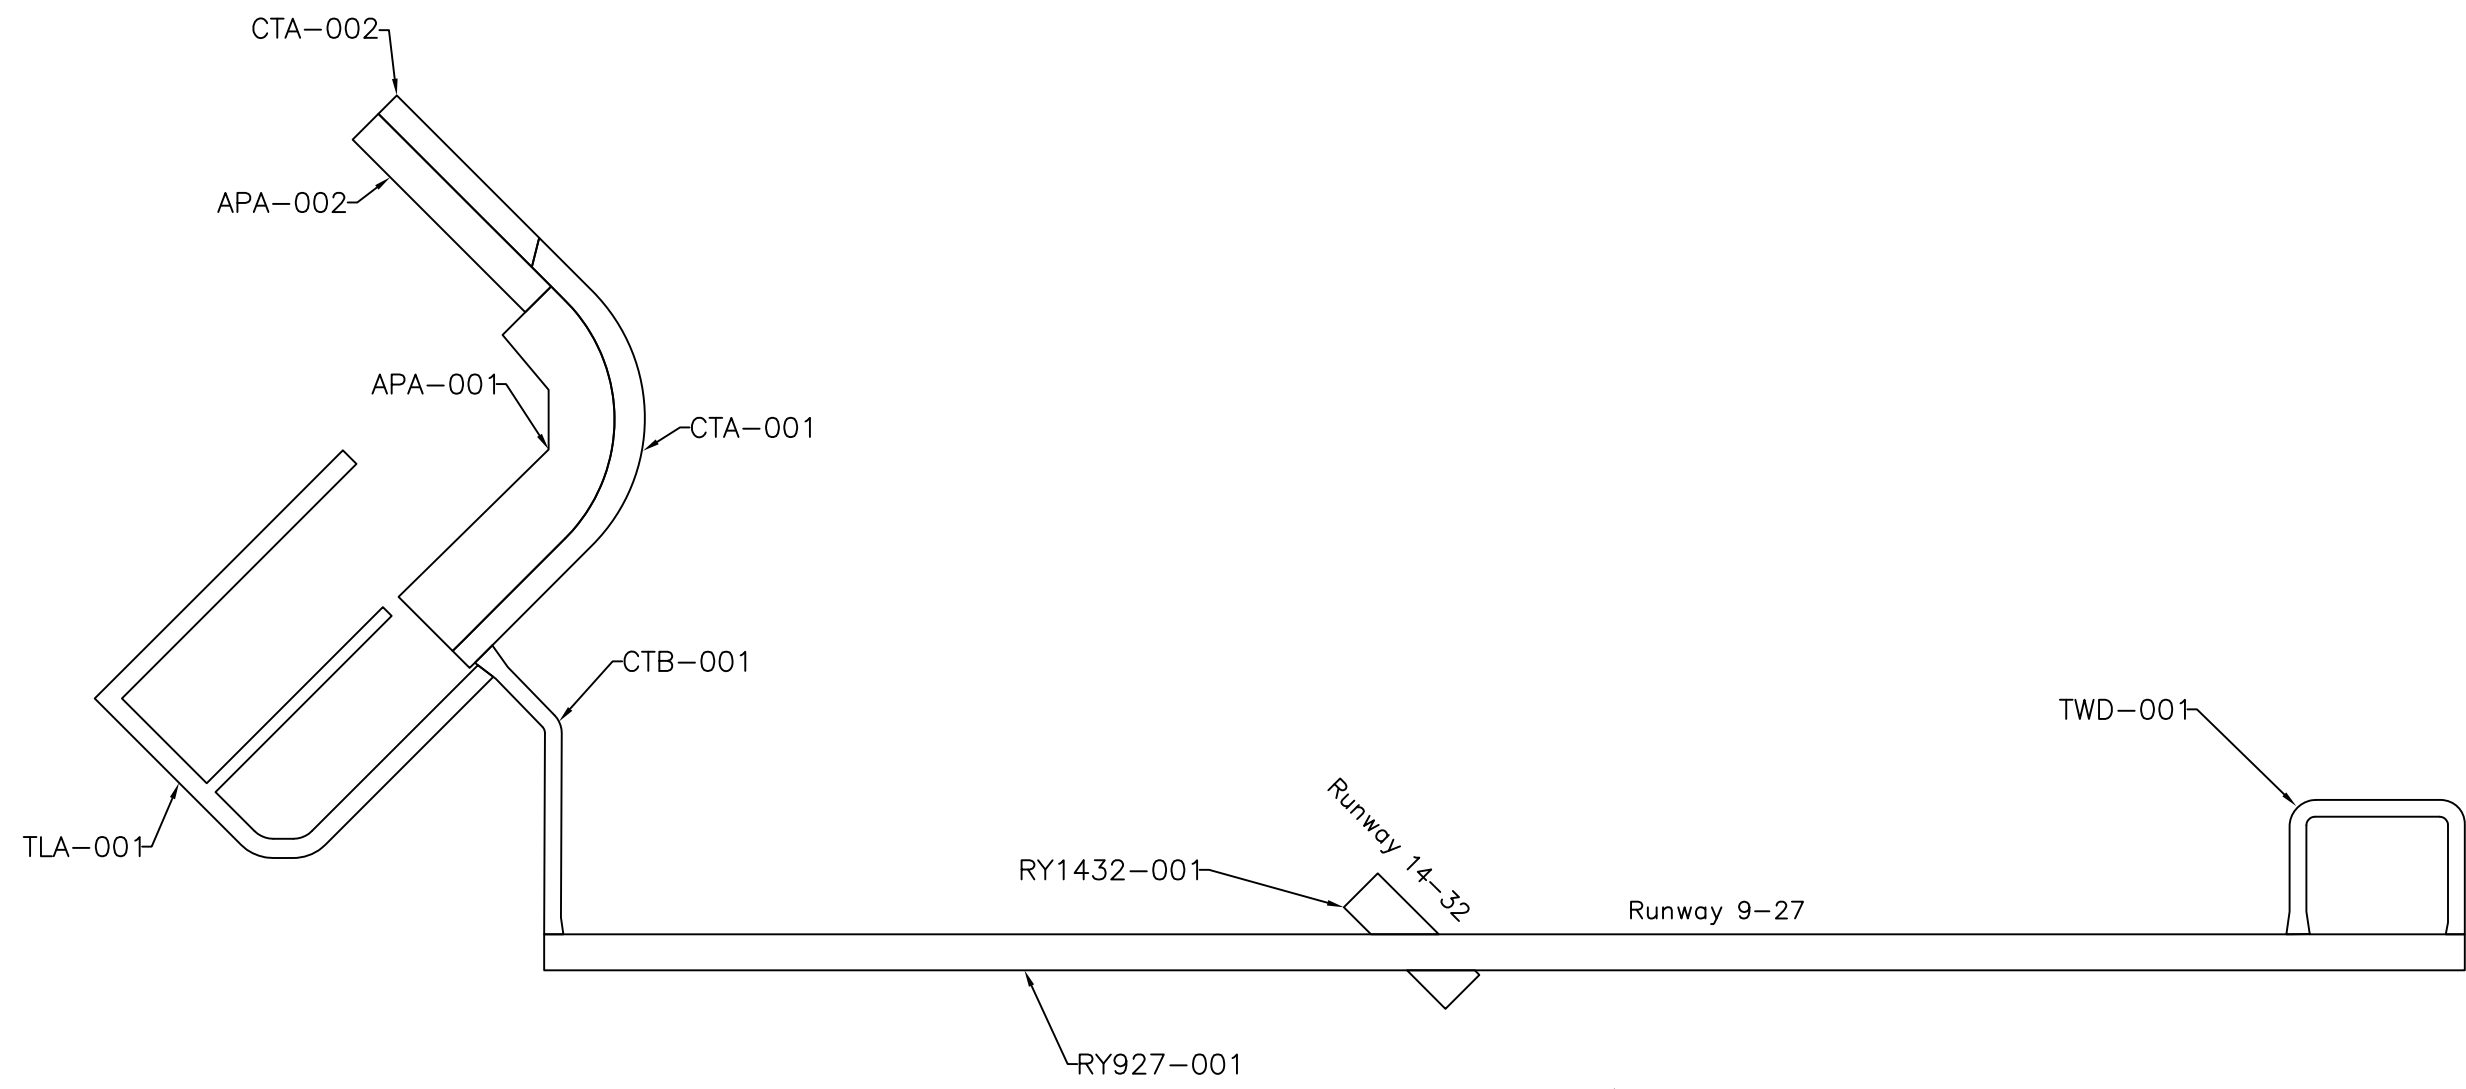
Figure 2. Network Definition at Eveleth-Virginia Municipal Airport (EVM).

Figure 2 presents the network definition for EVM and represents the pavements included in the APMS. Some privately built/maintained pavements and “driveways” leading into hangars may not be included here because they are considered outside the scope of work.

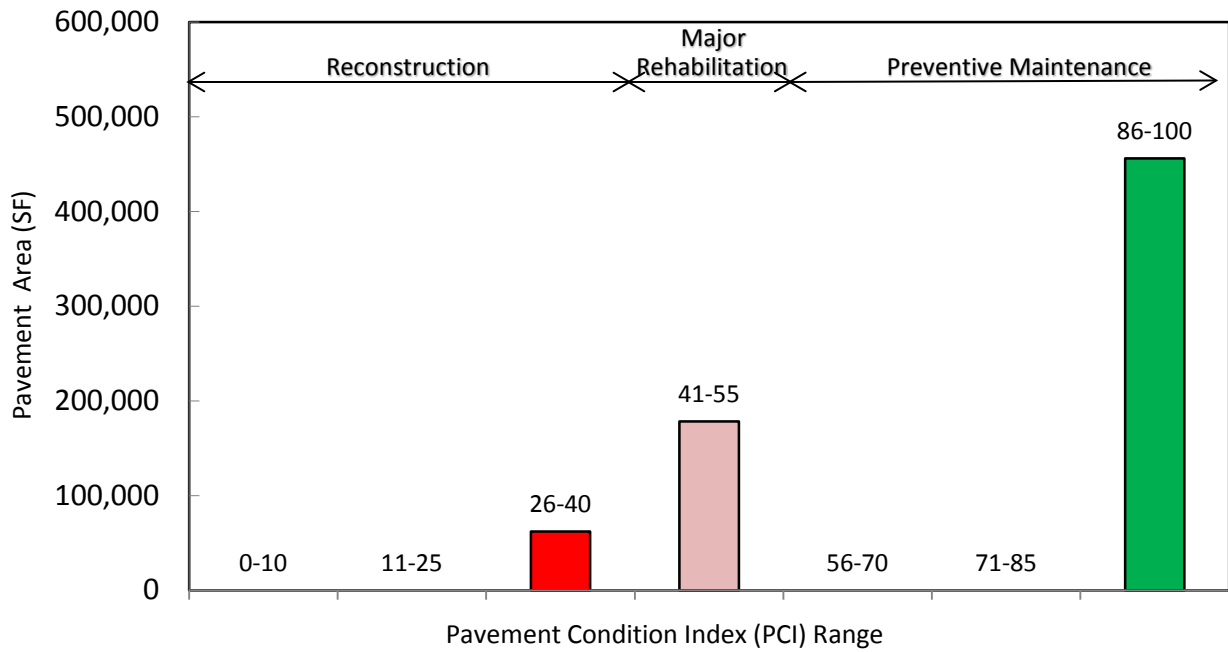
Figure 5. Condition distribution.

Figures 5 and 6 present the overall PCI for EVM by area distribution and pavement use, respectively. Table 3 presents the PCI summary for each section at EVM, including the drop in PCI per year. Generally, pavement sections will deteriorate between 1 and 3 PCI points per year. Sections deteriorating at higher rates may need maintenance above the normal application rates and should be closely monitored in case major repairs become necessary earlier than expected.

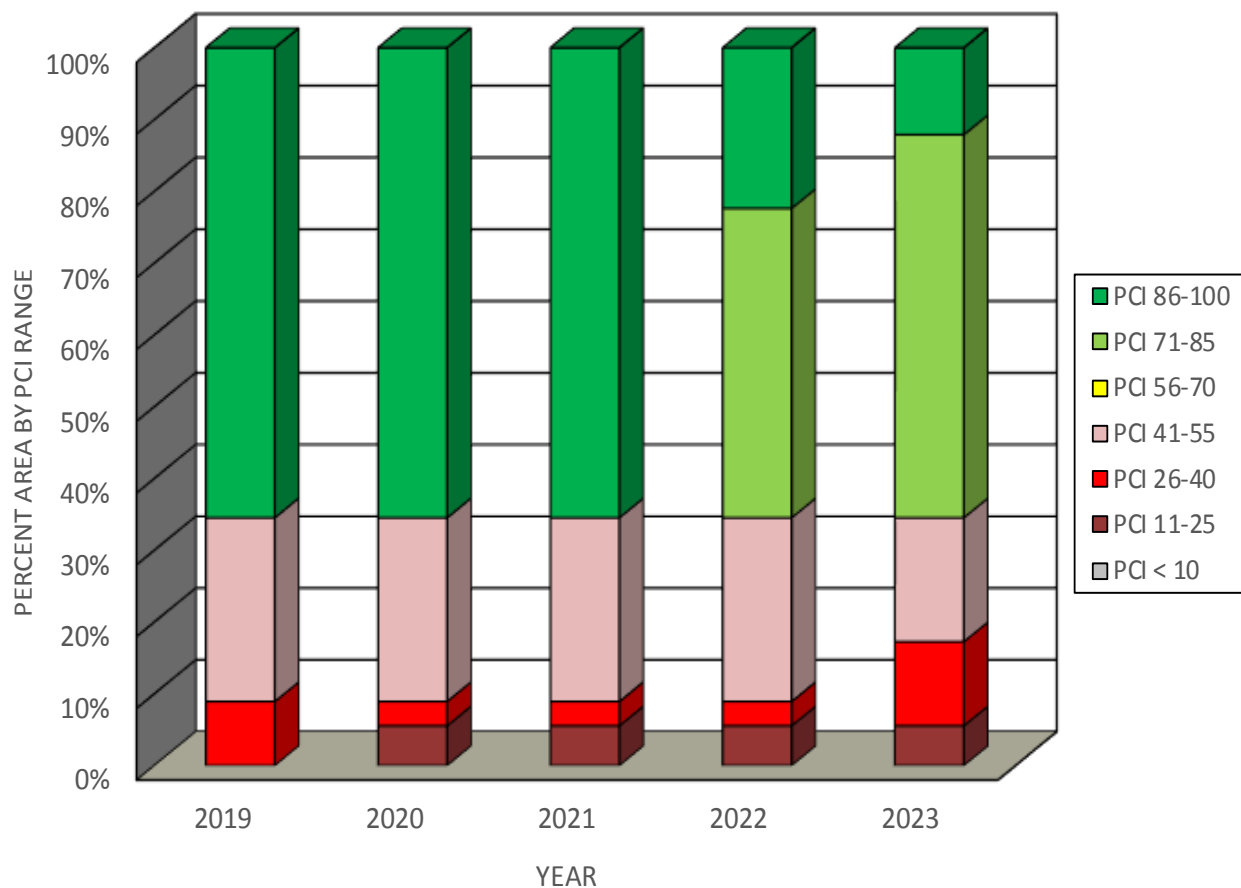
Figure 7. Projected PCI by percent area.

Figure 7 shows the projected PCI at EVM by percent area for the next 5 years assuming no major repairs (overlays, reconstruction, etc.) are performed during that period. It shows how quickly a pavement network can deteriorate when no capital improvements are made.
