Pavement Condition Report

Rush City Regional Airport (ROS)

January 2016

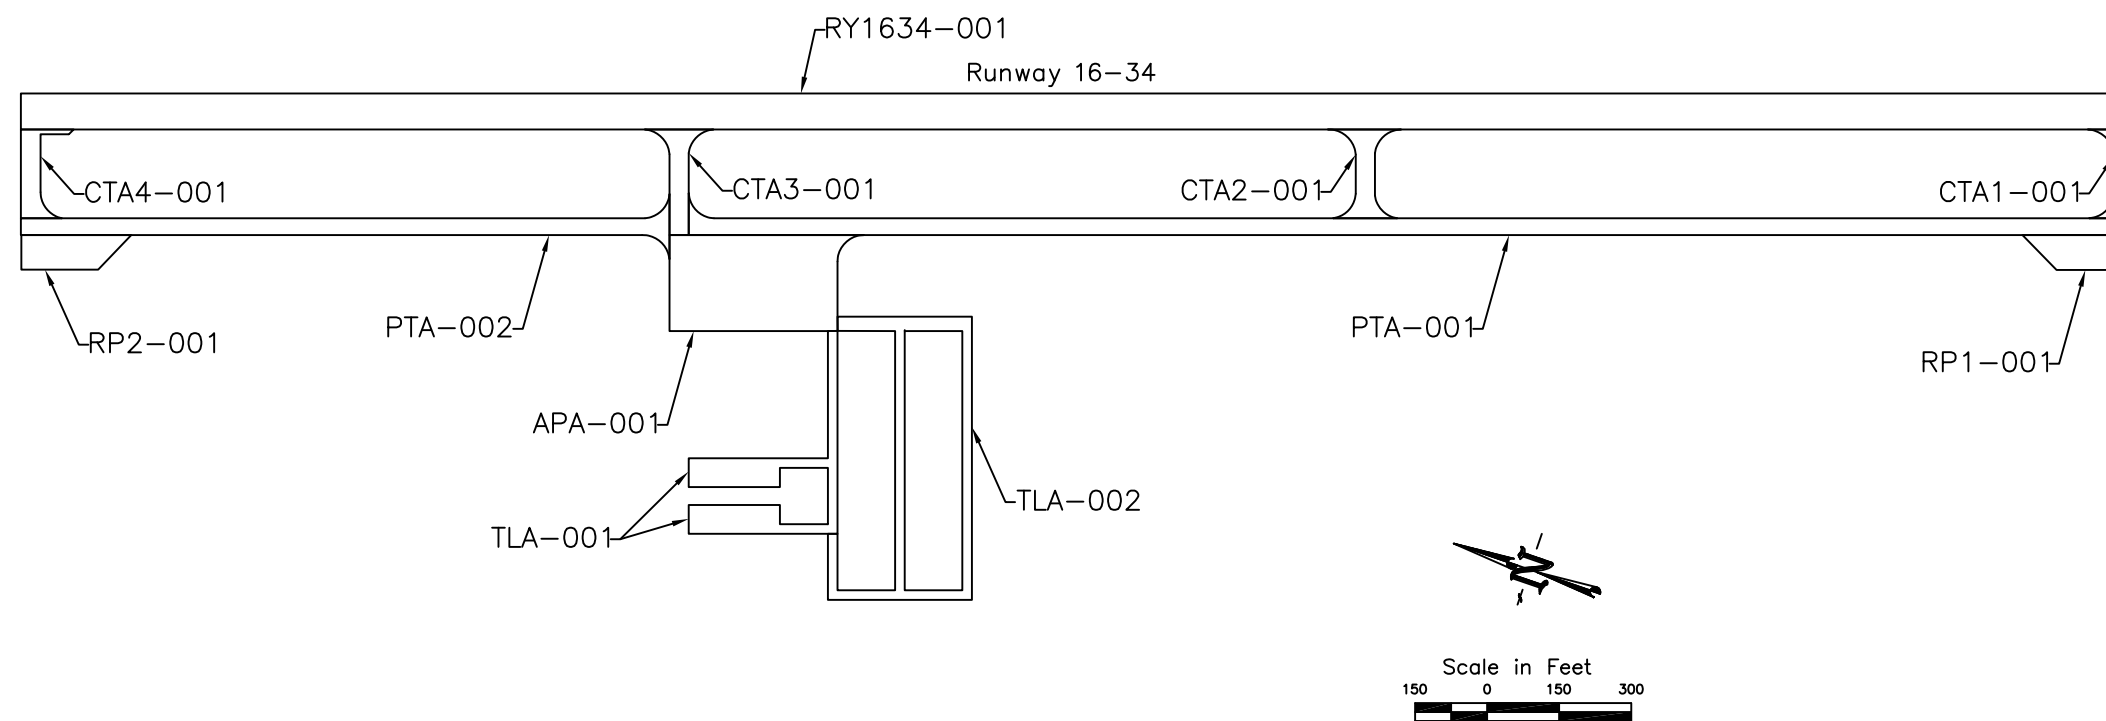
Figure 2. Network Definition at Rush City Regional Airport (ROS).

Figure 2 presents the network definition for ROS and represents the pavements included in the APMS. Some privately built/maintained pavements and “driveways” leading into hangars may not be included here because they are considered outside the scope of work.

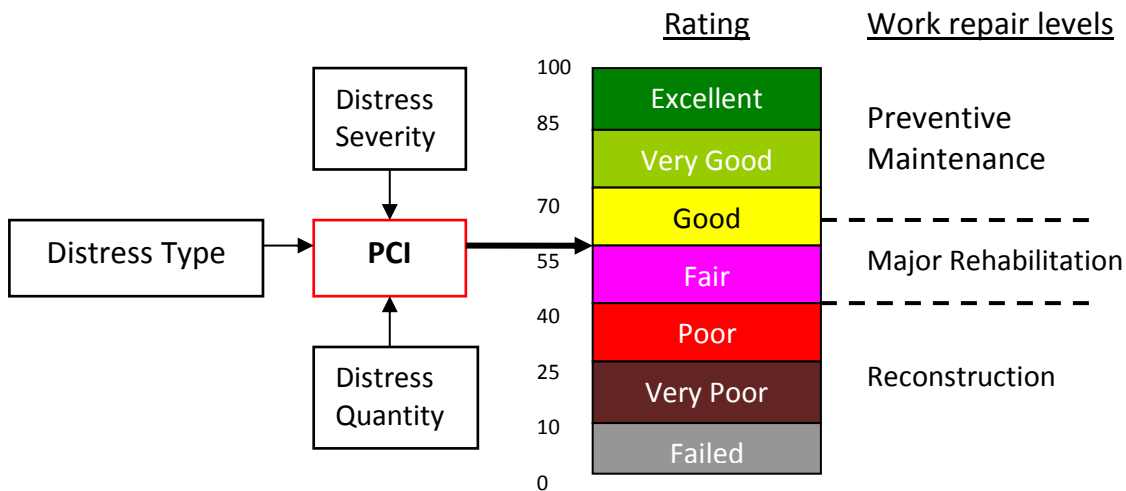
Figure 3. PCI rating scale and repair levels.

The PCI value provides a general sense as to the level of rehabilitation that will be needed to repair a given pavement. In general terms, maintenance activities such as crack sealing and patching often provide benefit when the PCI is above 60. However, as the pavement continues to deteriorate, more complex and expensive treatments will be necessary. Pavements with a PCI between 40 and 60 are good candidates for a variety of major repairs ranging from overlays to reconstruction. Once the PCI drops below 40, reconstruction is typically the only viable alternative. Figure 3 presents the PCI inputs, rating scale, and the corresponding general work repair levels.

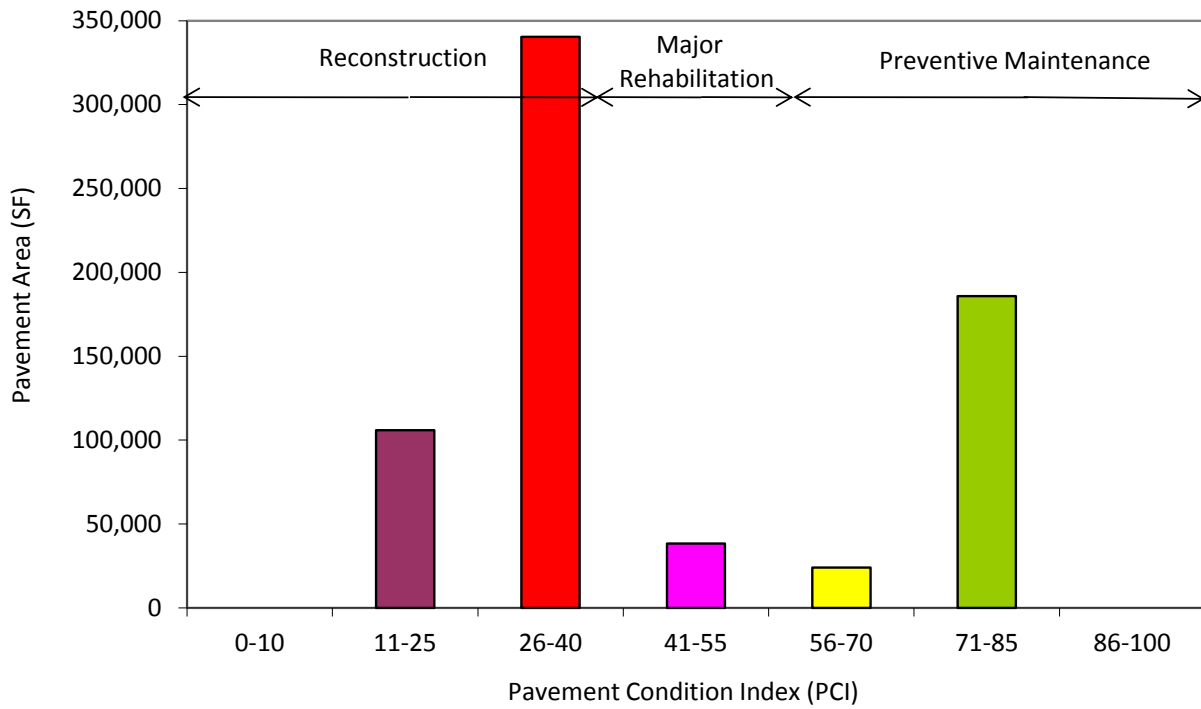
Figure 5. Condition distribution.

Figures 5 and 6 present the overall PCI for ROS by area distribution and pavement use, respectively. Table 3 presents the PCI summary for each section at ROS, including the drop in PCI per year. Generally, pavement sections will deteriorate between 1 and 3 PCI points per year. Sections deteriorating at higher rates may need maintenance above the normal application rates and should be closely monitored in case major repairs become necessary earlier than expected.

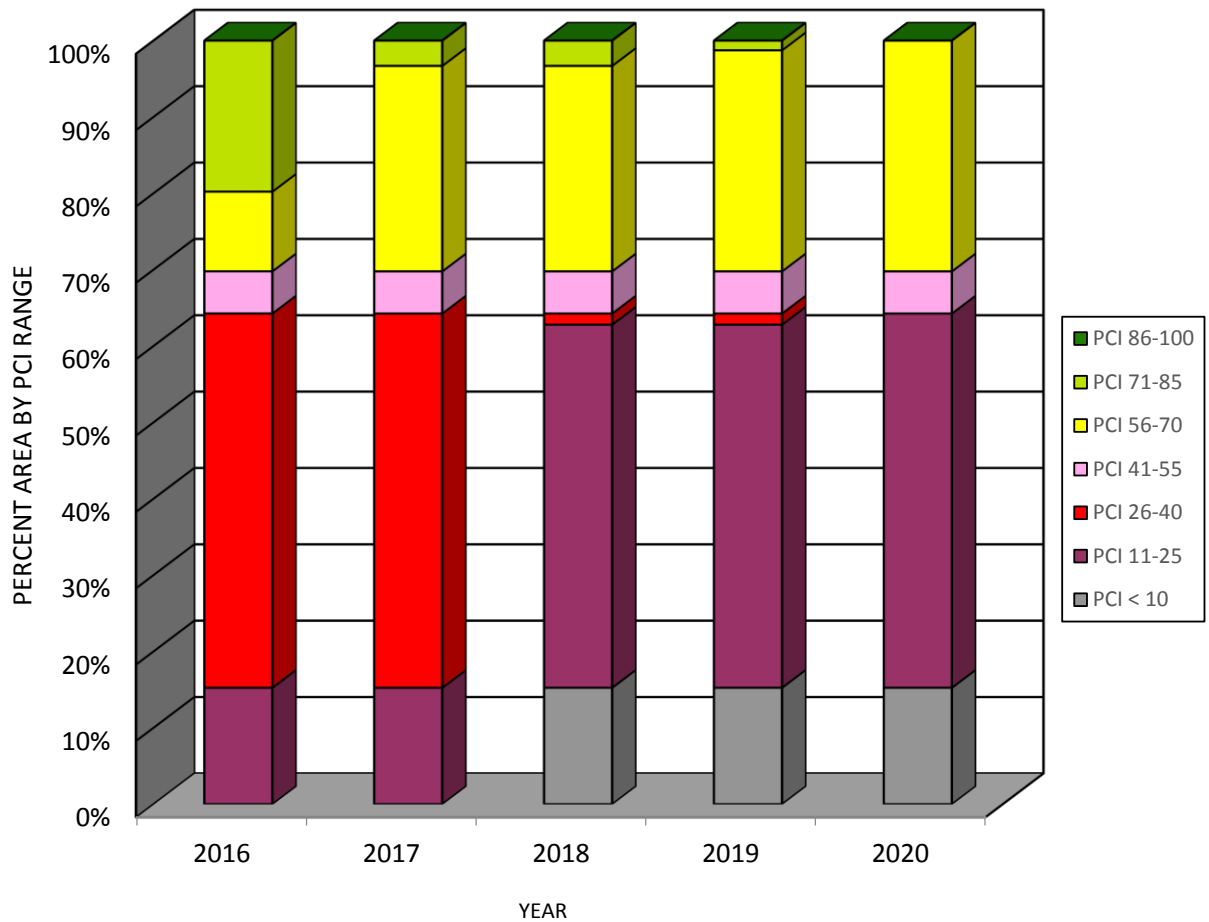
Figure 7. Projected PCI by percent area.

Figure 7 shows the projected PCI at ROS by percent area for the next 5 years assuming no major repairs (overlays, reconstruction, etc.) are performed during that period. It shows how quickly a pavement network can deteriorate when no capital improvements are made.
