Pavement Condition Report

Aitkin Municipal Airport (AIT)

December 2016

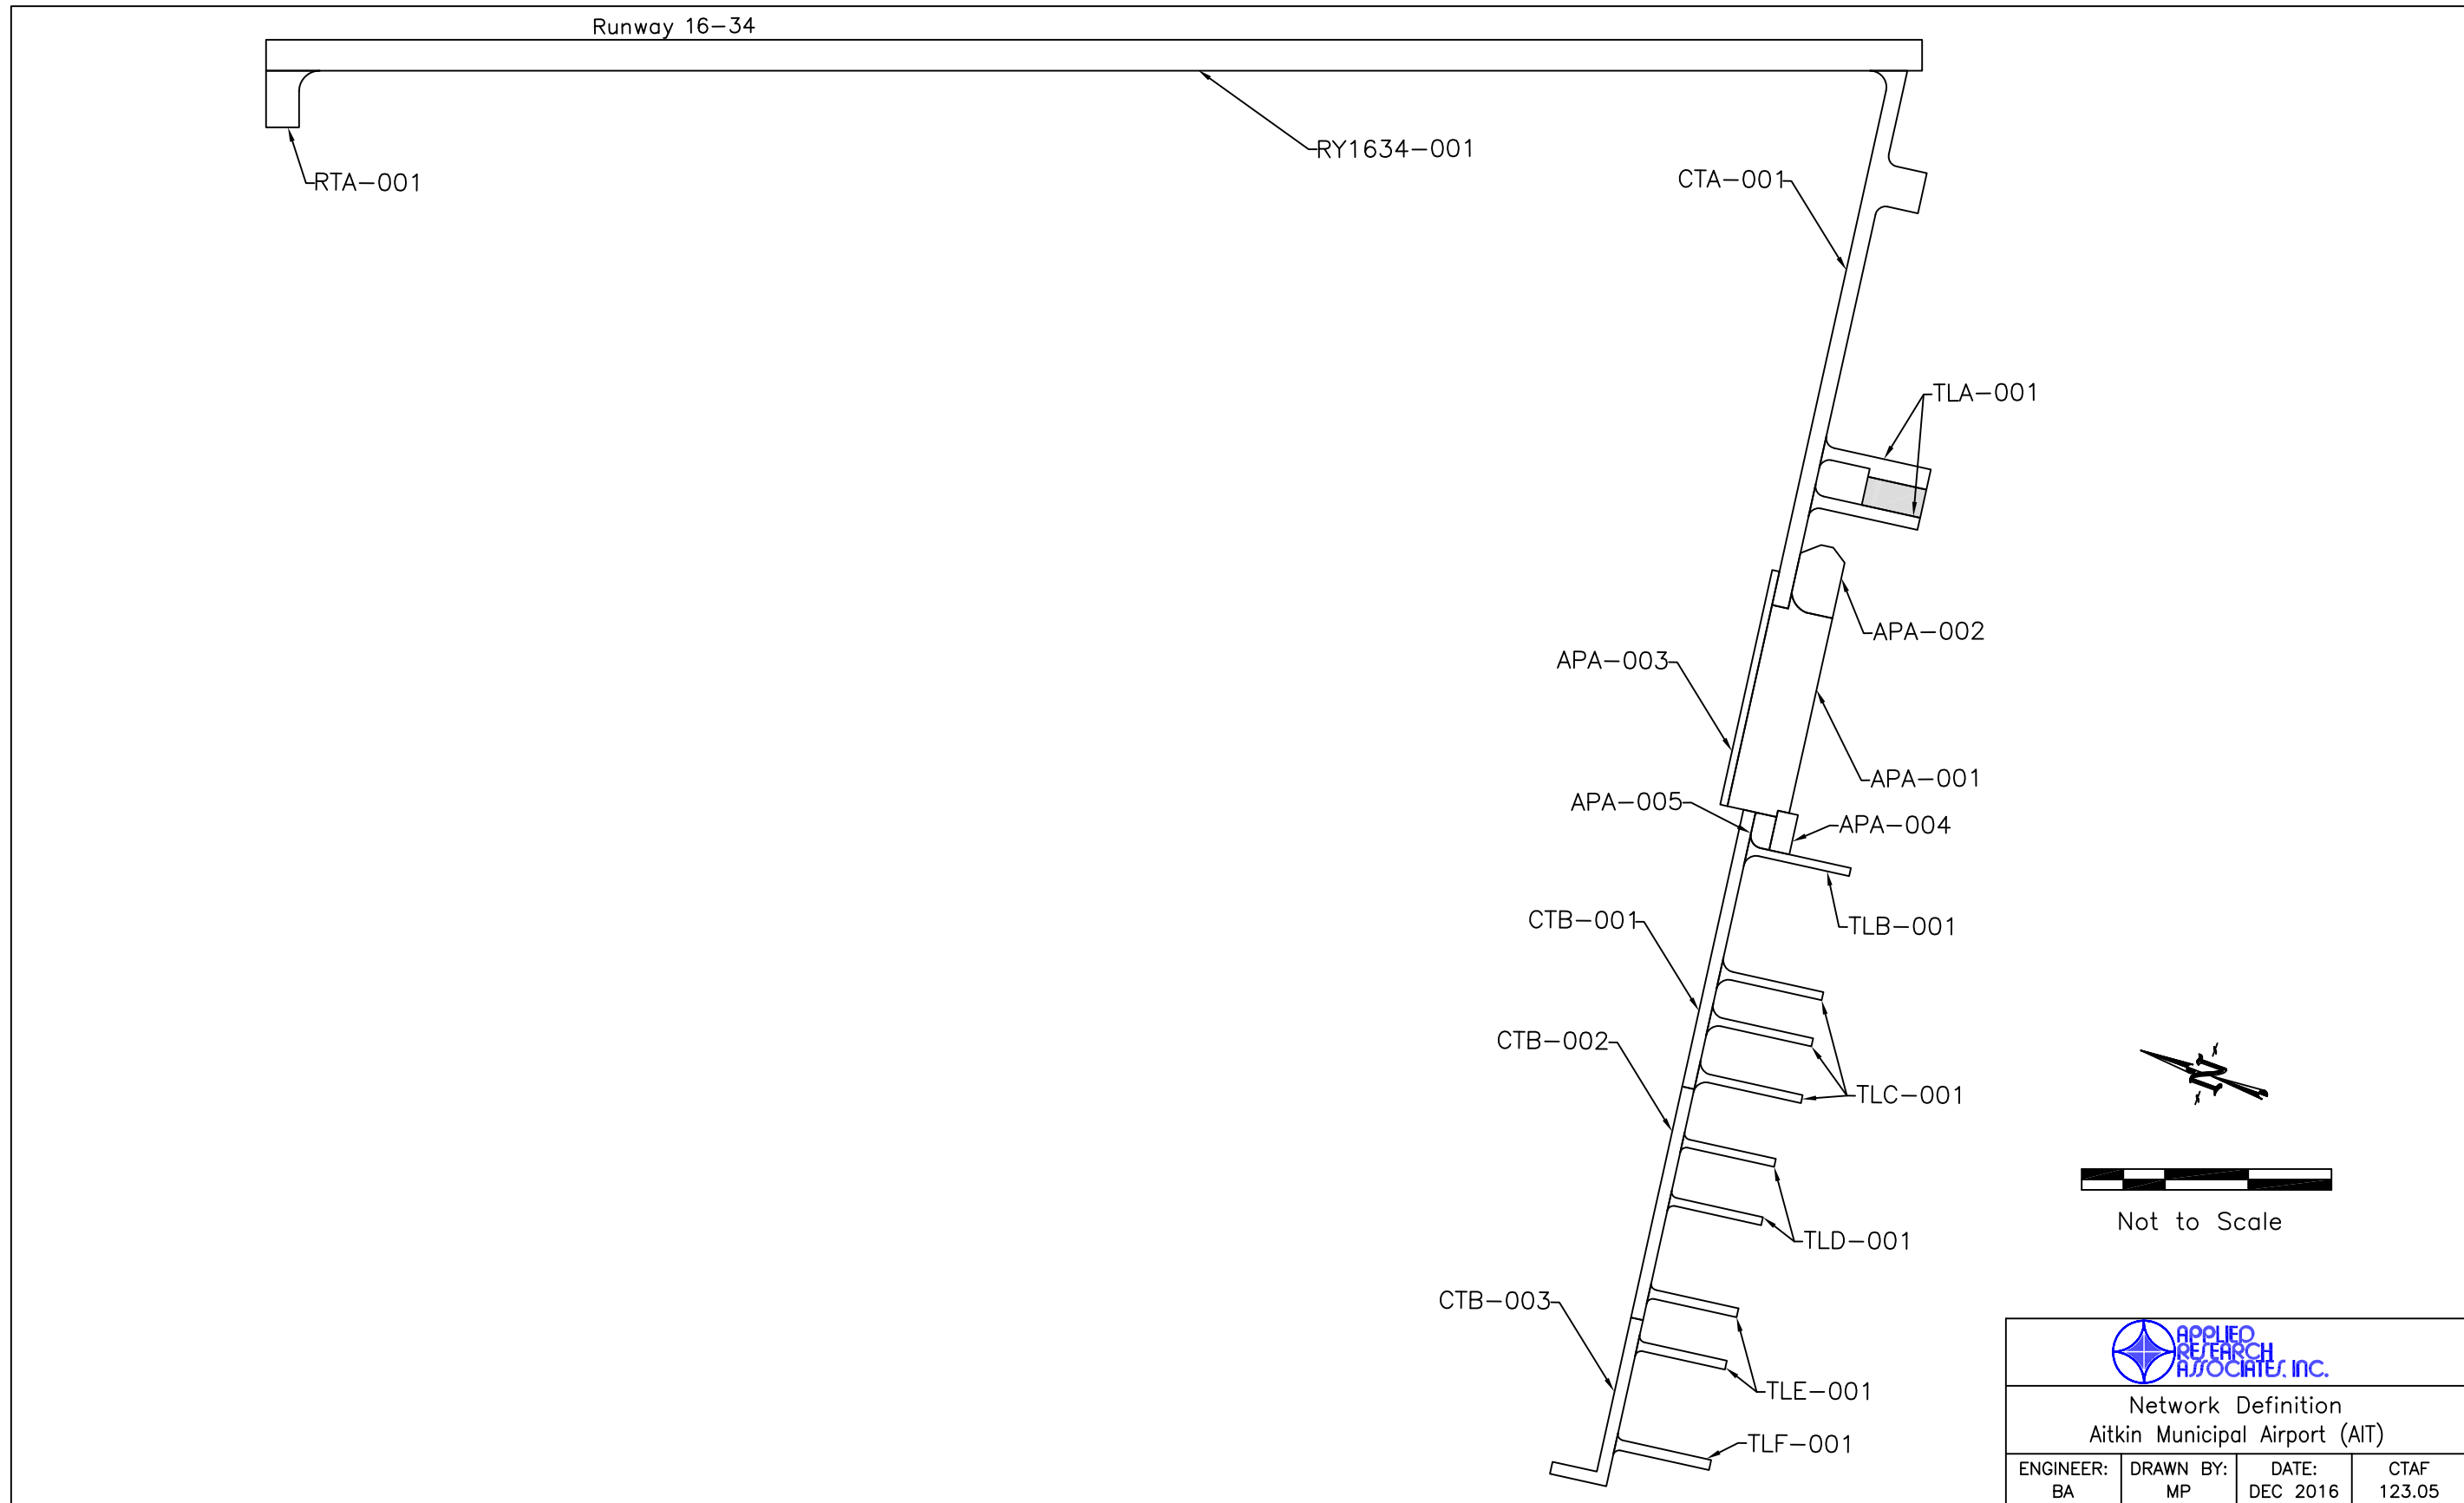
Figure 2. Network Definition at Aitkin Municipal Airport (AIT).

Figure 2 presents the network definition for AIT and represents the pavements included in the APMS. Some privately built/maintained pavements and “driveways” leading into hangars may not be included here because they are considered outside the scope of work.

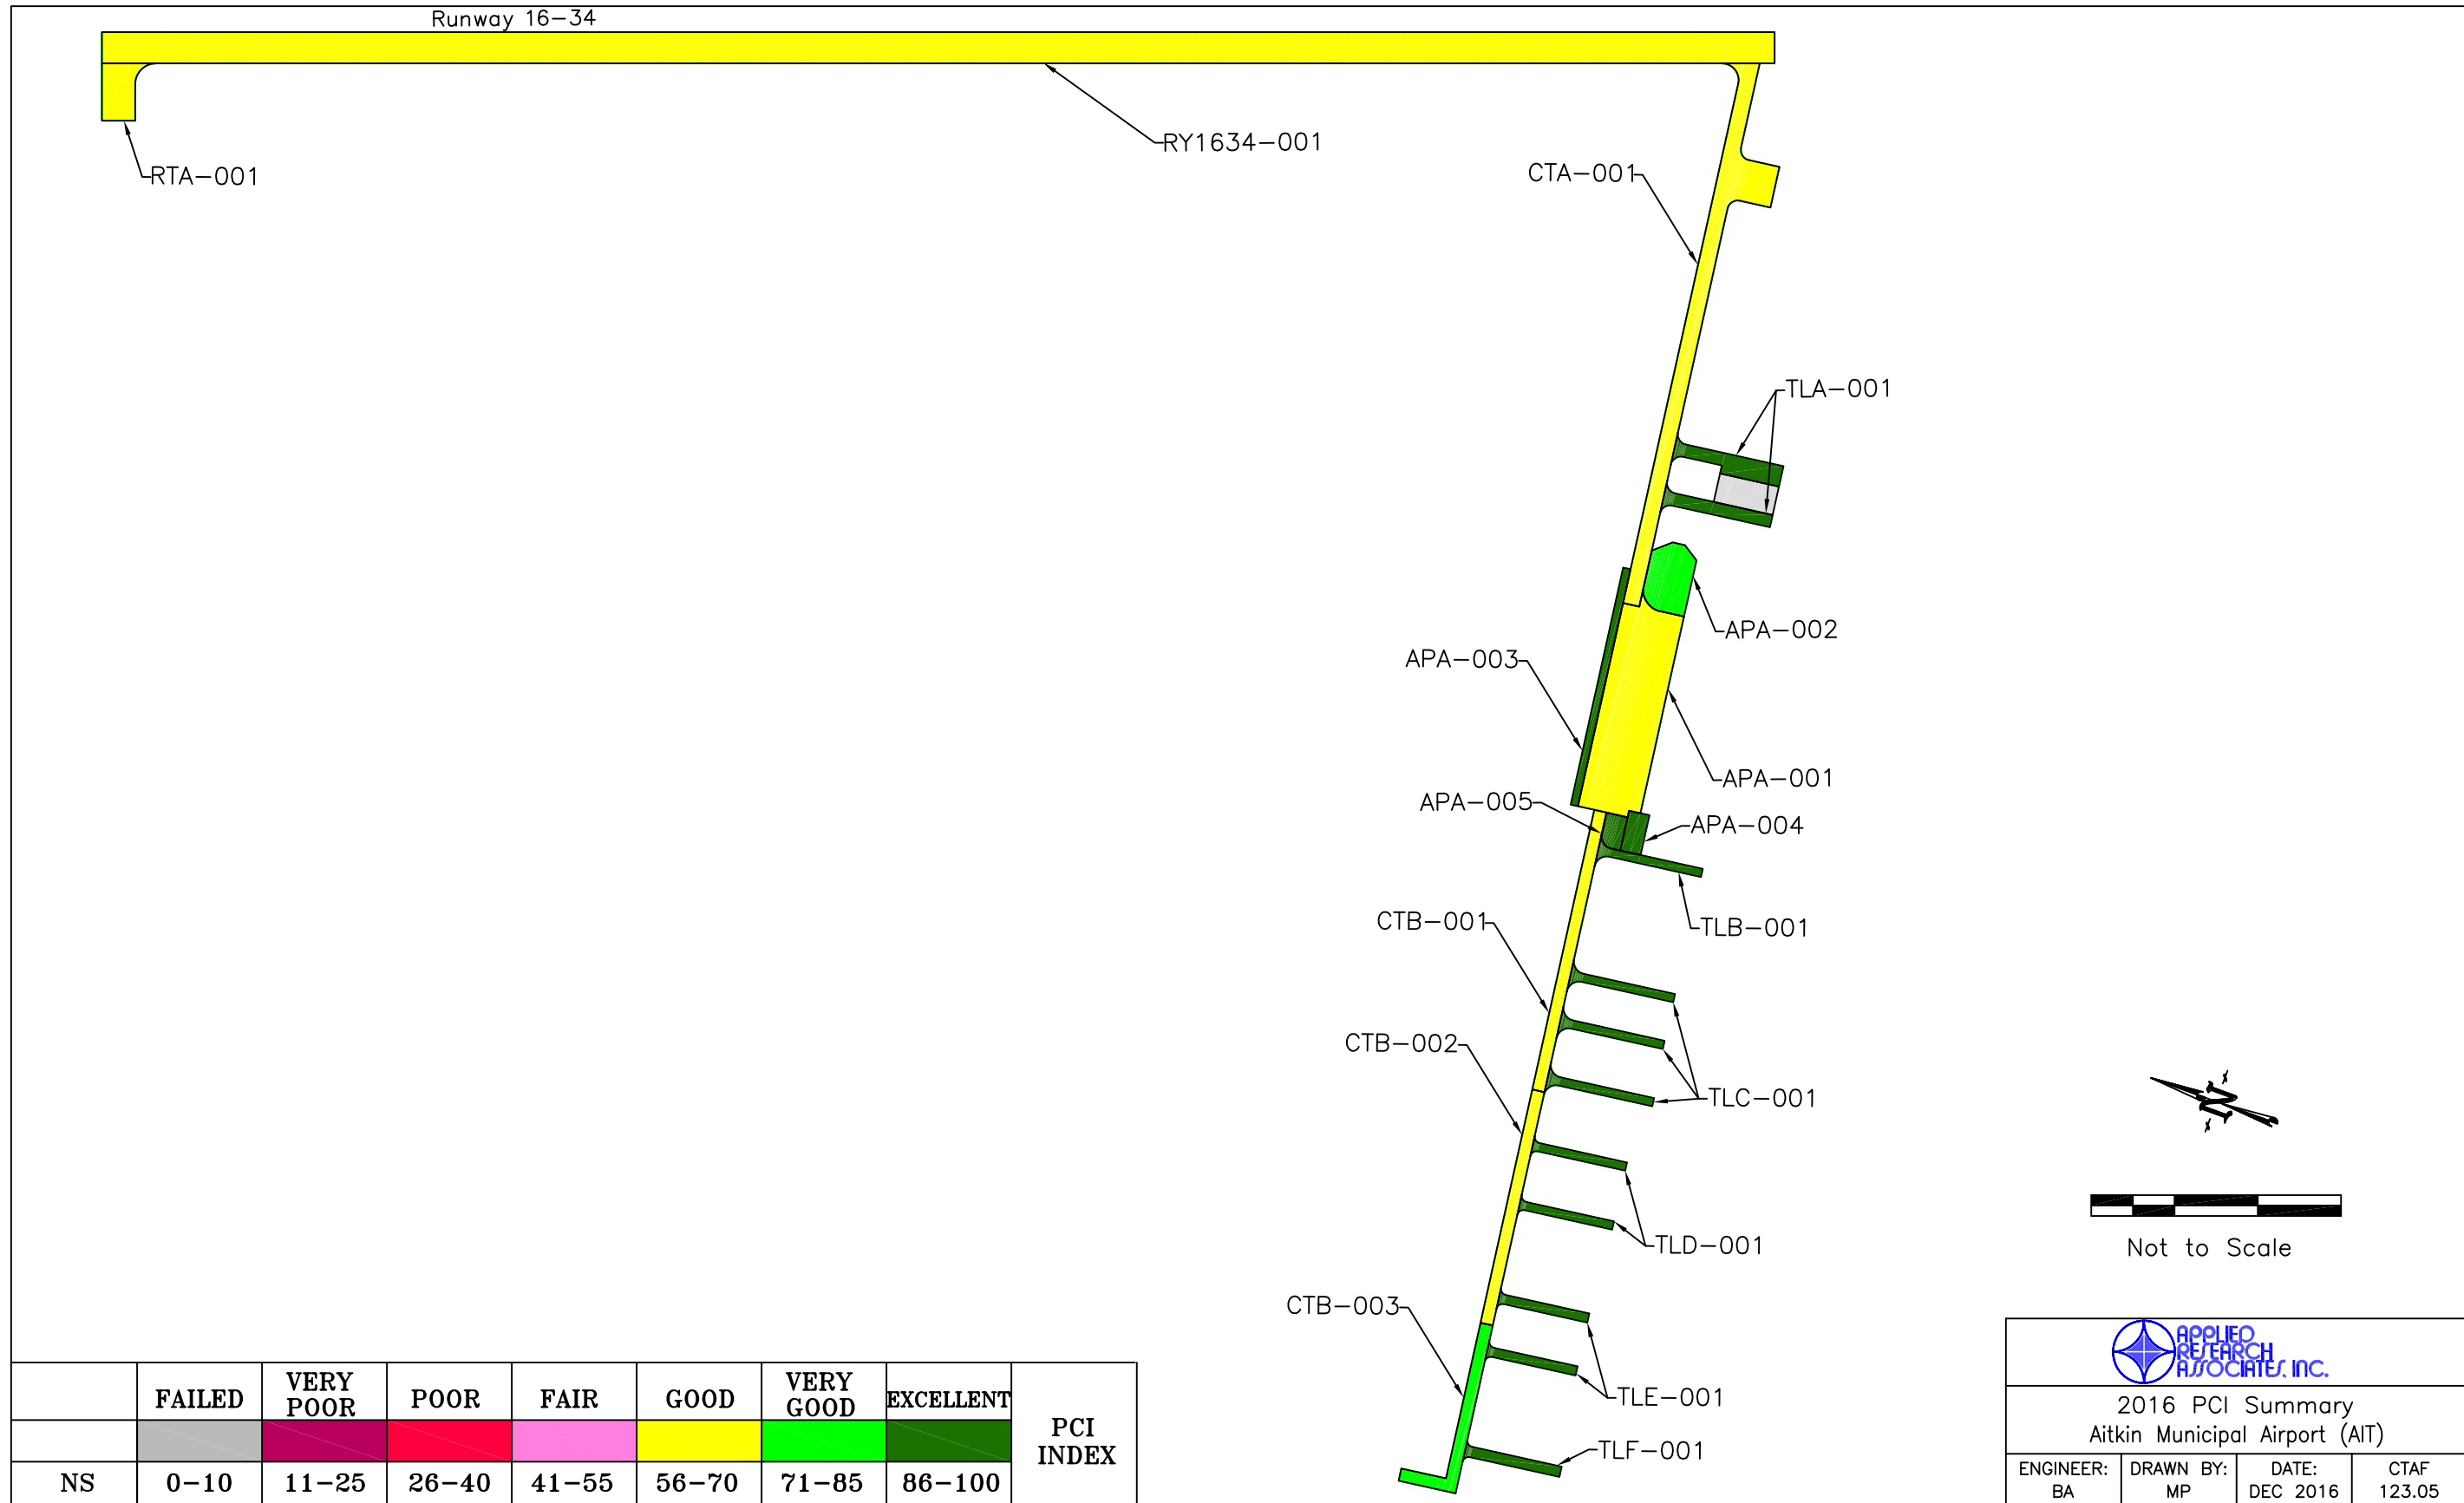
Figure 4. 2016 Pavement Condition Index Rating at Aitkin Municipal Airport (AIT).

The results of the 2016 PCI inspection are presented in figure 4. The overall area-weighted, inspected PCI for AIT is 71. When summarizing PCI values, an area-weighted calculation is used instead of a straight mathematical average because the area-weighted calculations eliminate the skewing of the PCI due to the disparity of the section sizes.
