Pavement Condition Report

Herman Municipal Airport (06Y)

December 2017

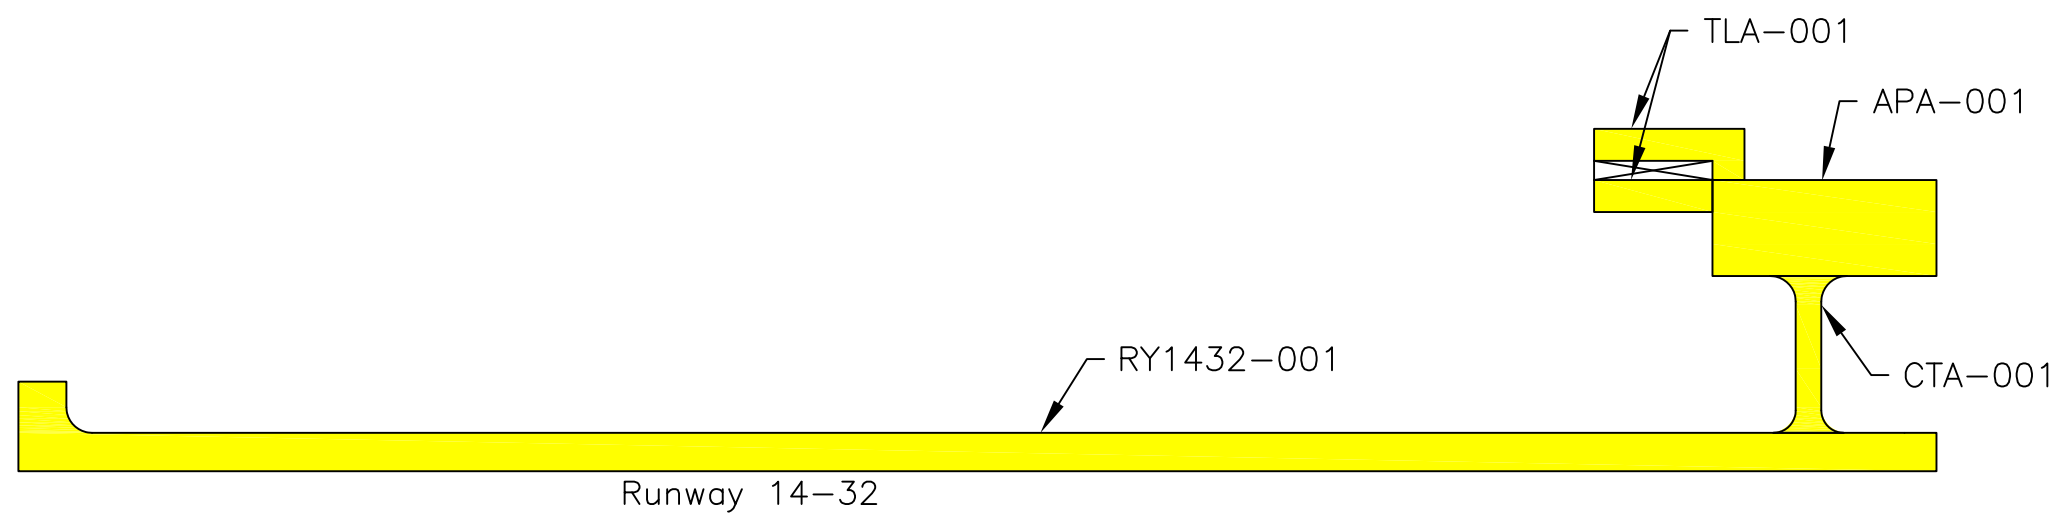
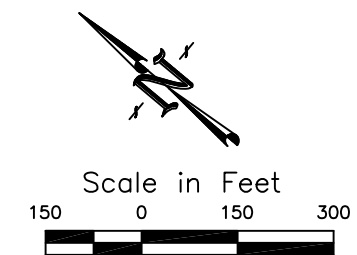
Figure 4. 2017 Pavement Condition Index Rating at Herman Municipal Airport (06Y).

The results of the 2017 PCI inspection are presented in figure 4. The overall area-weighted, inspected PCI for 06Y is 59. When summarizing PCI values, an area-weighted calculation is used instead of a straight mathematical average because the area-weighted calculations eliminate the skewing of the PCI due to the disparity of the section sizes.
