# Pavement Condition Report

## Sky Harbor Airport (DYT)

**December 2017**

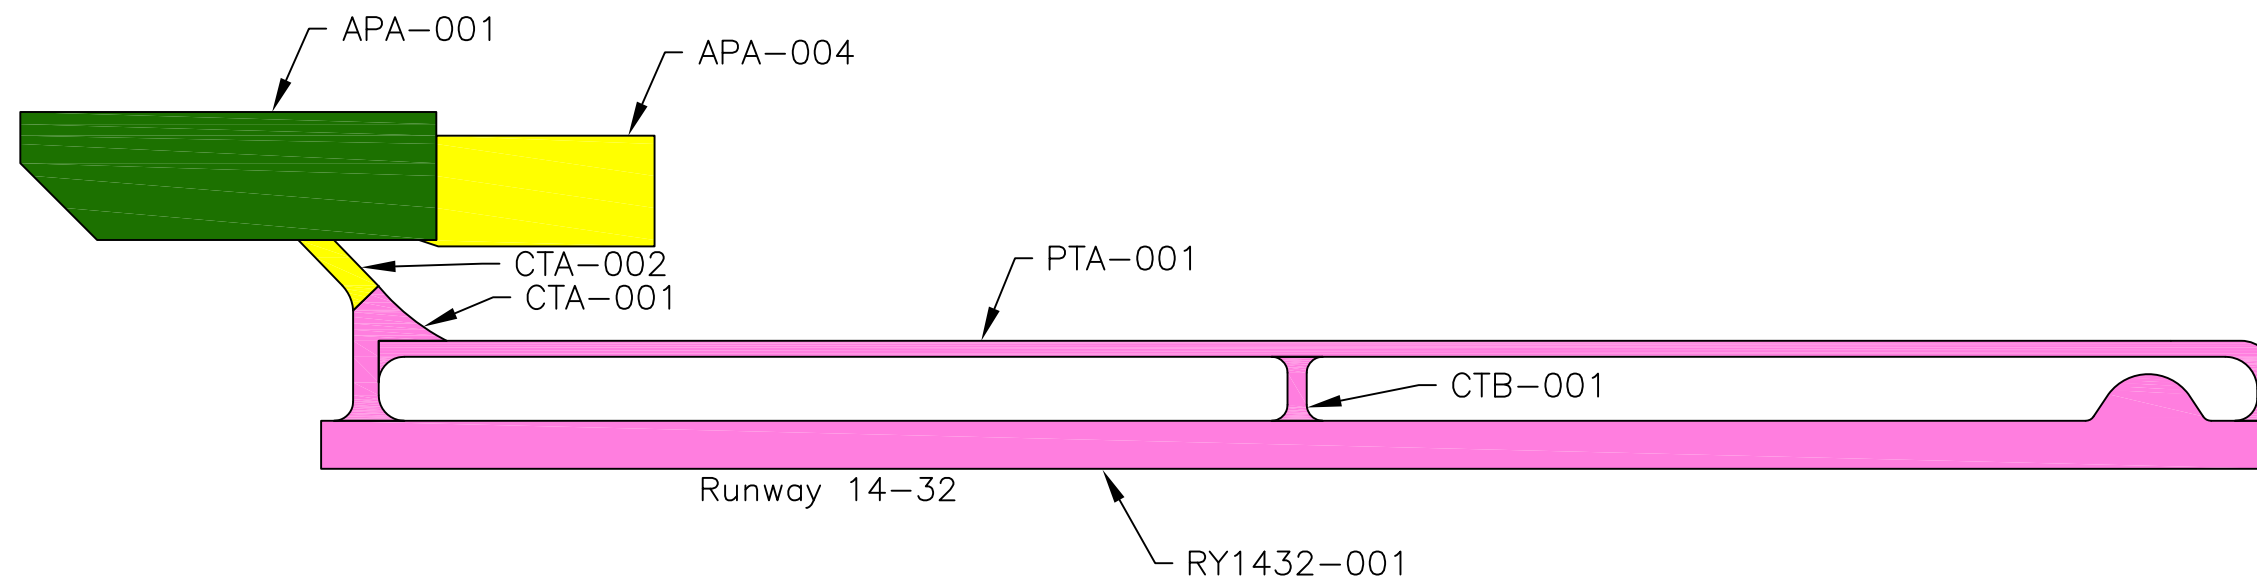
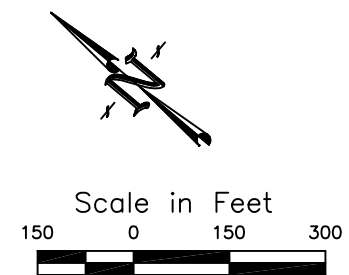
Figure 4. 2017 Pavement Condition Index Rating at Duluth Sky Harbor Airport (DYT).

The results of the 2017 PCI inspection are presented in figure 4. The overall area-weighted, inspected PCI for DYT is 66. When summarizing PCI values, an area-weighted calculation is used instead of a straight mathematical average because the area-weighted calculations eliminate the skewing of the PCI due to the disparity of the section sizes.

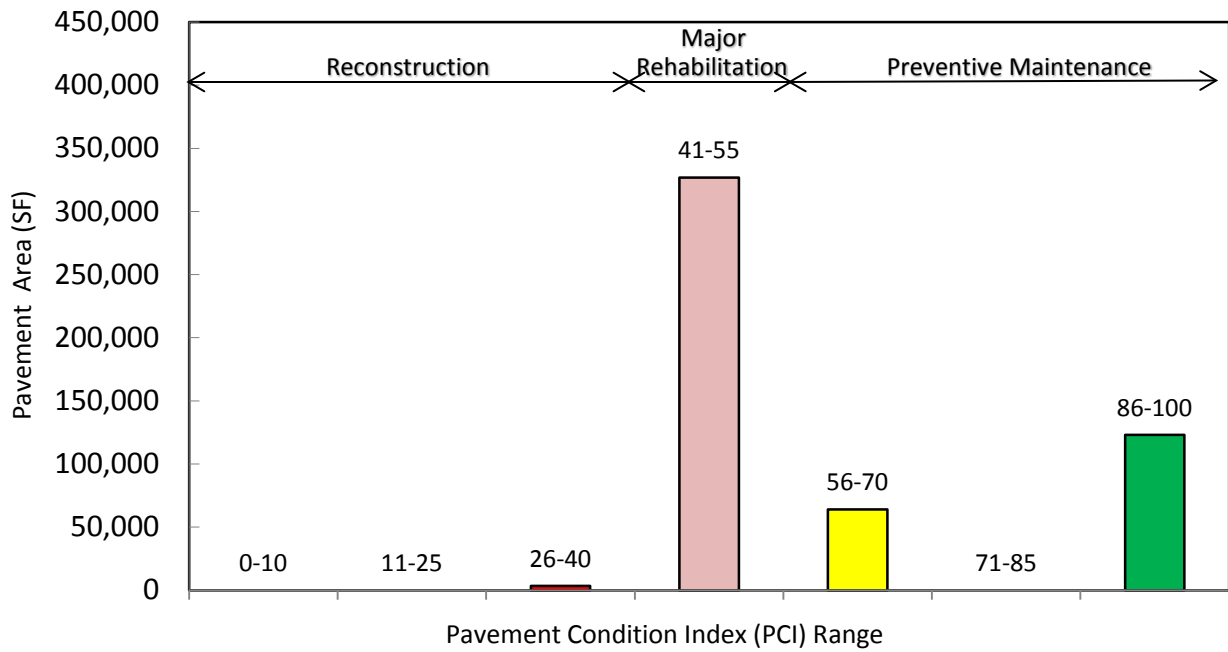
Figure 5. Condition distribution.

Figures 5 and 6 present the overall PCI for DYT by area distribution and pavement use, respectively. Table 3 presents the PCI summary for each section at DYT, including the drop in PCI per year. Generally, pavement sections will deteriorate between 1 and 3 PCI points per year. Sections deteriorating at higher rates may need maintenance above the normal application rates and should be closely monitored in case major repairs become necessary earlier than expected.

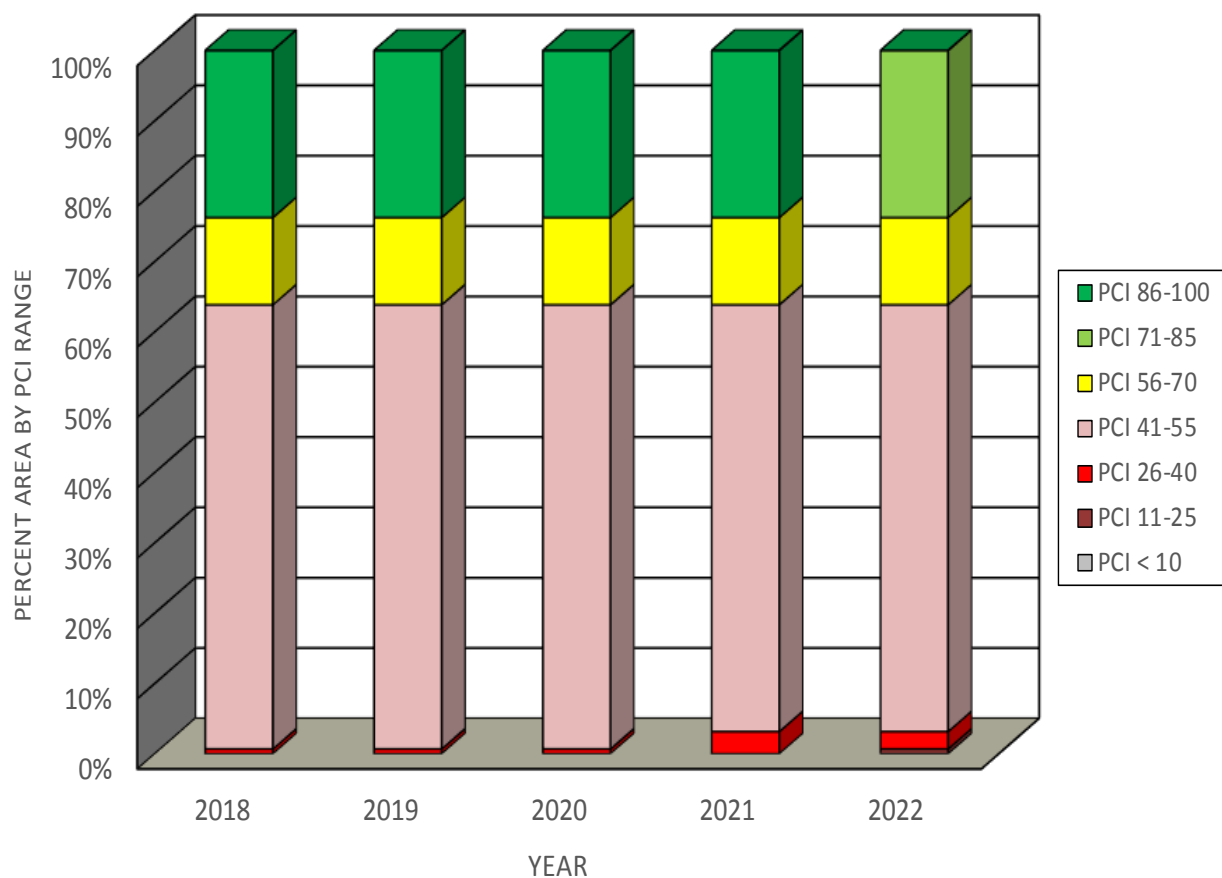
Figure 7. Projected PCI by percent area.

Figure 7 shows the projected PCI at DYT by percent area for the next 5 years assuming no major repairs (overlays, reconstruction, etc.) are performed during that period. It shows how quickly a pavement network can deteriorate when no capital improvements are made.
