Pavement Condition Report

Buffalo Municipal Airport (CFE)

December 2019

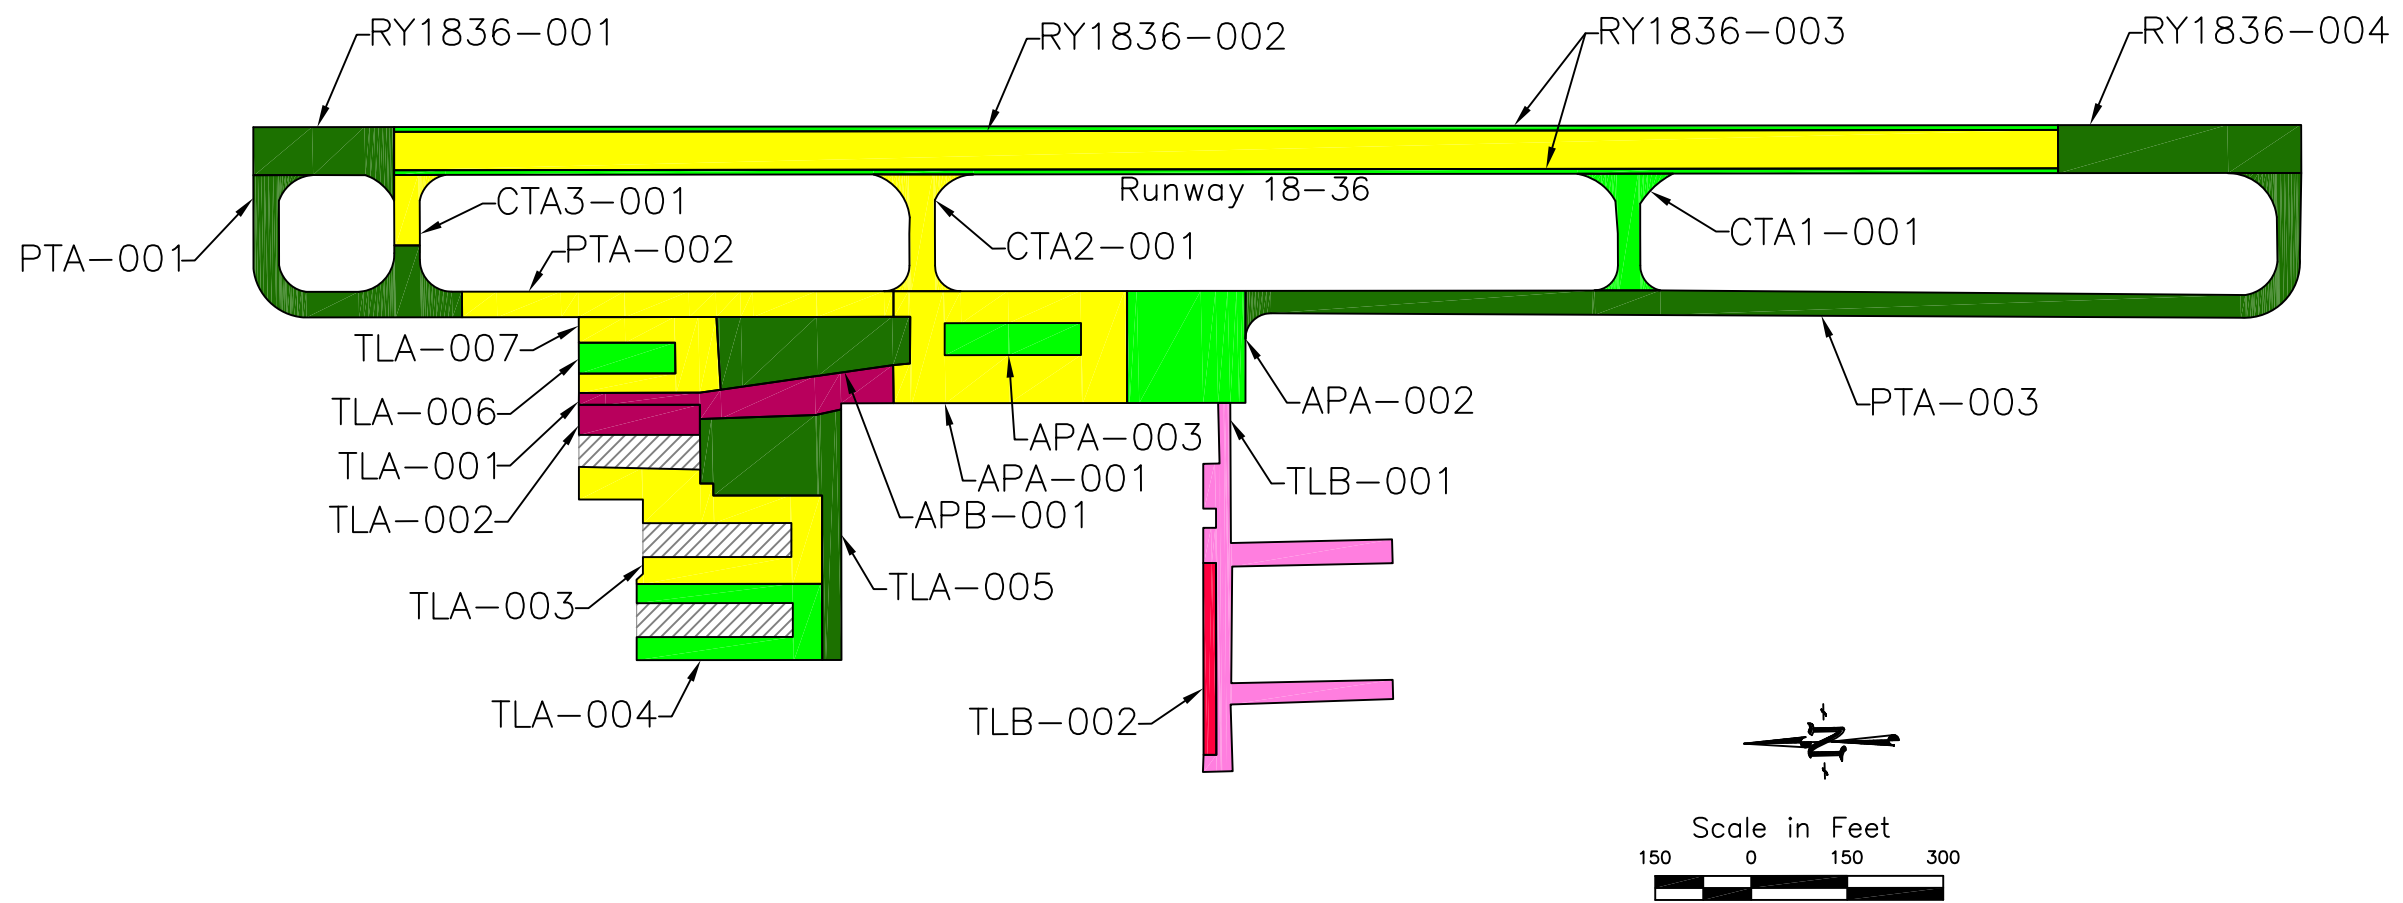
Figure 4. 2019 Pavement Condition Index Rating at Buffalo Municipal Airport (CFE).

The results of the 2019 PCI inspection are presented in figure 4. The overall area-weighted, inspected PCI for CFE is 72. When summarizing PCI values, an area-weighted calculation is used instead of a straight mathematical average because the area-weighted calculations eliminate the skewing of the PCI due to the disparity of the section sizes.
