# Minnesota Airport System Pavement Evaluation 2010 Update

Long Prairie Municipal Airport  
(14Y)

Long Prairie, Minnesota

December 2010

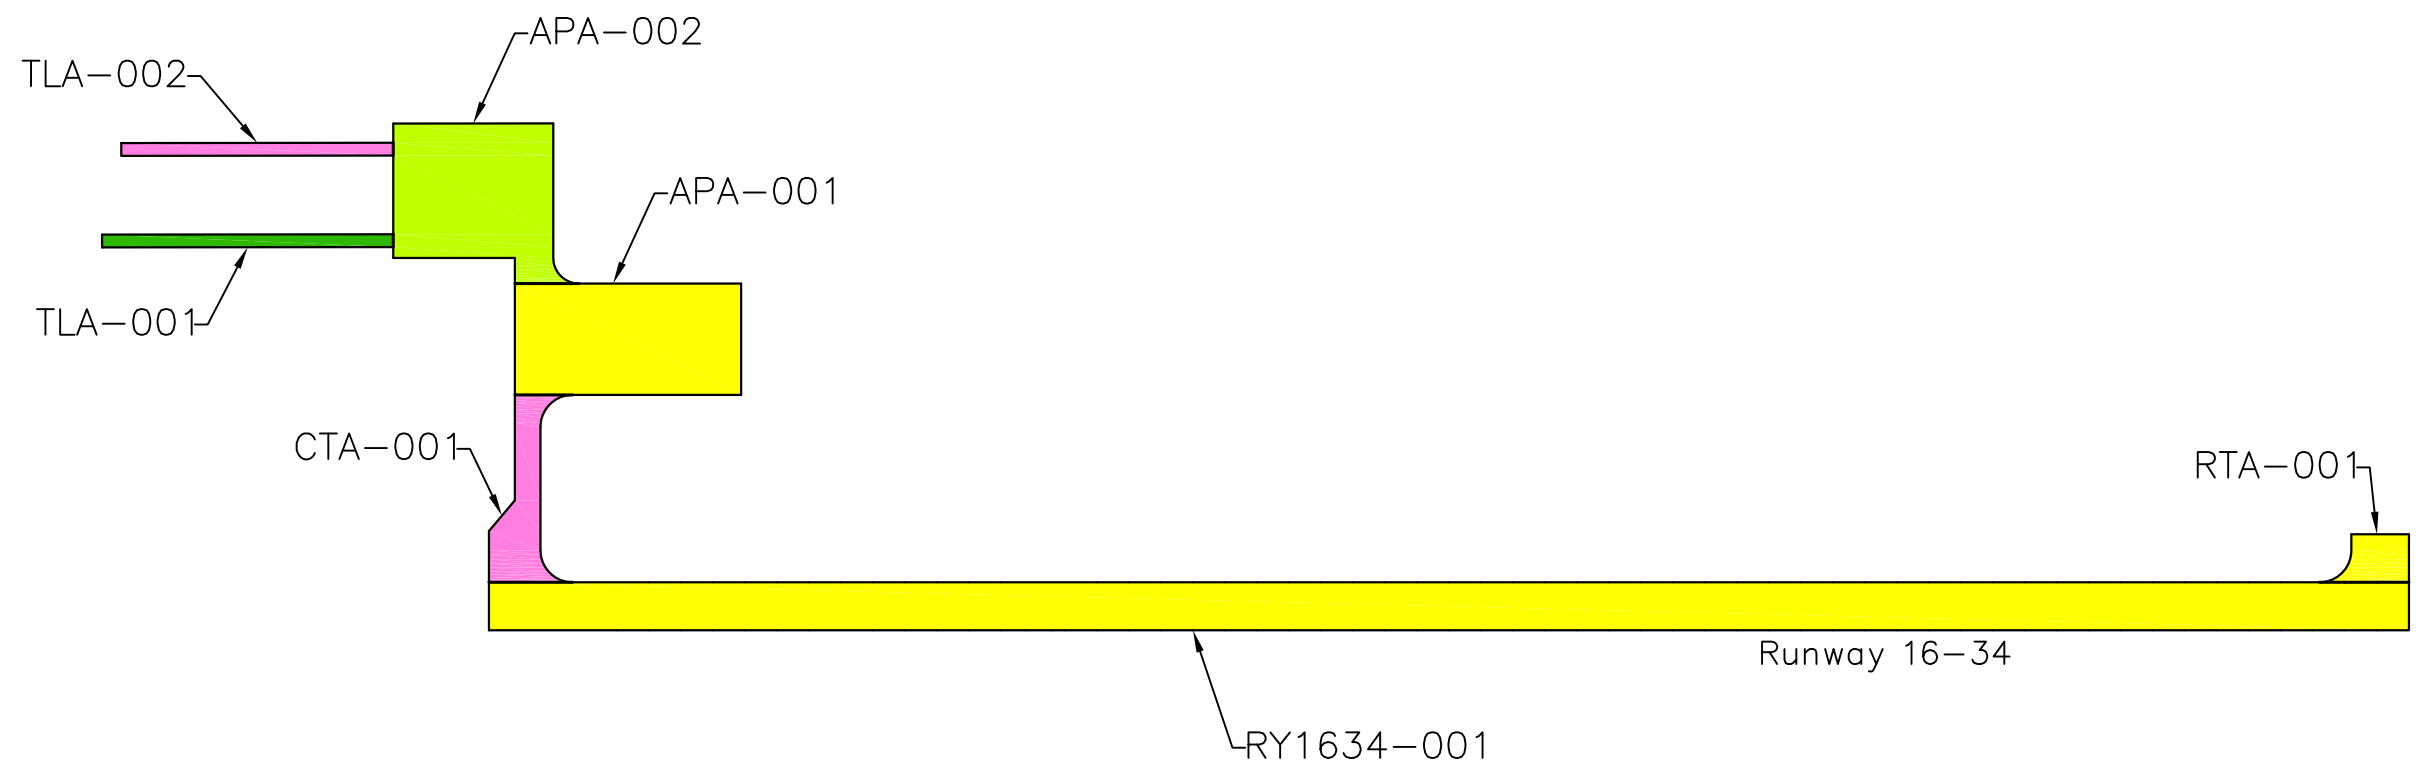
Figure 4. 2010 Pavement Condition Index Rating at Long Prairie Municipal Airport (14Y).

The results of the 2010 PCI inspection are presented in figure 4. The overall area-weighted PCI for 14Y is 64. When summarizing PCI values, an area-weighted calculation is used instead of a straight mathematical average because the area-weighted calculations eliminate the skewing of the PCI due to the disparity of the section sizes.

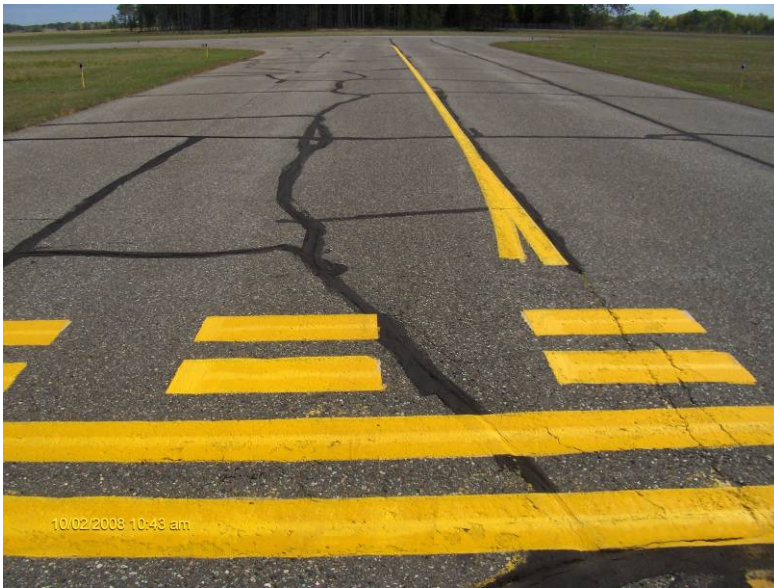
#### Example of Longitudinal and Transverse Cracking

Longitudinal and transverse cracks are caused by pavement aging, by construction, and by subsurface movement. Aging occurs as pavement loses some of its components to the atmosphere and becomes more brittle. Consistent application of pavement sealcoats can help to prevent the occurrence of age related cracks. Cracks will also develop along poorly constructed paving lane joints. Ensuring that joints are made when both sides are still hot, and near the same temperature, is one of the best ways to mitigate this potential problem. Seasonal movement caused by changes in moisture content or temperature differences can also cause pavement cracks. Asphalt pavement placed over a PCC pavement or cement stabilized base course may evidence reflective cracking from the underlying material. Longitudinal and transverse cracks are not caused by wheel loads, although traffic may worsen their condition.

Low severity longitudinal and transverse cracks are less than ¼ inch wide, or if sealed with suitable filler material in satisfactory condition can be any width, less than 3 inches, if they are not spalled. Maintenance usually is not indicated for low-severity cracking. Moderately spalled cracks and cracks wider than ¼ inch which are not satisfactorily sealed are at medium severity. Medium-severity cracks should be sealed with a high-

quality crack filling material. Severely spalled cracks and cracks wider than 3 inches are at high severity. High-severity L&T cracks normally require patching.

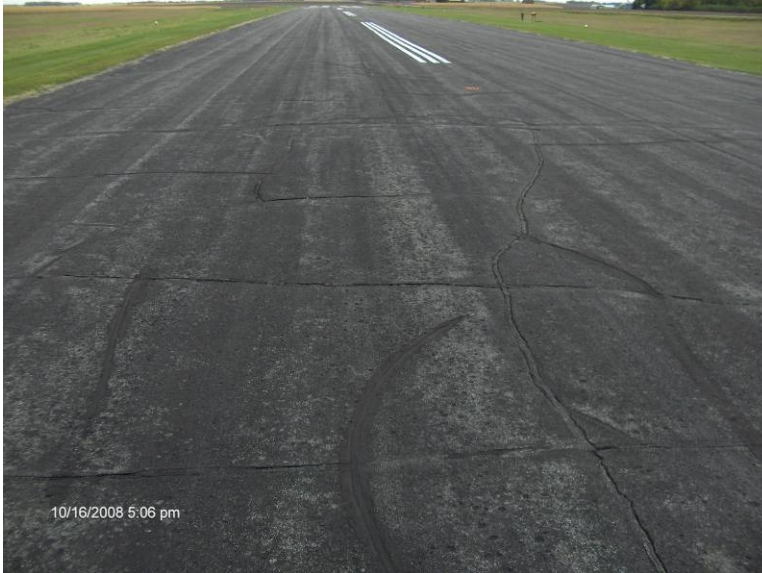
#### Example of Block Cracking

Block cracking is longitudinal and transverse cracking that has established a pattern of blocks ranging in size from 1ft x 1ft to 10ft x 10ft. This distress typically happens in older asphalt pavements and is an indication that the bituminous binder has lost most of its flexibility. The severity determination is basically determined by the crack width criteria defined for longitudinal and transverse cracking. Crack sealing typically is used to repair block cracking; however, the amount of required sealant can be extensive due to the high density of cracks.

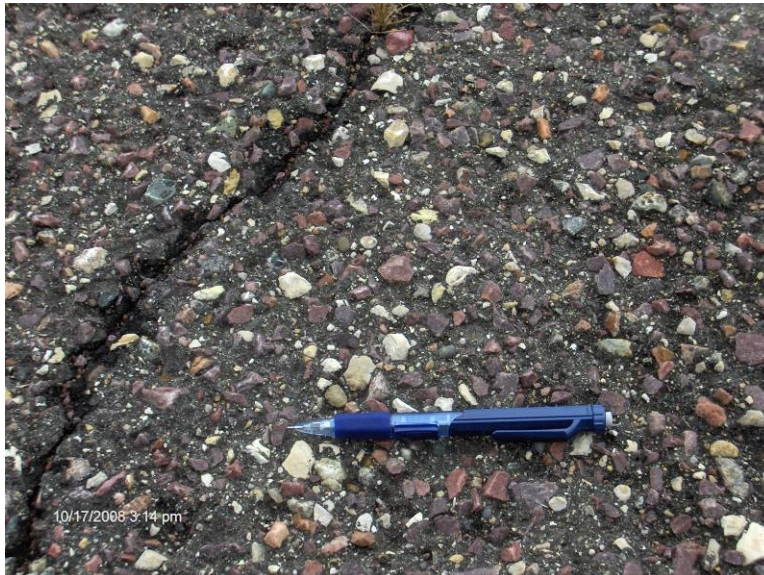
#### Example of Raveling/Weathering

Raveling and weathering are the wearing away of the pavement surface. This can be caused by the dislodging of aggregate particles or the loss of asphalt binder. This distress is usually evident over large areas. Raveling and weathering may indicate that the asphalt binder has hardened significantly. At low severity, the surface has started to wear away with few (if any) loose particles and the coarse surface aggregate is exposed to 1/4 of its diameter. At medium severity, the aggregate and/or binder have worn away with some loose and missing particles, and the surface texture is moderately rough and pitted, but the average depth of erosion is less than 1/4 inch. At high severity, the aggregate and/or binder have worn away with a large amount of loose and missing particles, the surface texture is severely rough and pitted, and the top layer of aggregate has eroded away.

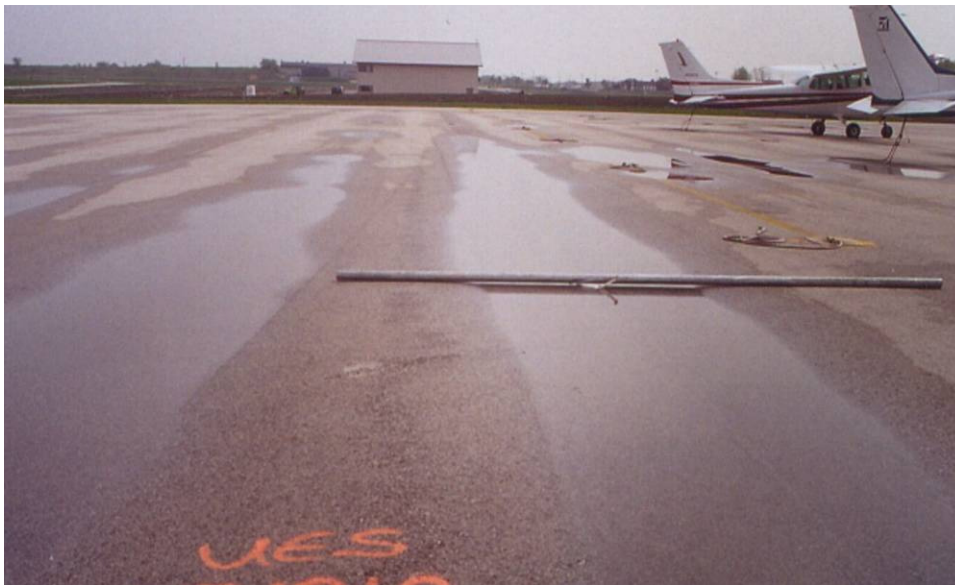
### Example of Rutting

Ruts are localized, load related, areas of pavement having elevations lower than the surrounding sections. Rutting is due to base and subgrade consolidation, caused by

excessive wheel loads or poor compactions. Ruts indicate structural failure, and can cause hydroplaning. At low severity, ruts have an average depth of  $\frac{1}{4}$  to  $\frac{1}{2}$  inches. At medium severity, ruts have an average depth of  $\frac{1}{2}$  to 1 inch. High severity, ruts have an average depth greater than 1 inch.

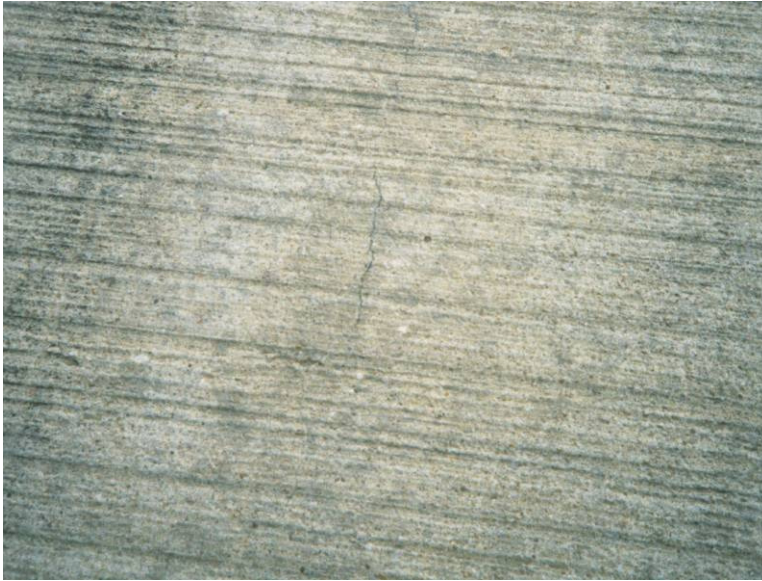
### Example of Shrinkage Cracking

Shrinkage cracks are small, nonworking (no spalling along edge) cracks that are visible at the surface but do not penetrate through the full depth of concrete. Shrinkage cracks most commonly occur shortly after construction due to concrete shrinkage during the curing process. Shrinkage cracks are usually so small that they are not visible until staining or material loss at crack edges begins to take place. Shrinkage cracks do not represent a structural weakness, and no corrective action is prescribed.

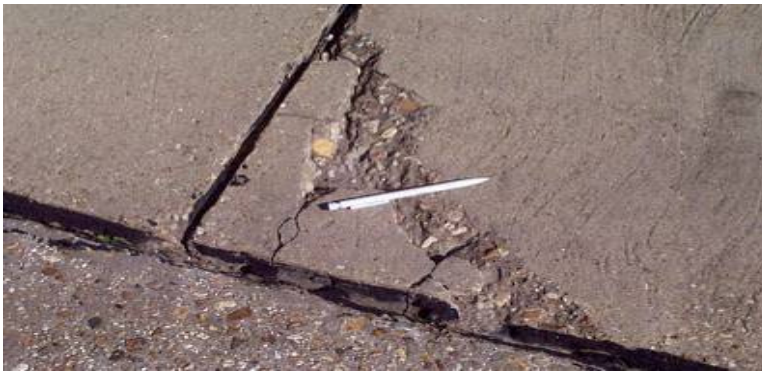
### Example of Joint and Corner Spalling

Spalls at slab joints and corners are caused by excessive internal stress in the pavement. Spalls occur when these stresses exceed the shear strength of the concrete. Spalling usually results from thermal expansion during warm or hot weather. As slabs expand, they push against one another at joints. If the joints are filled with incompressibles, such as sand, or if adjacent slabs offset slightly, stresses can become severe, causing spalls. Spalling can be reduced significantly by conscientious maintenance of joint sealant.

Spall repair requires patching. The extent and severity of spalling on a pavement surface suggests appropriate action. For example, at low severity, spalled concrete remains securely in place in the slab. A low-severity spall should be monitored closely for further

deterioration and should be patched when spalled particles become loose in place, or at the next scheduled patching activity in the section. Medium- and high-severity spalls should be repaired immediately to prevent the incidence of FOD. If the pavement can be restored to serviceable condition, spalls should be carefully patched for long-term service. If the pavement is beyond repair, temporary patching should be considered to control FOD.

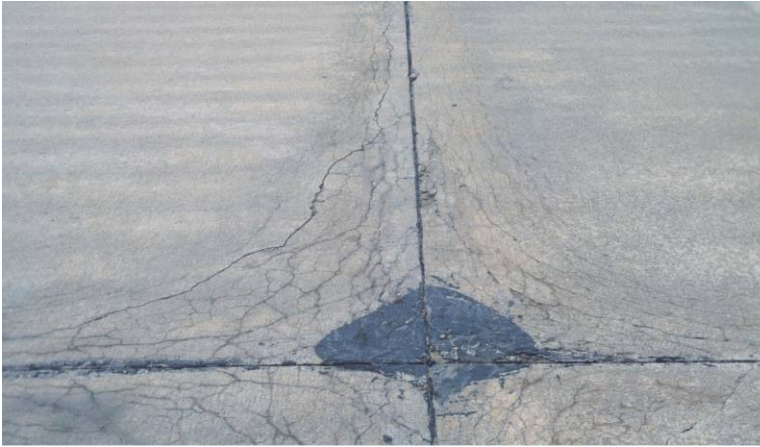
#### Example of Durability Cracking

Durability cracking (D-cracking) is caused by environmental factors, the most common of which is freezing/thawing. It usually appears as a pattern of hairline cracks running parallel to a joint or crack, or in a corner, where water tends to collect. This type of cracking eventually leads to disintegration of the pavement, creating FOD potential. At low severity, D-cracking is evident, but no disintegration has occurred. As the distress advances to medium severity, the distress pattern is evident over a significant area of the slab, and some disintegration and FOD potential exists. High severity durability cracking is evidenced by extensive cracking with loose and missing pieces and significant FOD potential.

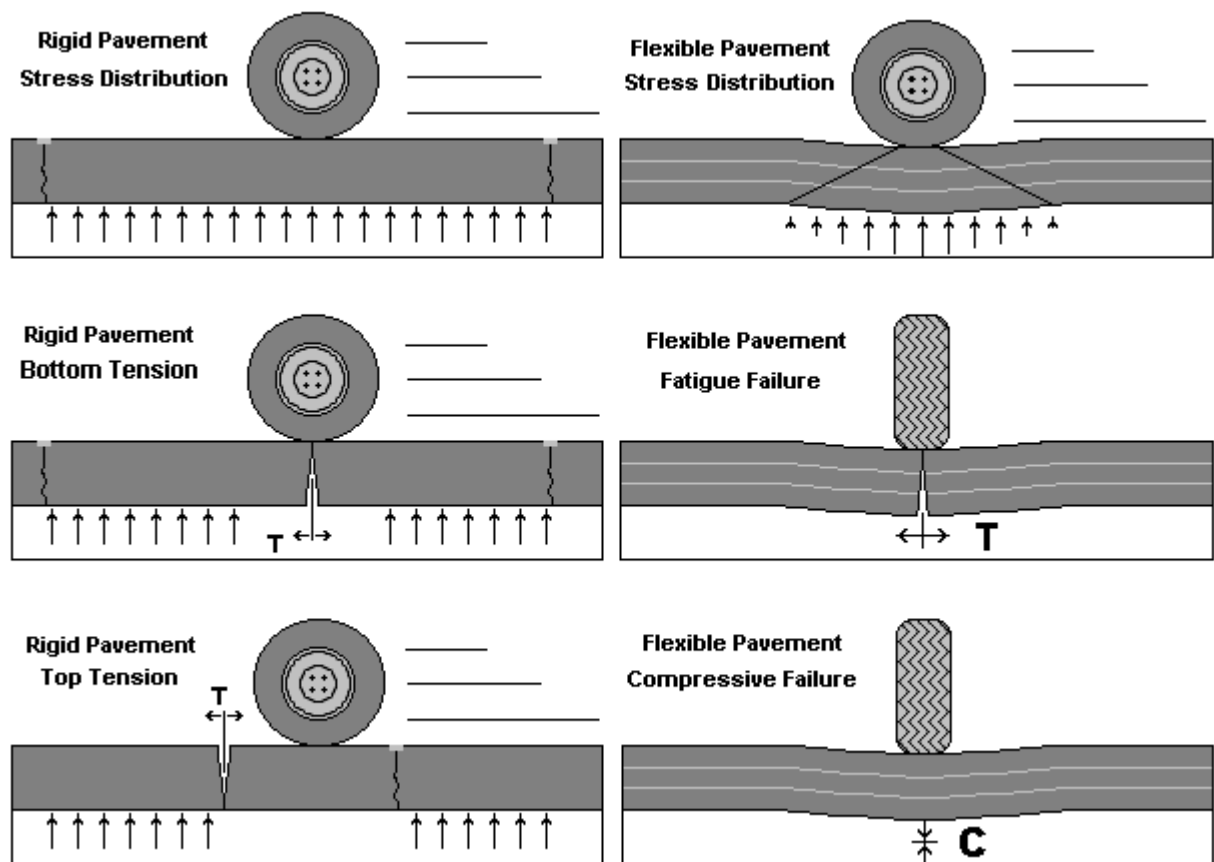
**Figure 1. Pavement failure.**

Load-related cracks can start at the top or bottom of a pavement section. In asphalt sections, load-related (fatigue) cracks start at the bottom. If a load-related crack reaches the surface, it usually indicates significant structural deficiency. In PCC pavement, corner breaks are caused by top tension, and the crack propagates downward. Mid-slab LTD cracks are examples of bottom tension.

Spalls can be caused by either wheel loads or environmental factors, anytime there is movement between adjacent slabs. If a small rock is allowed into a joint, a differential movement between adjacent slabs can cause a spall. Spalling can be minimized by keeping joint and crack sealant intact.

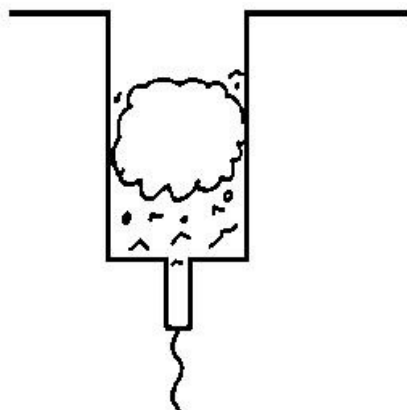
**Typical joint with deficient sealant and a collection of debris & incompressibles.**
