Minnesota Airport System Pavement Evaluation 2010 Update

Piney – Pinecreek Border
Airport (48Y)

Pinecreek, Minnesota

December 2010

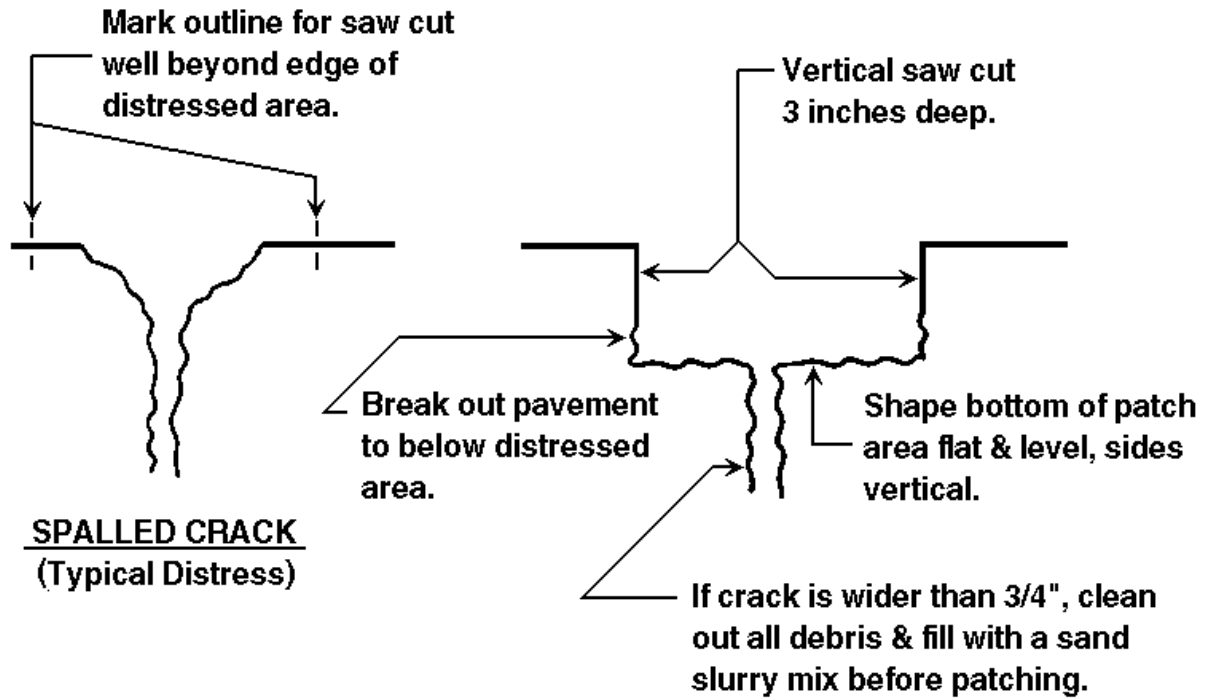
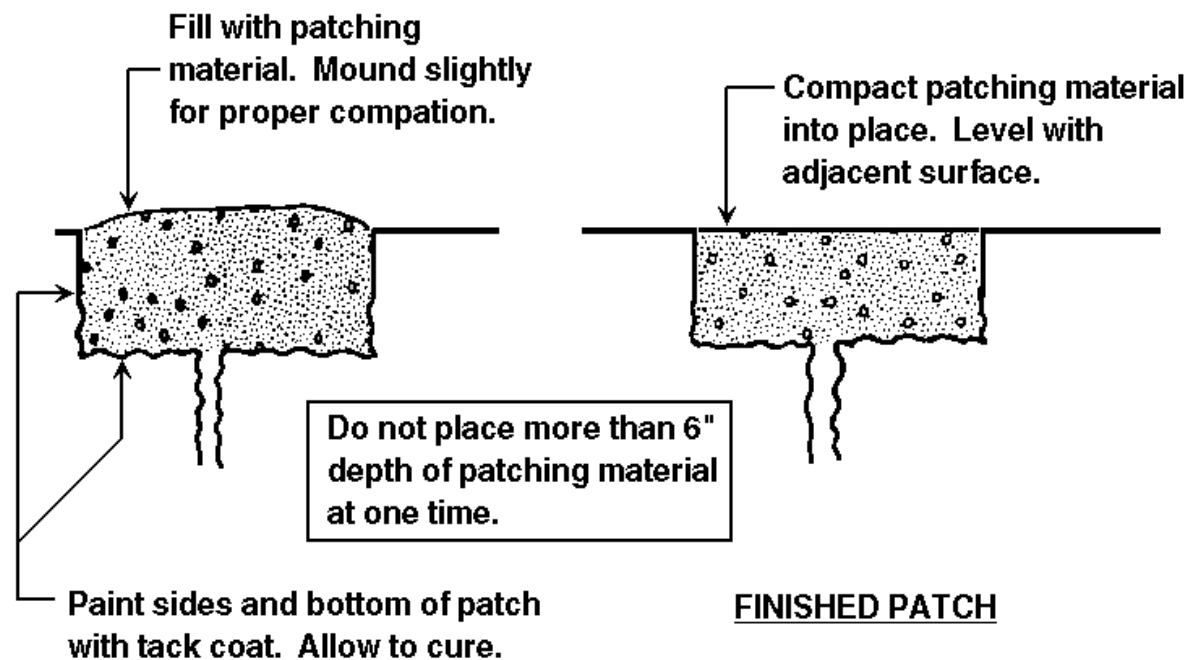
Figure 4. AC patch.

Cracks wider than 3 inches should be patched. Cracks with secondary cracking and vertical movement should also be patched. Failed existing patches should be replaced. Patching can also repair small areas of alligator cracking and rutting. A patch differs from sealant in that it restores load-bearing capacity. Therefore, it must be constructed carefully to distribute stresses evenly and perform as an integral piece of the surrounding pavement. The patch must be wide enough to ensure that it bonds to fresh, vital pavement on all sides, and deep enough to reach fresh underlying layers, but never less than 3 inches.

- In deep, narrow patches such as at joint reflective cracks, a sand asphalt mix may be required in lower layers to allow movement and prevent bridging the adjacent slabs.

- Considerable judgment is required in placing the asphalt concrete to achieve a fully compacted patch without creating a bump or depression. The ¼ inch per inch factor is a rule of thumb. Actual compression will vary with the mix. Experimentation and experience are required to achieve optimum results.

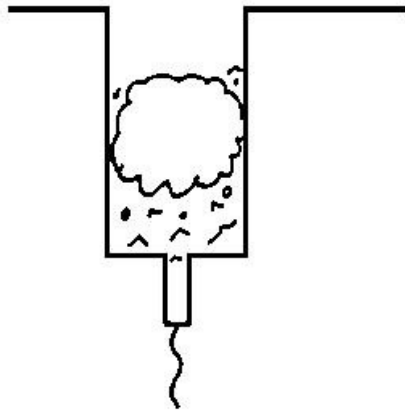
Typical joint with deficient sealant and a collection of debris & incompressibles.
