Minnesota Airport System Pavement Evaluation 2010 Update

Bagley Municipal Airport (7Y4)

Bagley, Minnesota

December 2010

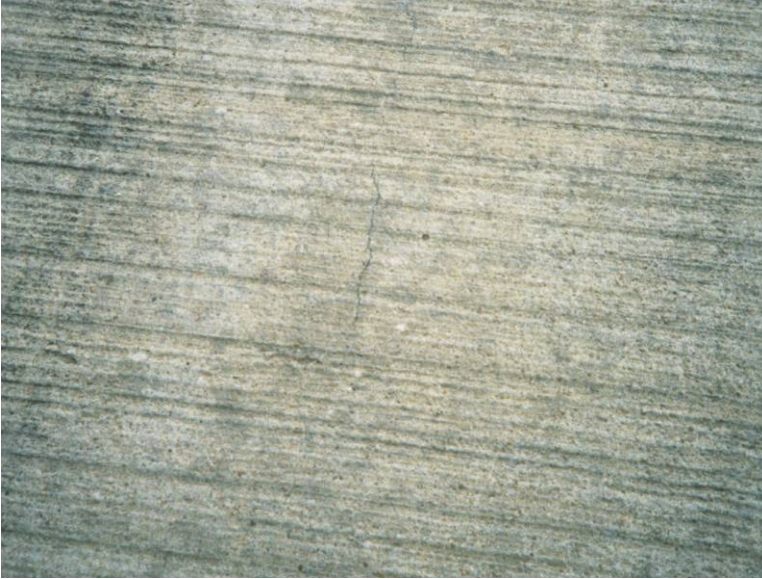
Example of Shrinkage Cracking

Shrinkage cracks are small, nonworking (no spalling along edge) cracks that are visible at the surface but do not penetrate through the full depth of concrete. Shrinkage cracks most commonly occur shortly after construction due to concrete shrinkage during the curing process. Shrinkage cracks are usually so small that they are not visible until staining or material loss at crack edges begins to take place. Shrinkage cracks do not represent a structural weakness, and no corrective action is prescribed.

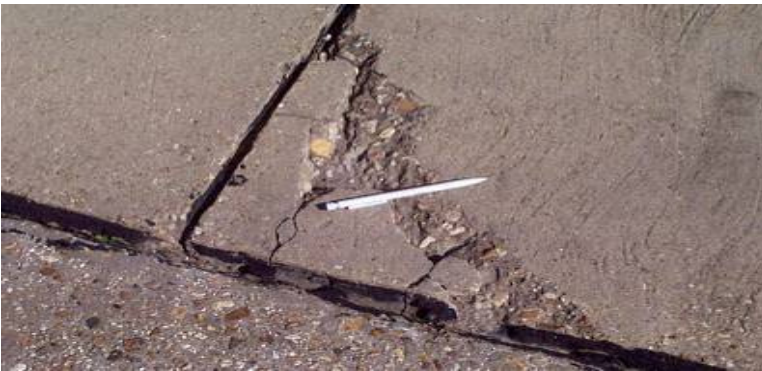
Example of Joint and Corner Spalling

Spalls at slab joints and corners are caused by excessive internal stress in the pavement. Spalls occur when these stresses exceed the shear strength of the concrete. Spalling usually results from thermal expansion during warm or hot weather. As slabs expand, they push against one another at joints. If the joints are filled with incompressibles, such as sand, or if adjacent slabs offset slightly, stresses can become severe, causing spalls. Spalling can be reduced significantly by conscientious maintenance of joint sealant.

Spall repair requires patching. The extent and severity of spalling on a pavement surface suggests appropriate action. For example, at low severity, spalled concrete remains securely in place in the slab. A low-severity spall should be monitored closely for further

deterioration and should be patched when spalled particles become loose in place, or at the next scheduled patching activity in the section. Medium- and high-severity spalls should be repaired immediately to prevent the incidence of FOD. If the pavement can be restored to serviceable condition, spalls should be carefully patched for long-term service. If the pavement is beyond repair, temporary patching should be considered to control FOD.
