Minnesota Airport System Pavement Evaluation 2010 Update

Albert Lea Municipal Airport
(AEL)

Albert Lea, Minnesota

December 2010

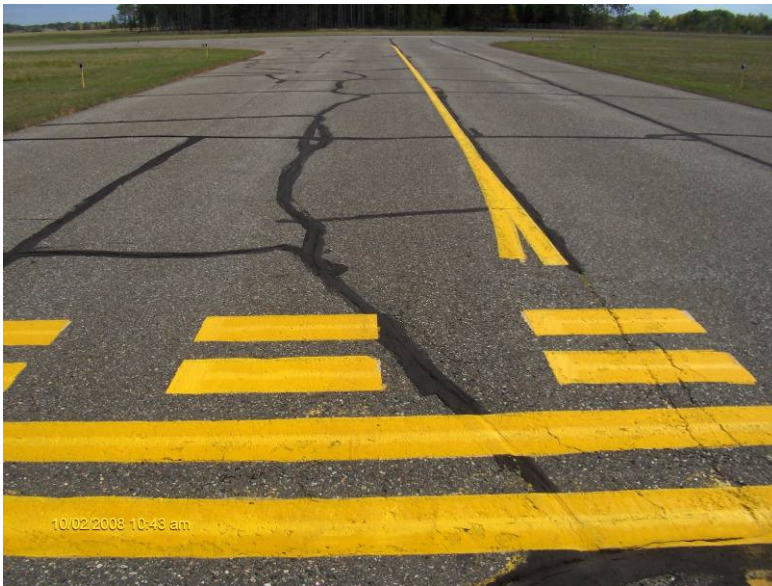
Example of Longitudinal and Transverse Cracking

Longitudinal and transverse cracks are caused by pavement aging, by construction, and by subsurface movement. Aging occurs as pavement loses some of its components to the atmosphere and becomes more brittle. Consistent application of pavement sealcoats can help to prevent the occurrence of age related cracks. Cracks will also develop along poorly constructed paving lane joints. Ensuring that joints are made when both sides are still hot, and near the same temperature, is one of the best ways to mitigate this potential problem. Seasonal movement caused by changes in moisture content or temperature differences can also cause pavement cracks. Asphalt pavement placed over a PCC pavement or cement stabilized base course may evidence reflective cracking from the underlying material. Longitudinal and transverse cracks are not caused by wheel loads, although traffic may worsen their condition.

Low severity longitudinal and transverse cracks are less than ¼ inch wide, or if sealed with suitable filler material in satisfactory condition can be any width, less than 3 inches, if they are not spalled. Maintenance usually is not indicated for low-severity cracking. Moderately spalled cracks and cracks wider than ¼ inch which are not satisfactorily sealed are at medium severity. Medium-severity cracks should be sealed with a high-

quality crack filling material. Severely spalled cracks and cracks wider than 3 inches are at high severity. High-severity L&T cracks normally require patching.

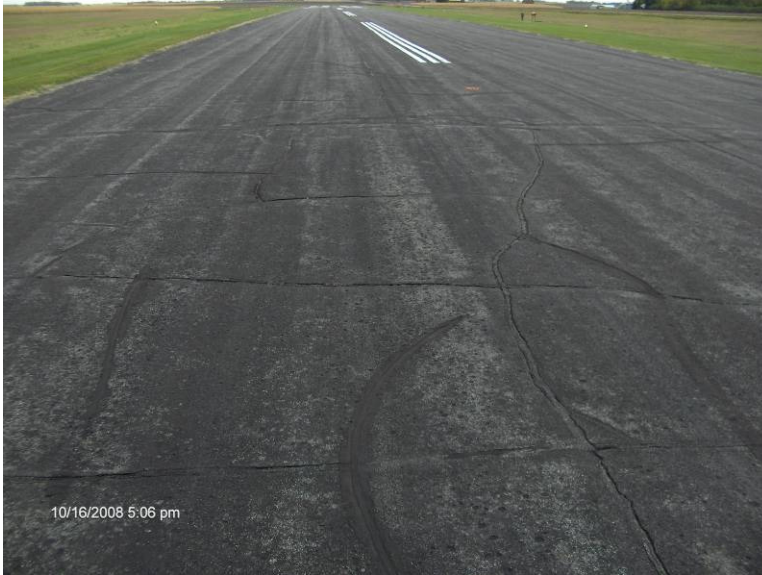
Example of Block Cracking

Block cracking is longitudinal and transverse cracking that has established a pattern of blocks ranging in size from 1ft x 1ft to 10ft x 10ft. This distress typically happens in older asphalt pavements and is an indication that the bituminous binder has lost most of its flexibility. The severity determination is basically determined by the crack width criteria defined for longitudinal and transverse cracking. Crack sealing typically is used to repair block cracking; however, the amount of required sealant can be extensive due to the high density of cracks.

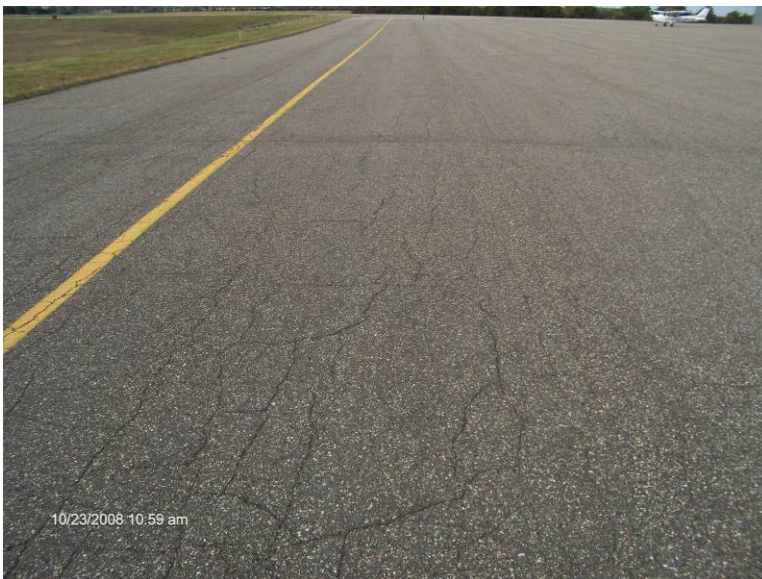
Example of Alligator Cracking

Alligator (or fatigue) cracks are a series of interconnected load-related cracks caused by fatigue of the asphalt surface. Alligator cracking is a significant structural distress and develops only in places subject to traffic loads. These cracks typically initiate at the bottom of the asphalt layer (where tensile strains are highest) and propagate upward - so once a fatigue crack is visible, significant damage has already occurred.

At low severity, alligator cracks are evidenced by a series of parallel hairline cracks (usually in a wheel path). Further traffic and deterioration leads to the interconnection of these cracks. Medium severity alligator cracking is a well-defined pattern of interconnected cracks, some spalling may be present. High severity alligator cracks have lost aggregate interlock between adjacent pieces, the cracks may be severely spalled with FOD potential, and most likely the pieces will move freely under traffic.

Alligator cracking is a structural failure and cannot be repaired with sealant, the proper repair is full-depth patching.

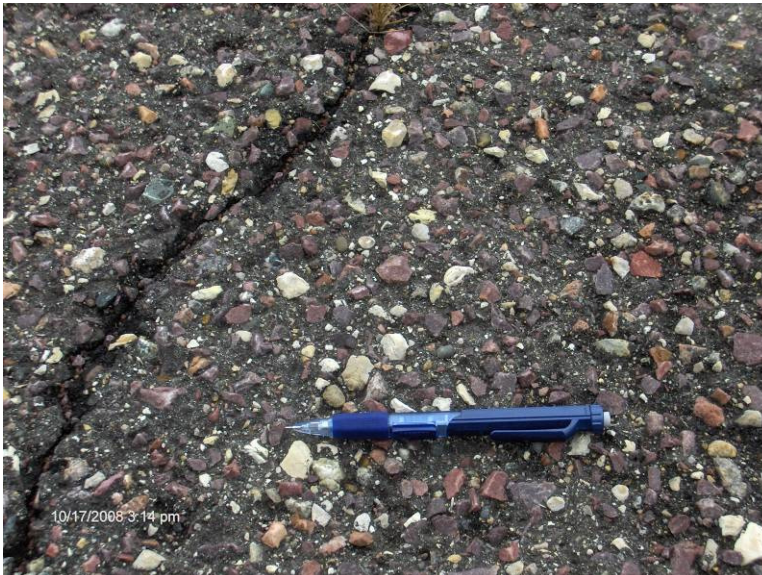
Example of Raveling/Weathering

Raveling and weathering are the wearing away of the pavement surface. This can be caused by the dislodging of aggregate particles or the loss of asphalt binder. This distress is usually evident over large areas. Raveling and weathering may indicate that the asphalt binder has hardened significantly. At low severity, the surface has started to wear away with few (if any) loose particles and the coarse surface aggregate is exposed to 1/4 of its diameter. At medium severity, the aggregate and/or binder have worn away with some loose and missing particles, and the surface texture is moderately rough and pitted, but the average depth of erosion is less than 1/4 inch. At high severity, the aggregate and/or binder have worn away with a large amount of loose and missing particles, the surface texture is severely rough and pitted, and the top layer of aggregate has eroded away.

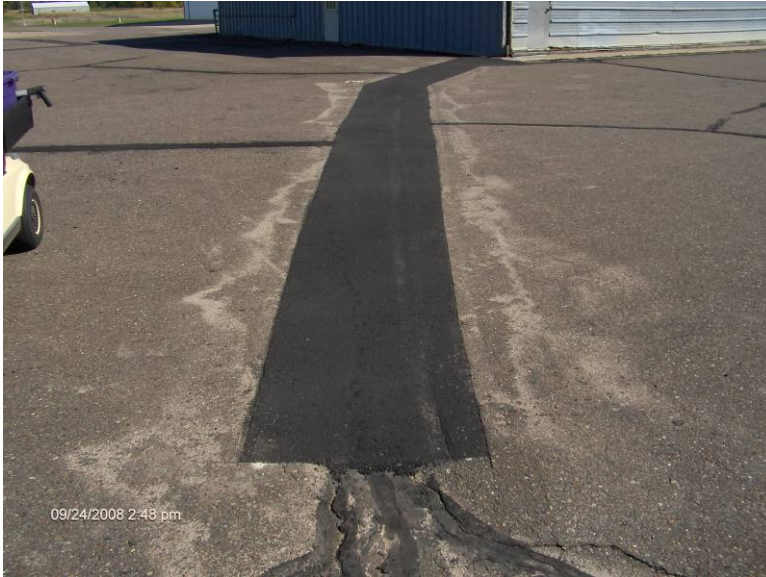
Example of Patching

Patched areas are defined when a portion of the original pavement is replaced with a material intended as a semi-permanent repair. A patch is documented as a defect because it is considered a break in the integrity of the pavement structure. Patches are constructed for a variety of reasons including utility repairs, correcting grade issues, and addressing a defect in the original pavement.

The severity level of patches is determined by the amount of distress (i.e. cracking, depression, weathering/raveling, etc.) occurring within the limits of the patched area.

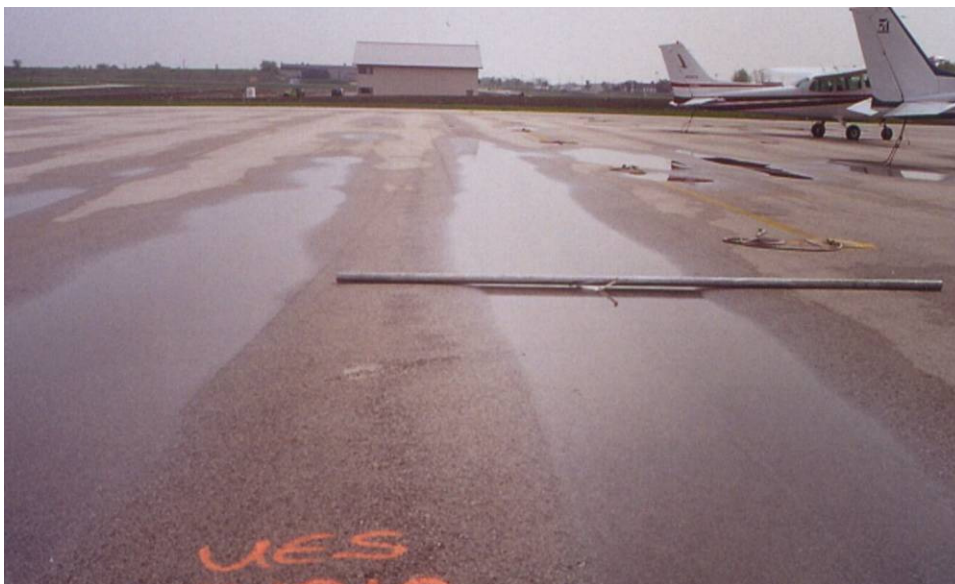
Example of Rutting

Ruts are localized, load related, areas of pavement having elevations lower than the surrounding sections. Rutting is due to base and subgrade consolidation, caused by

excessive wheel loads or poor compactions. Ruts indicate structural failure, and can cause hydroplaning. At low severity, ruts have an average depth of $\frac{1}{4}$ to $\frac{1}{2}$ inches. At medium severity, ruts have an average depth of $\frac{1}{2}$ to 1 inch. High severity, ruts have an average depth greater than 1 inch.

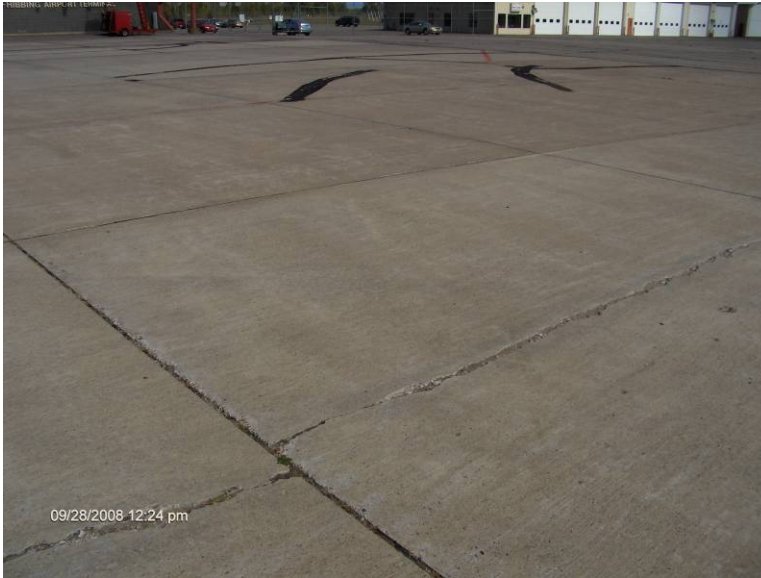
Example of Longitudinal, Transverse, and Diagonal Cracking

LTD cracking is most often a result of externally applied loads and/or constrained temperature deformations. External loads cause LTD cracking through flexure. Temperature changes on restrained slabs will result in stresses due to friction or curling. When any of these stresses exceed the strength of the slab, cracking will occur. LTD cracking is recorded at low, medium, or high severity, depending on the width of crack opening and degree of deterioration. At low severity, the crack is less than $\frac{1}{8}$ th inch wide with little spalling and no corrective action is indicated. At medium severity, LTD cracks can be up to 1 inch wide with moderate spalling, and should be repaired and sealed using procedures similar to joint sealing. At high severity, cracks exceed 1 inch in width and may be severely spalled. High-severity LTD cracking is evidence of serious load failure of the slab, and correction may require patching or slab replacement. If the distress occurs in several adjacent slabs at medium or high severity, major rehabilitation of that pavement area is indicated.

When a slab is divided by LTD cracks into four or more pieces, the slab is said to be "divided" or "shattered." Shattered slab is a separate distress category and is indicative of significant structural failure as the slab loses its ability to distribute loads to subgrade and further slab deterioration can be expected. Shattered slabs are rated in three severities, with slab replacement recommended for medium and high severities.

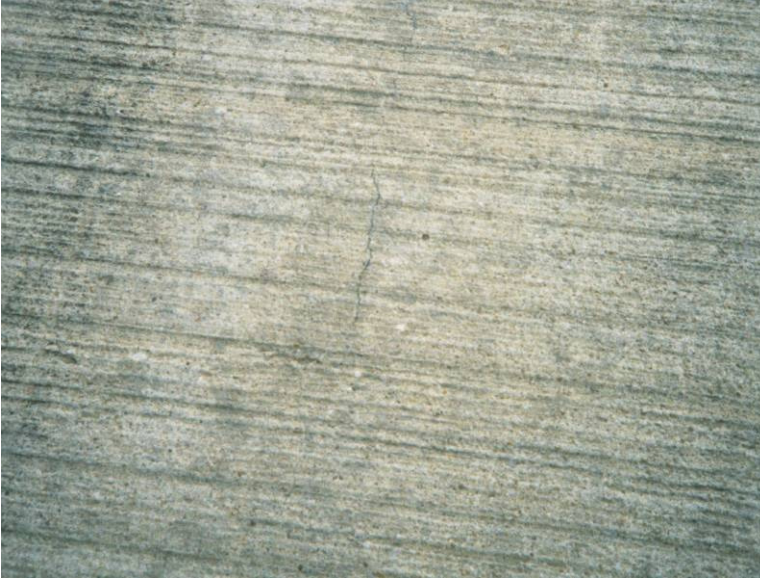
Example of Shrinkage Cracking

Shrinkage cracks are small, nonworking (no spalling along edge) cracks that are visible at the surface but do not penetrate through the full depth of concrete. Shrinkage cracks most commonly occur shortly after construction due to concrete shrinkage during the curing process. Shrinkage cracks are usually so small that they are not visible until staining or material loss at crack edges begins to take place. Shrinkage cracks do not represent a structural weakness, and no corrective action is prescribed.

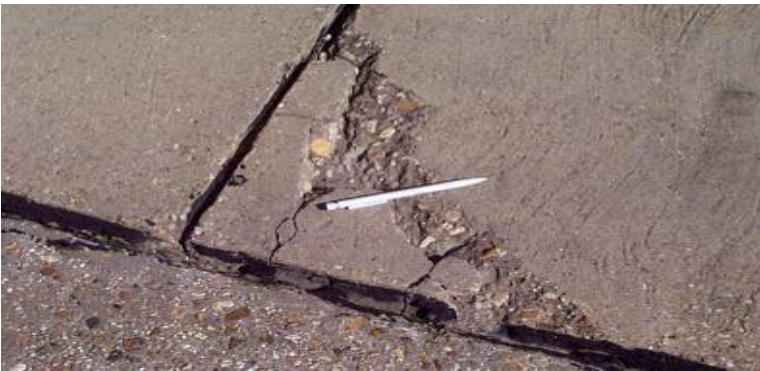
Example of Joint and Corner Spalling

Spalls at slab joints and corners are caused by excessive internal stress in the pavement. Spalls occur when these stresses exceed the shear strength of the concrete. Spalling usually results from thermal expansion during warm or hot weather. As slabs expand, they push against one another at joints. If the joints are filled with incompressibles, such as sand, or if adjacent slabs offset slightly, stresses can become severe, causing spalls. Spalling can be reduced significantly by conscientious maintenance of joint sealant.

Spall repair requires patching. The extent and severity of spalling on a pavement surface suggests appropriate action. For example, at low severity, spalled concrete remains securely in place in the slab. A low-severity spall should be monitored closely for further

deterioration and should be patched when spalled particles become loose in place, or at the next scheduled patching activity in the section. Medium- and high-severity spalls should be repaired immediately to prevent the incidence of FOD. If the pavement can be restored to serviceable condition, spalls should be carefully patched for long-term service. If the pavement is beyond repair, temporary patching should be considered to control FOD.

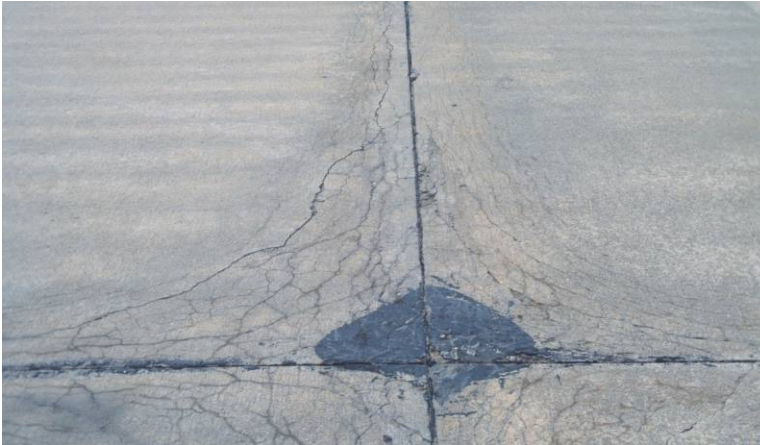
Example of Durability Cracking

Durability cracking (D-cracking) is caused by environmental factors, the most common of which is freezing/thawing. It usually appears as a pattern of hairline cracks running parallel to a joint or crack, or in a corner, where water tends to collect. This type of cracking eventually leads to disintegration of the pavement, creating FOD potential. At low severity, D-cracking is evident, but no disintegration has occurred. As the distress advances to medium severity, the distress pattern is evident over a significant area of the slab, and some disintegration and FOD potential exists. High severity durability cracking is evidenced by extensive cracking with loose and missing pieces and significant FOD potential.

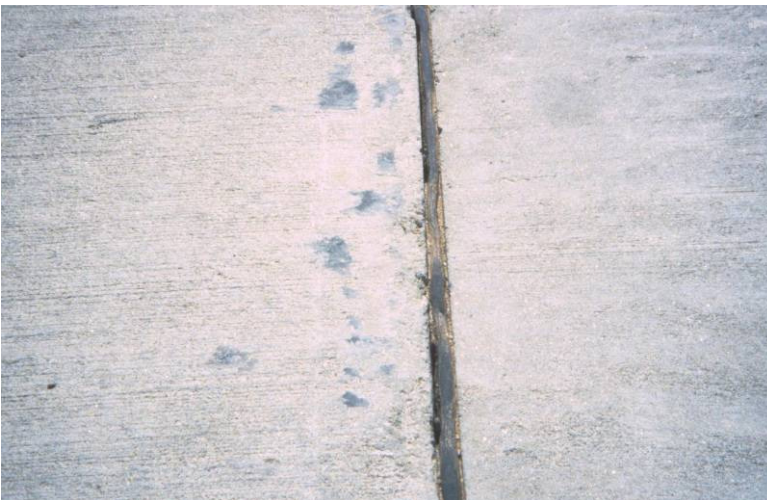
Example of Joint Seal Damage

Joint seal damage is recorded at three severities: low, medium, and high. When joint sealant is in perfect condition (no damage), it is not a distress. At low severity, at least 10 percent of the sealant is debonded but still in contact with the joint edges (i.e., joint sealant is in serviceable condition but should be monitored for evidence of more serious failure). Medium-severity joint seal damage is recorded when at least 10 percent of the sealant has visible gaps smaller than 1/8th inch and is an indicator that replacement should be programmed as soon as is practicable. In the mean time, aggressive inspection and sustaining maintenance is recommended to minimize subsurface damage from moisture penetration. At high severity, visible gaps exceed 1/8th inch and the amount and degree of joint seal damage is such that repair is no longer feasible. The only appropriate corrective action is sealant replacement.

On serviceable pavement, deteriorated joint sealant should be repaired or replaced to preserve pavement and subgrade integrity and prolong service life. The issue is not so clear-cut with unserviceable pavement. Pavement that can be restored to serviceable condition by maintenance activities such as patching and joint seal repair, or by slab replacement, should be so maintained as long as the process is cost-effective. However, when age and condition preclude economical return to serviceable condition by such means, joint seal repair would no longer be cost-effective and should be suspended except for an interim maintenance program to control FOD potential.

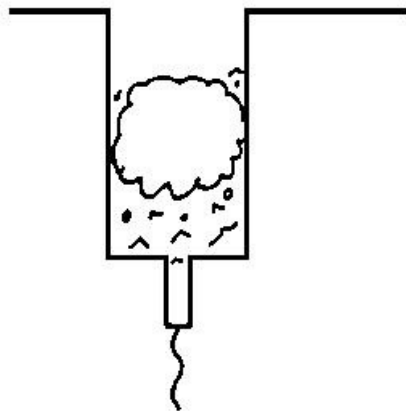
Typical joint with deficient sealant and a collection of debris & incompressibles.
