Minnesota Airport System Pavement Evaluation 2010 Update

Granite Falls Municipal Airport
(GDB)

Granite Falls, Minnesota

December 2010

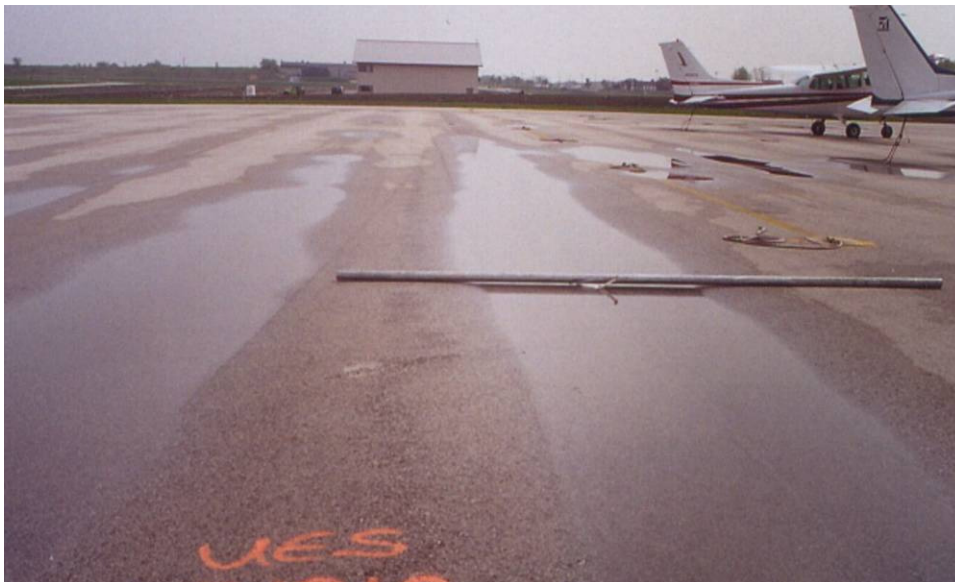
Example of Rutting

Ruts are localized, load related, areas of pavement having elevations lower than the surrounding sections. Rutting is due to base and subgrade consolidation, caused by

excessive wheel loads or poor compactions. Ruts indicate structural failure, and can cause hydroplaning. At low severity, ruts have an average depth of $\frac{1}{4}$ to $\frac{1}{2}$ inches. At medium severity, ruts have an average depth of $\frac{1}{2}$ to 1 inch. High severity, ruts have an average depth greater than 1 inch.
