Minnesota Airport System Pavement Evaluation 2010 Update

Hutchinson Municipal Airport
(HCD)

Hutchinson, Minnesota

December 2010

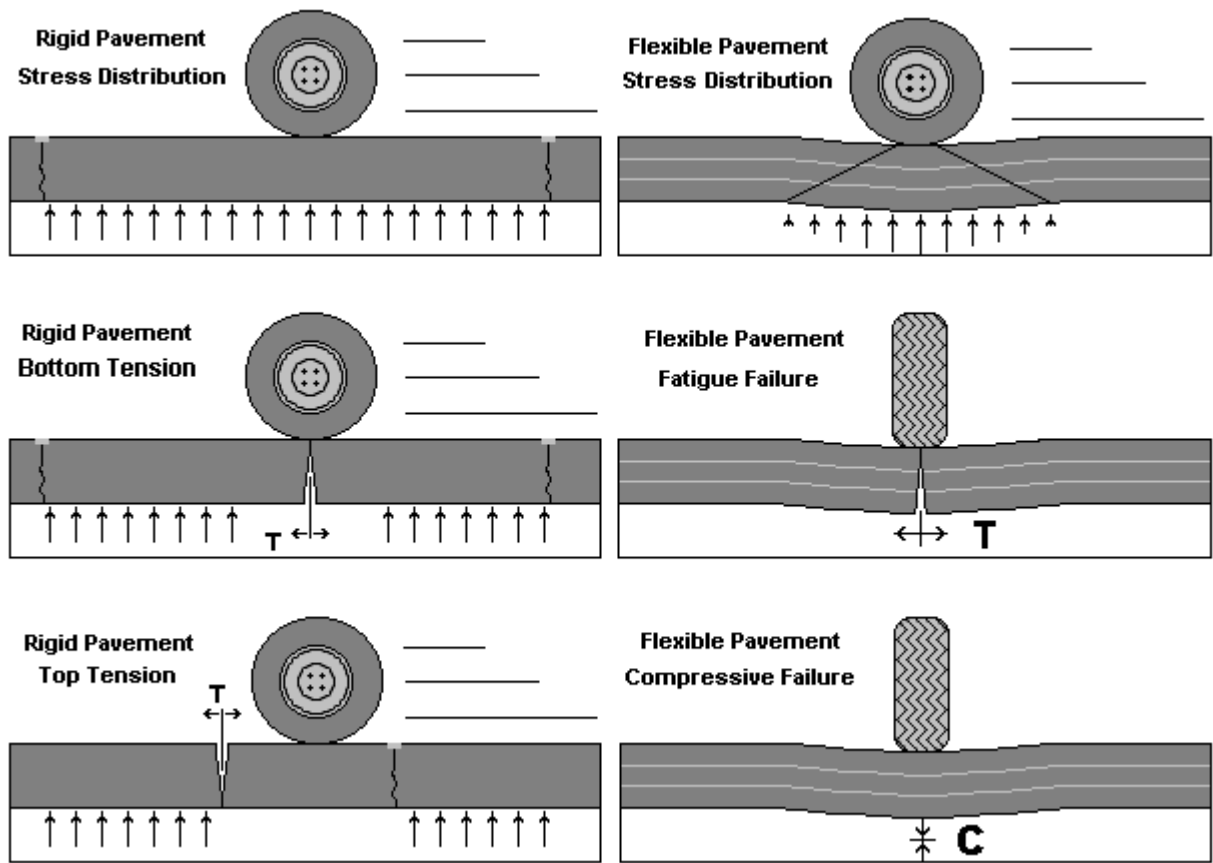
Figure 1. Pavement failure.

Load-related cracks can start at the top or bottom of a pavement section. In asphalt sections, load-related (fatigue) cracks start at the bottom. If a load-related crack reaches the surface, it usually indicates significant structural deficiency. In PCC pavement, corner breaks are caused by top tension, and the crack propagates downward. Mid-slab LTD cracks are examples of bottom tension.

Spalls can be caused by either wheel loads or environmental factors, anytime there is movement between adjacent slabs. If a small rock is allowed into a joint, a differential movement between adjacent slabs can cause a spall. Spalling can be minimized by keeping joint and crack sealant intact.

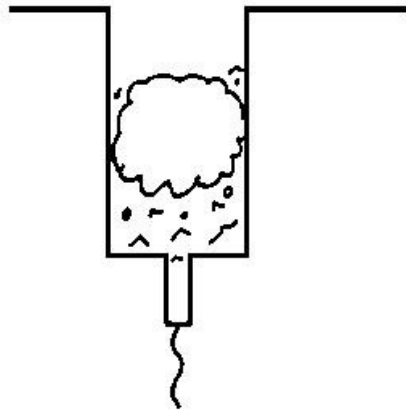
Typical joint with deficient sealant and a collection of debris & incompressibles.

Seal joints in PCC pavement when existing sealant has deteriorated to a degree that allows water and incompressibles to enter the joint. Hairline cracks are not yet candidates for sealing.
