Minnesota Airport System Pavement Evaluation 2010 Update

Southwest Minnesota Regional
Airport - Marshall (MML)

Marshall, Minnesota

December 2010

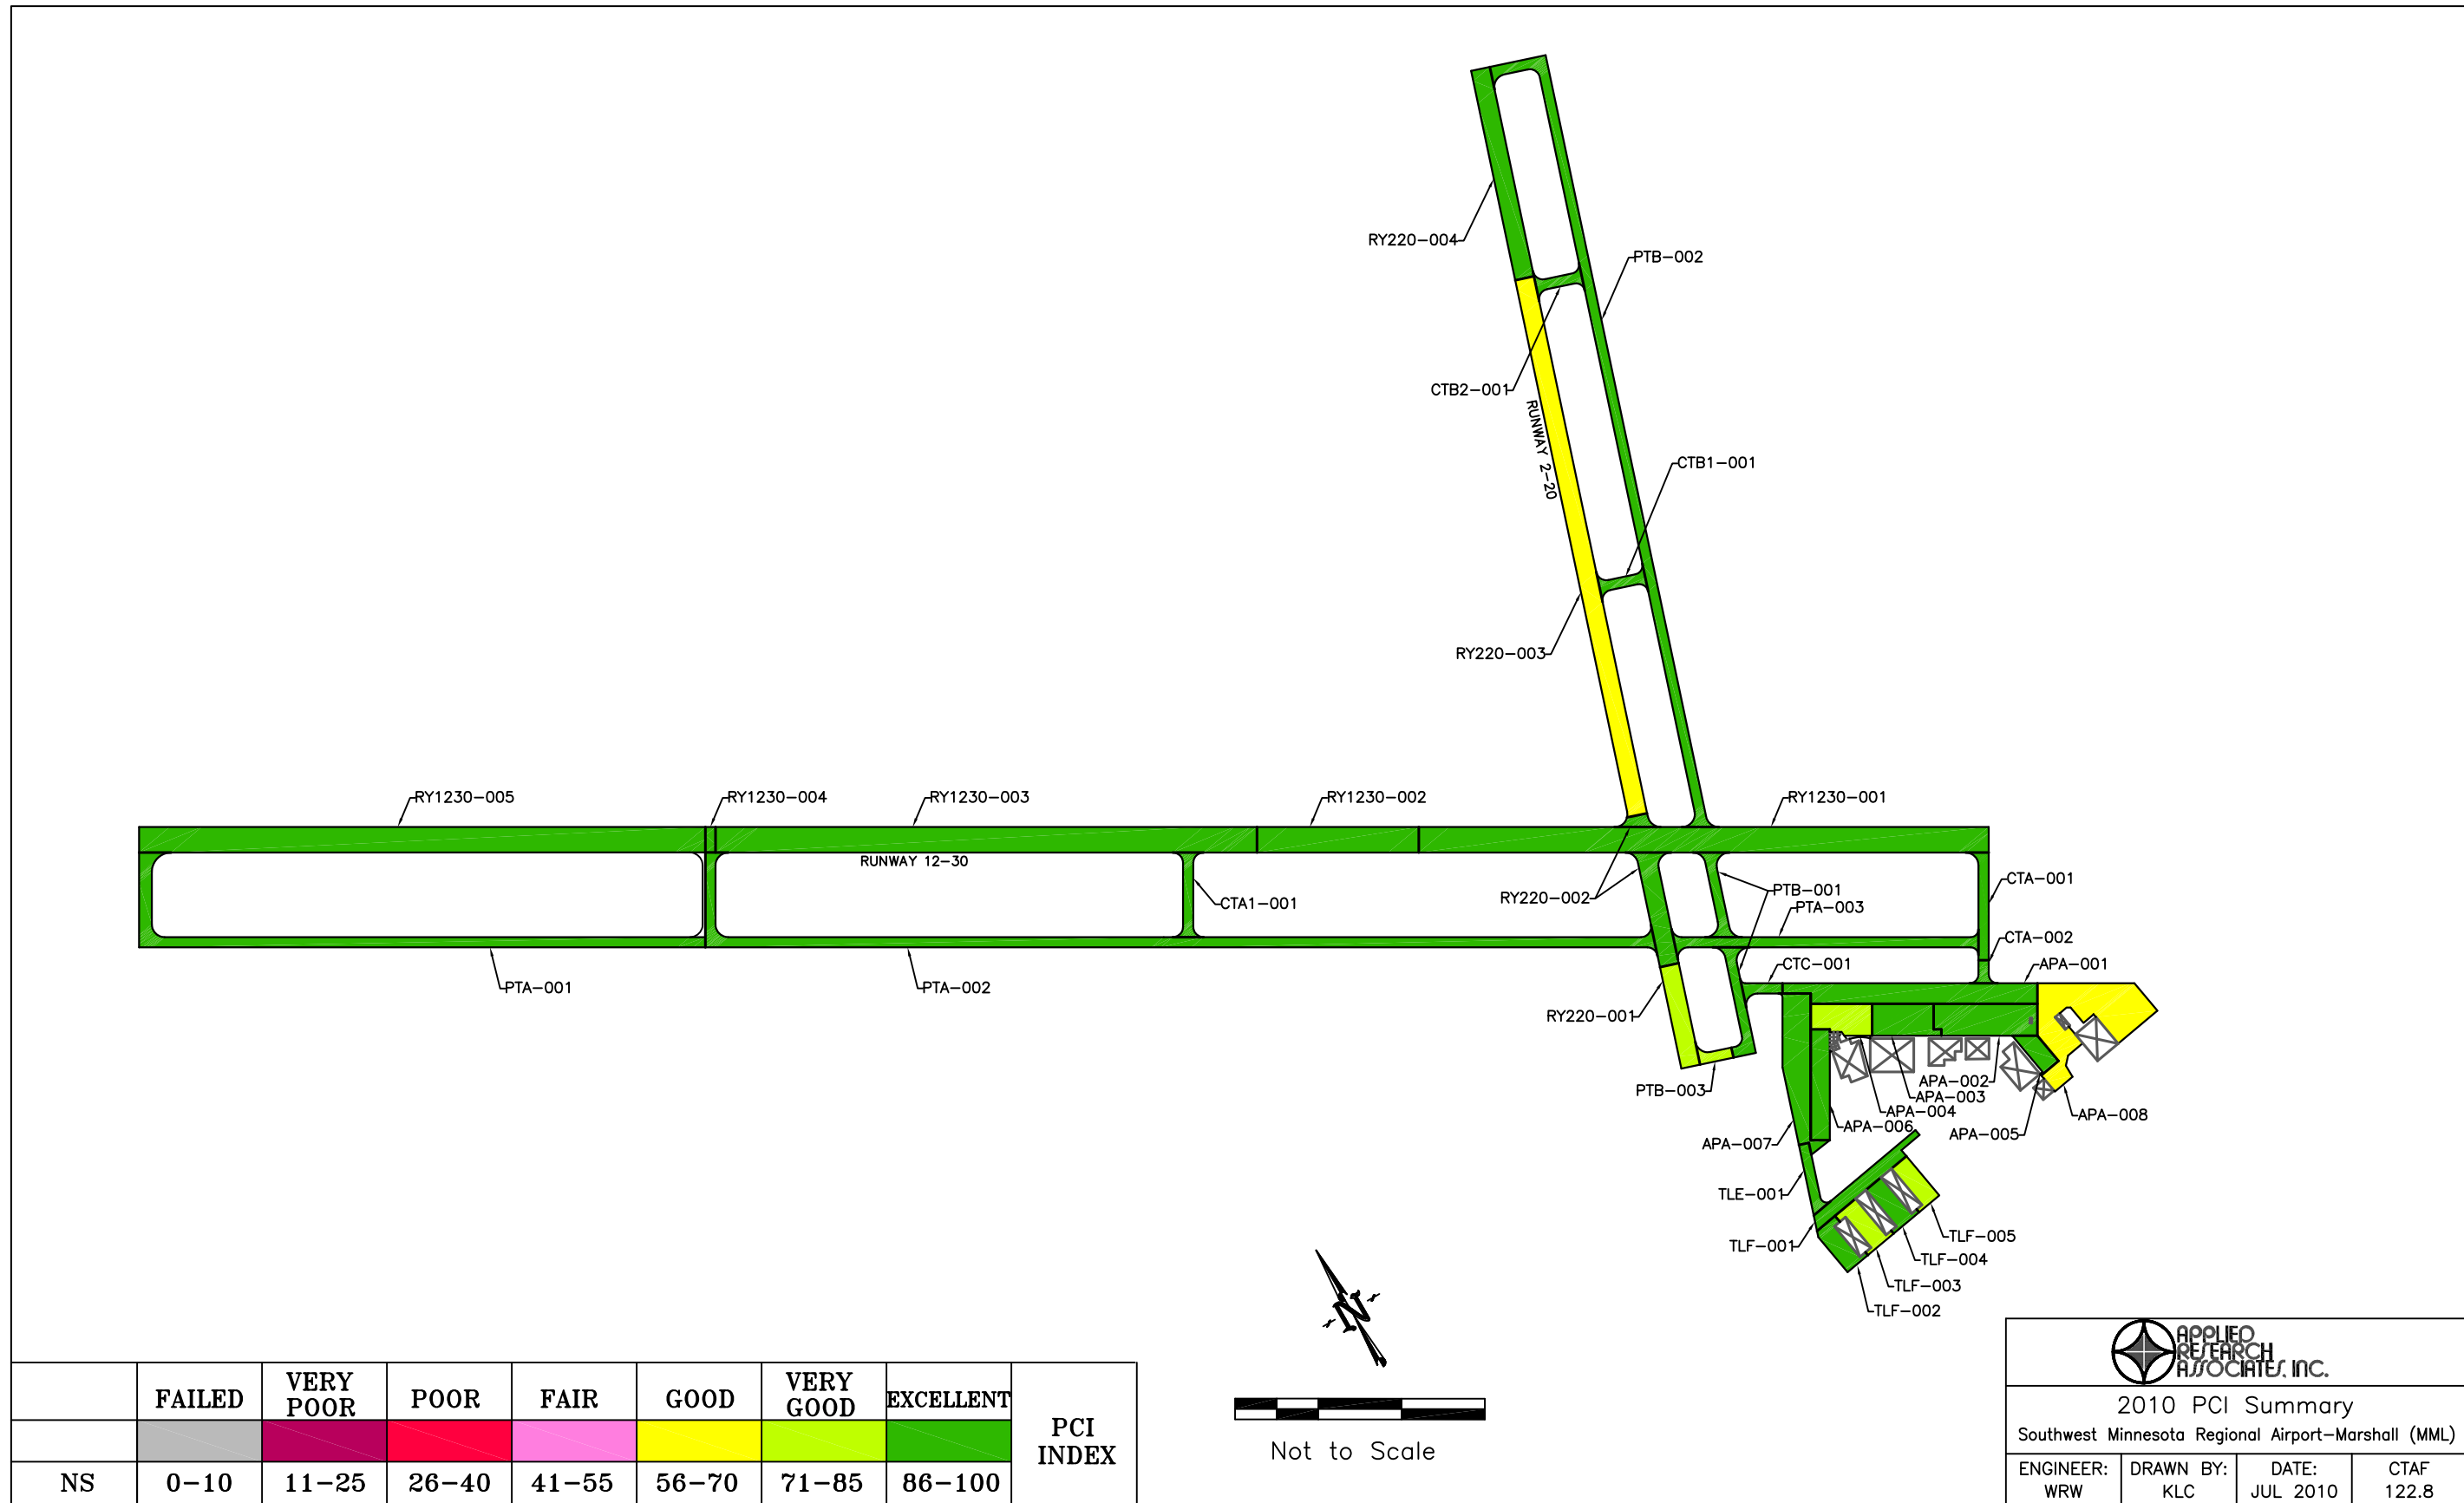
Figure 4. 2010 Pavement Condition Index Rating at Southwest Minnesota Regional Airport-Marshall (MML).

The results of the 2010 PCI inspection are presented in figure 4. The overall area-weighted PCI for MML is 91. When summarizing PCI values, an area-weighted calculation is used instead of a straight mathematical average because the area-weighted calculations eliminate the skewing of the PCI due to the disparity of the section sizes.
