Minnesota Airport System Pavement Evaluation 2010 Update

Orr Regional Airport (ORB)

Orr, Minnesota

December 2010

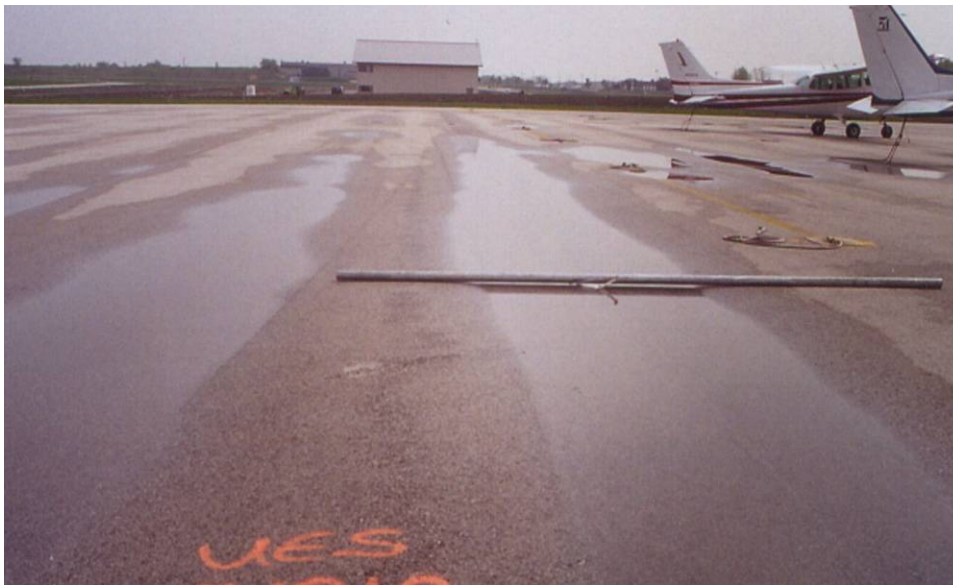
Example of Rutting

Ruts are localized, load related, areas of pavement having elevations lower than the surrounding sections. Rutting is due to base and subgrade consolidation, caused by

excessive wheel loads or poor compactions. Ruts indicate structural failure, and can cause hydroplaning. At low severity, ruts have an average depth of $\frac{1}{4}$ to $\frac{1}{2}$ inches. At medium severity, ruts have an average depth of $\frac{1}{2}$ to 1 inch. High severity, ruts have an average depth greater than 1 inch.
