# Minnesota Airport System Pavement Evaluation 2010 Update

Pine River Regional Airport  
(PWC)

Pine River, Minnesota

December 2010

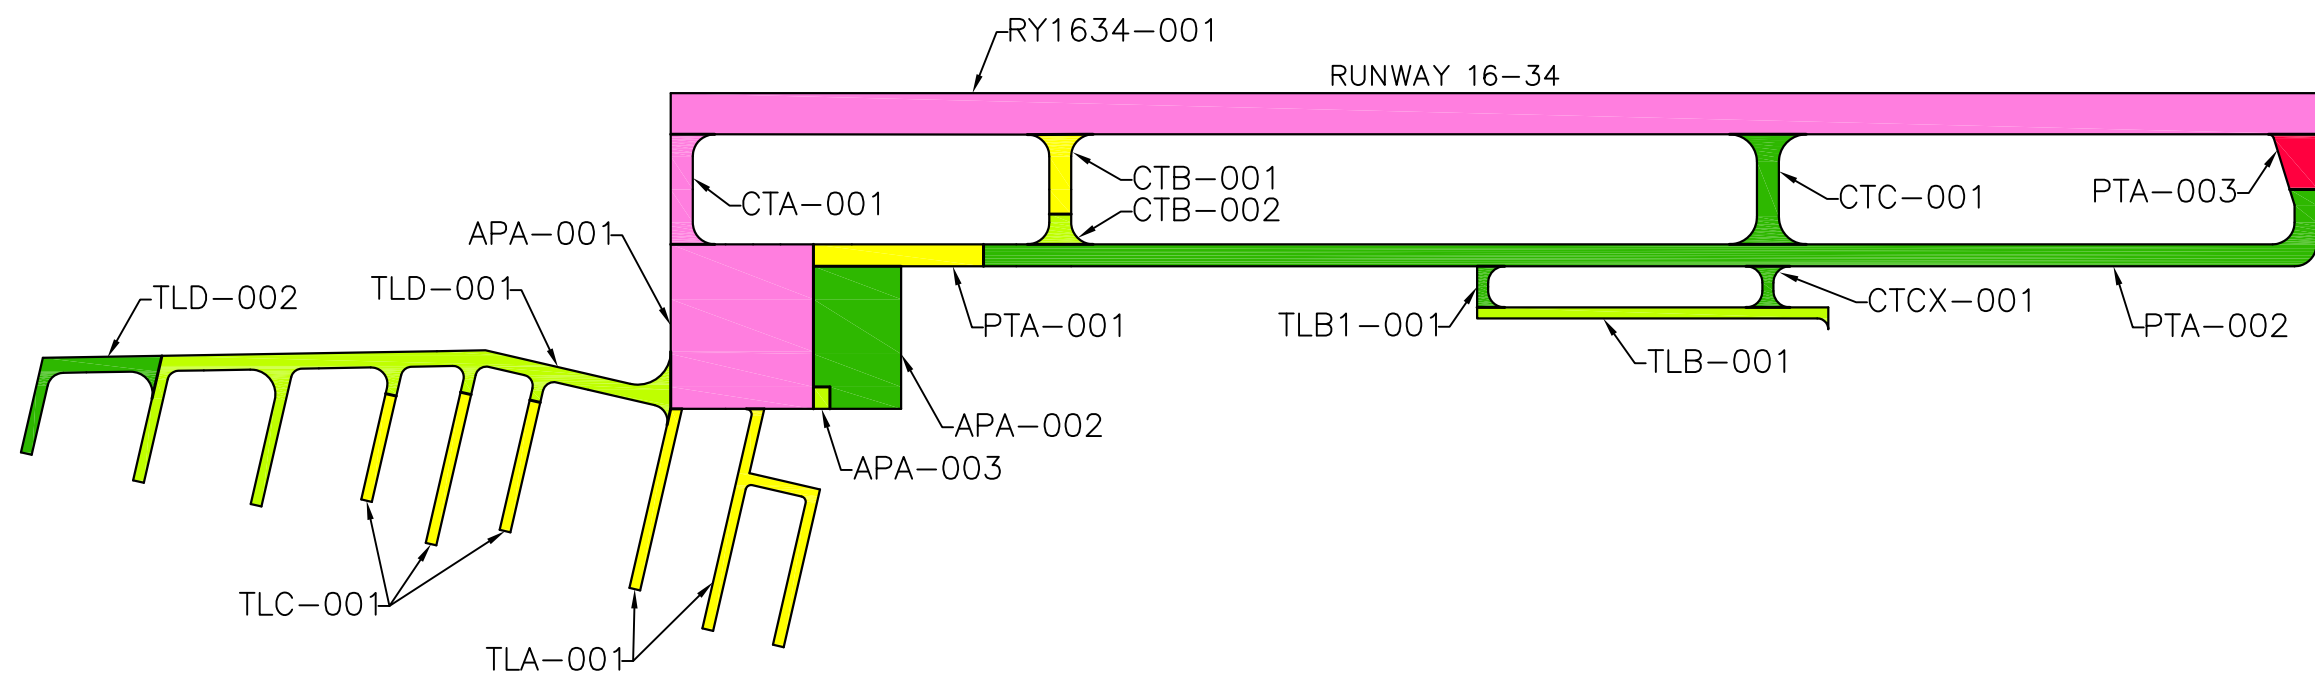
Figure 4. 2010 Pavement Condition Index Rating at Pine River Regional Airport (PWC).

The results of the 2010 PCI inspection are presented in figure 4. The overall area-weighted PCI for PWC is 66. When summarizing PCI values, an area-weighted calculation is used instead of a straight mathematical average because the area-weighted calculations eliminate the skewing of the PCI due to the disparity of the section sizes.
