Minnesota Airport System Pavement Evaluation 2010 Update

Thief River Falls Regional
Airport (TVF)

Thief River Falls, Minnesota

December 2010

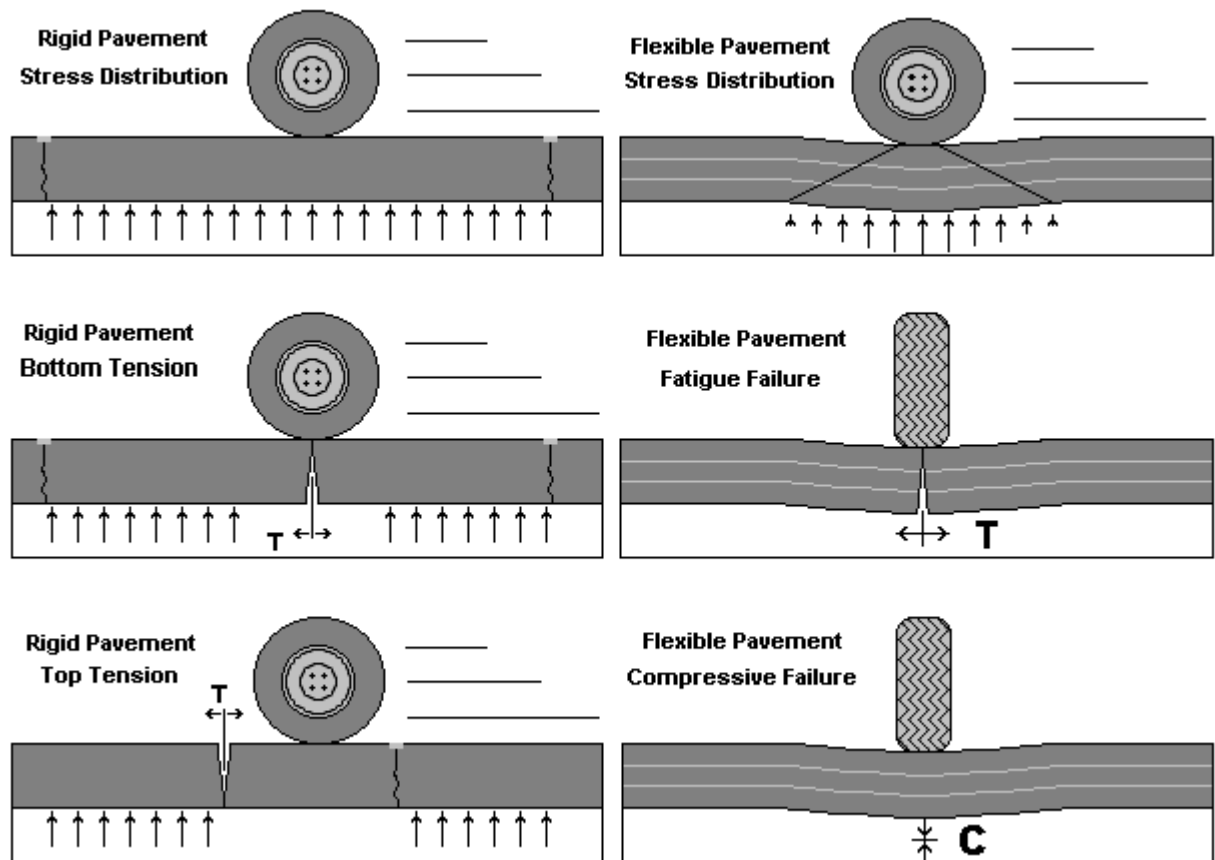
Figure 1. Pavement failure.

Load-related cracks can start at the top or bottom of a pavement section. In asphalt sections, load-related (fatigue) cracks start at the bottom. If a load-related crack reaches the surface, it usually indicates significant structural deficiency. In PCC pavement, corner breaks are caused by top tension, and the crack propagates downward. Mid-slab LTD cracks are examples of bottom tension.

Spalls can be caused by either wheel loads or environmental factors, anytime there is movement between adjacent slabs. If a small rock is allowed into a joint, a differential movement between adjacent slabs can cause a spall. Spalling can be minimized by keeping joint and crack sealant intact.
