# Minnesota Airport System Pavement Evaluation 2010 Update

New Ulm Municipal Airport  
(ULM)

New Ulm, Minnesota

December 2010

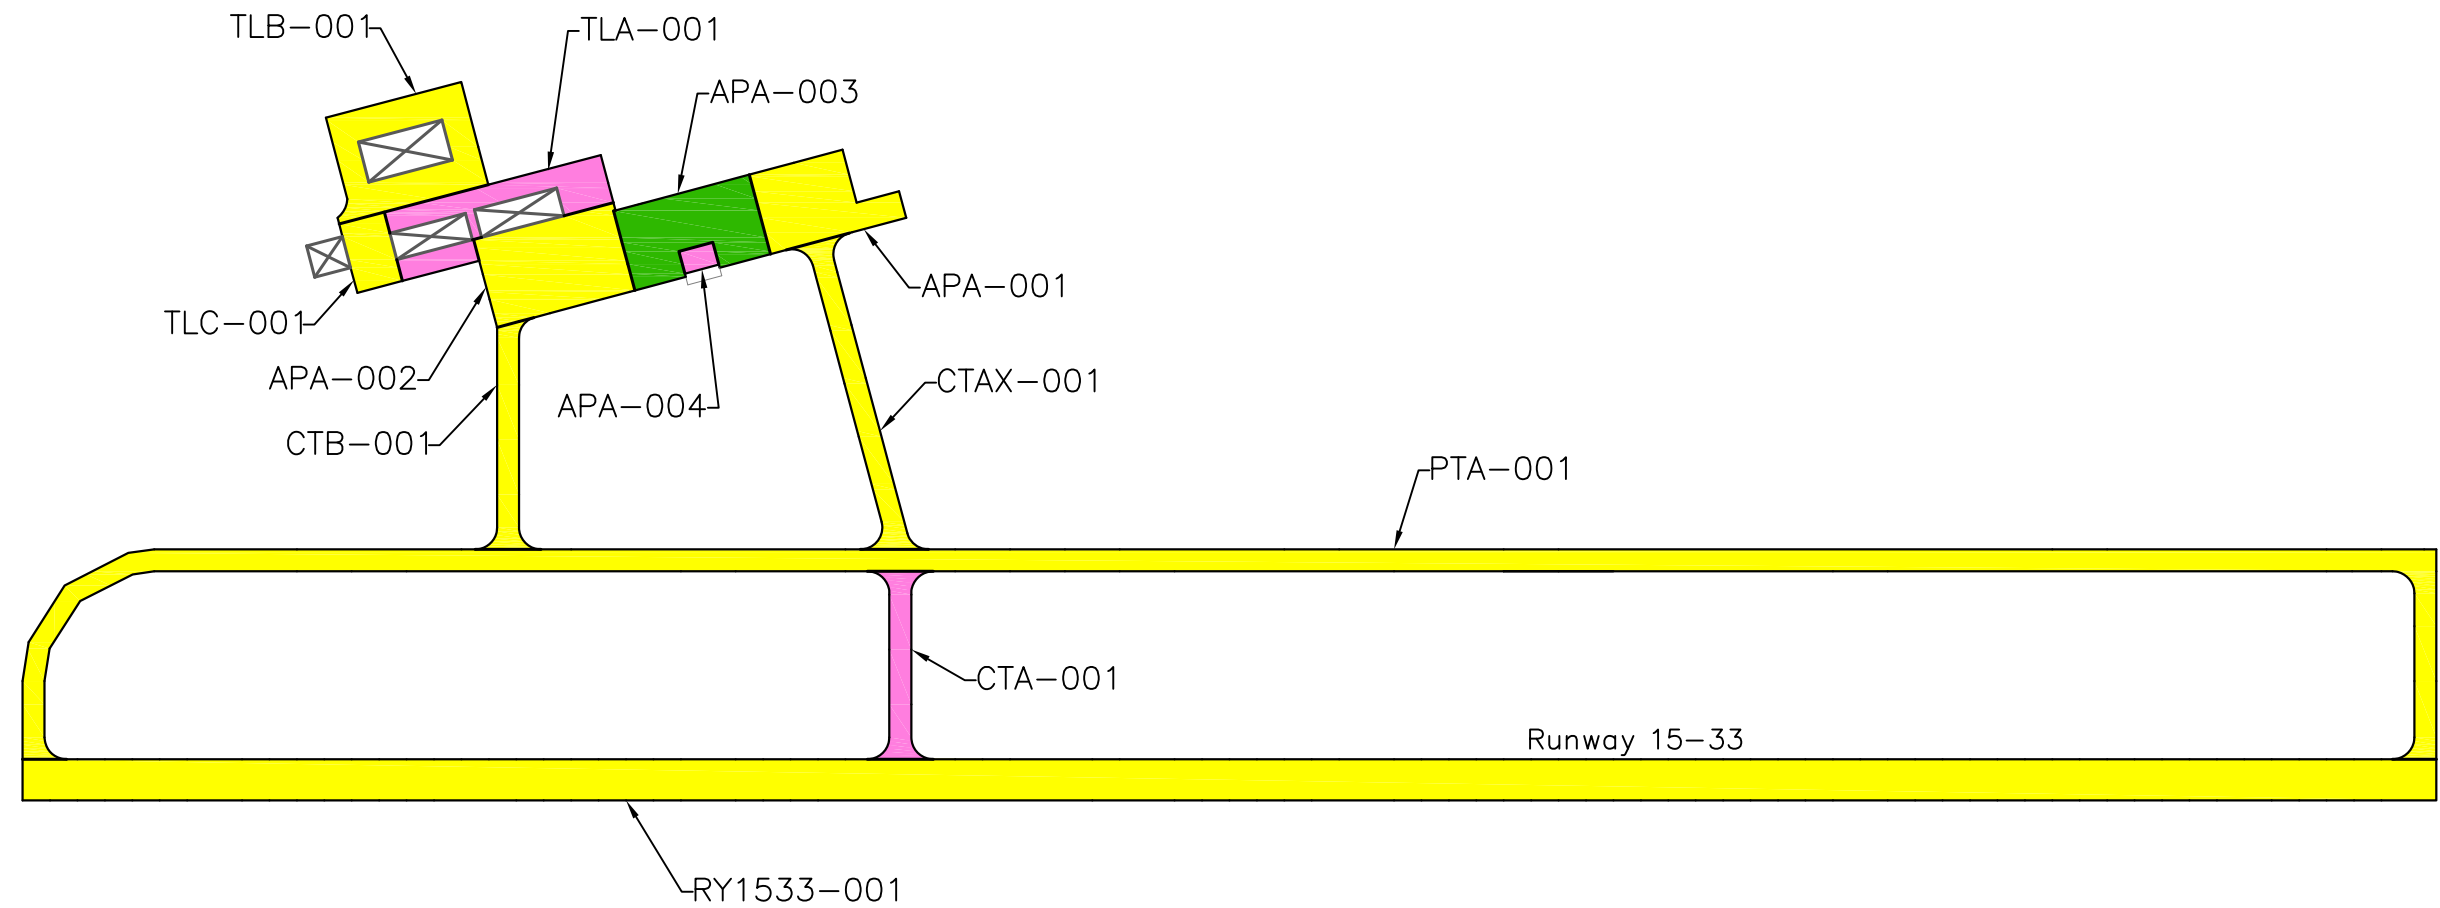
Figure 4. 2010 Pavement Condition Index Rating at New Ulm Municipal Airport (ULM).

The results of the 2010 PCI inspection are presented in figure 4. The overall area-weighted PCI for ULM is 61. When summarizing PCI values, an area-weighted calculation is used instead of a straight mathematical average because the area-weighted calculations eliminate the skewing of the PCI due to the disparity of the section sizes.
