Minnesota Airport System Pavement Evaluation 2010 Update

Longville Municipal Airport
(XVG)

Longville, Minnesota

December 2010

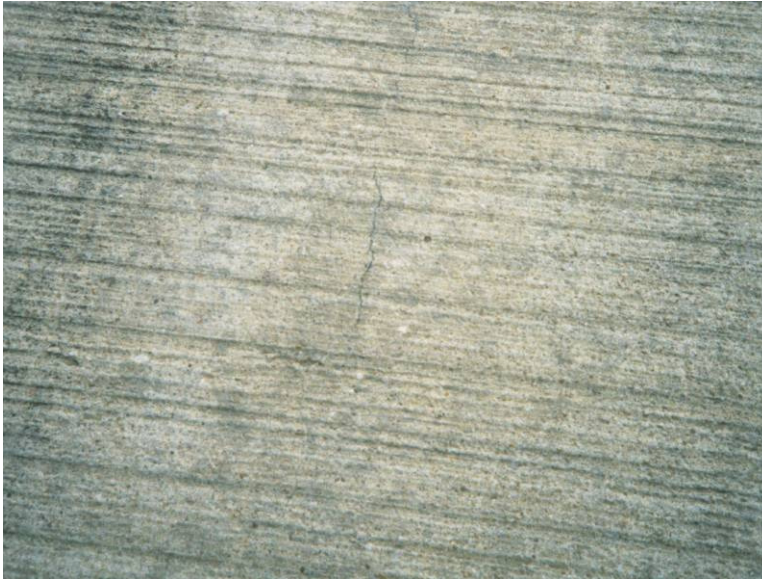
Example of Shrinkage Cracking

Shrinkage cracks are small, nonworking (no spalling along edge) cracks that are visible at the surface but do not penetrate through the full depth of concrete. Shrinkage cracks most commonly occur shortly after construction due to concrete shrinkage during the curing process. Shrinkage cracks are usually so small that they are not visible until staining or material loss at crack edges begins to take place. Shrinkage cracks do not represent a structural weakness, and no corrective action is prescribed.

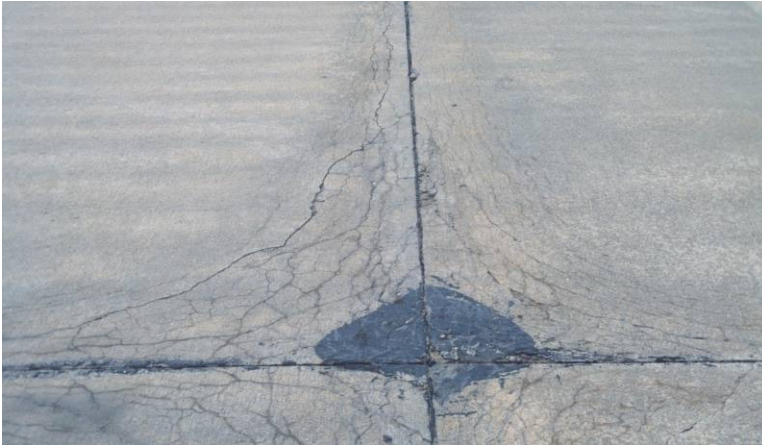
Example of Durability Cracking

Durability cracking (D-cracking) is caused by environmental factors, the most common of which is freezing/thawing. It usually appears as a pattern of hairline cracks running parallel to a joint or crack, or in a corner, where water tends to collect. This type of cracking eventually leads to disintegration of the pavement, creating FOD potential. At low severity, D-cracking is evident, but no disintegration has occurred. As the distress advances to medium severity, the distress pattern is evident over a significant area of the slab, and some disintegration and FOD potential exists. High severity durability cracking is evidenced by extensive cracking with loose and missing pieces and significant FOD potential.
