# Minnesota Airport System Pavement Evaluation 2011 Update

Austin Municipal Airport (AUM)

Austin, Minnesota

January 2012

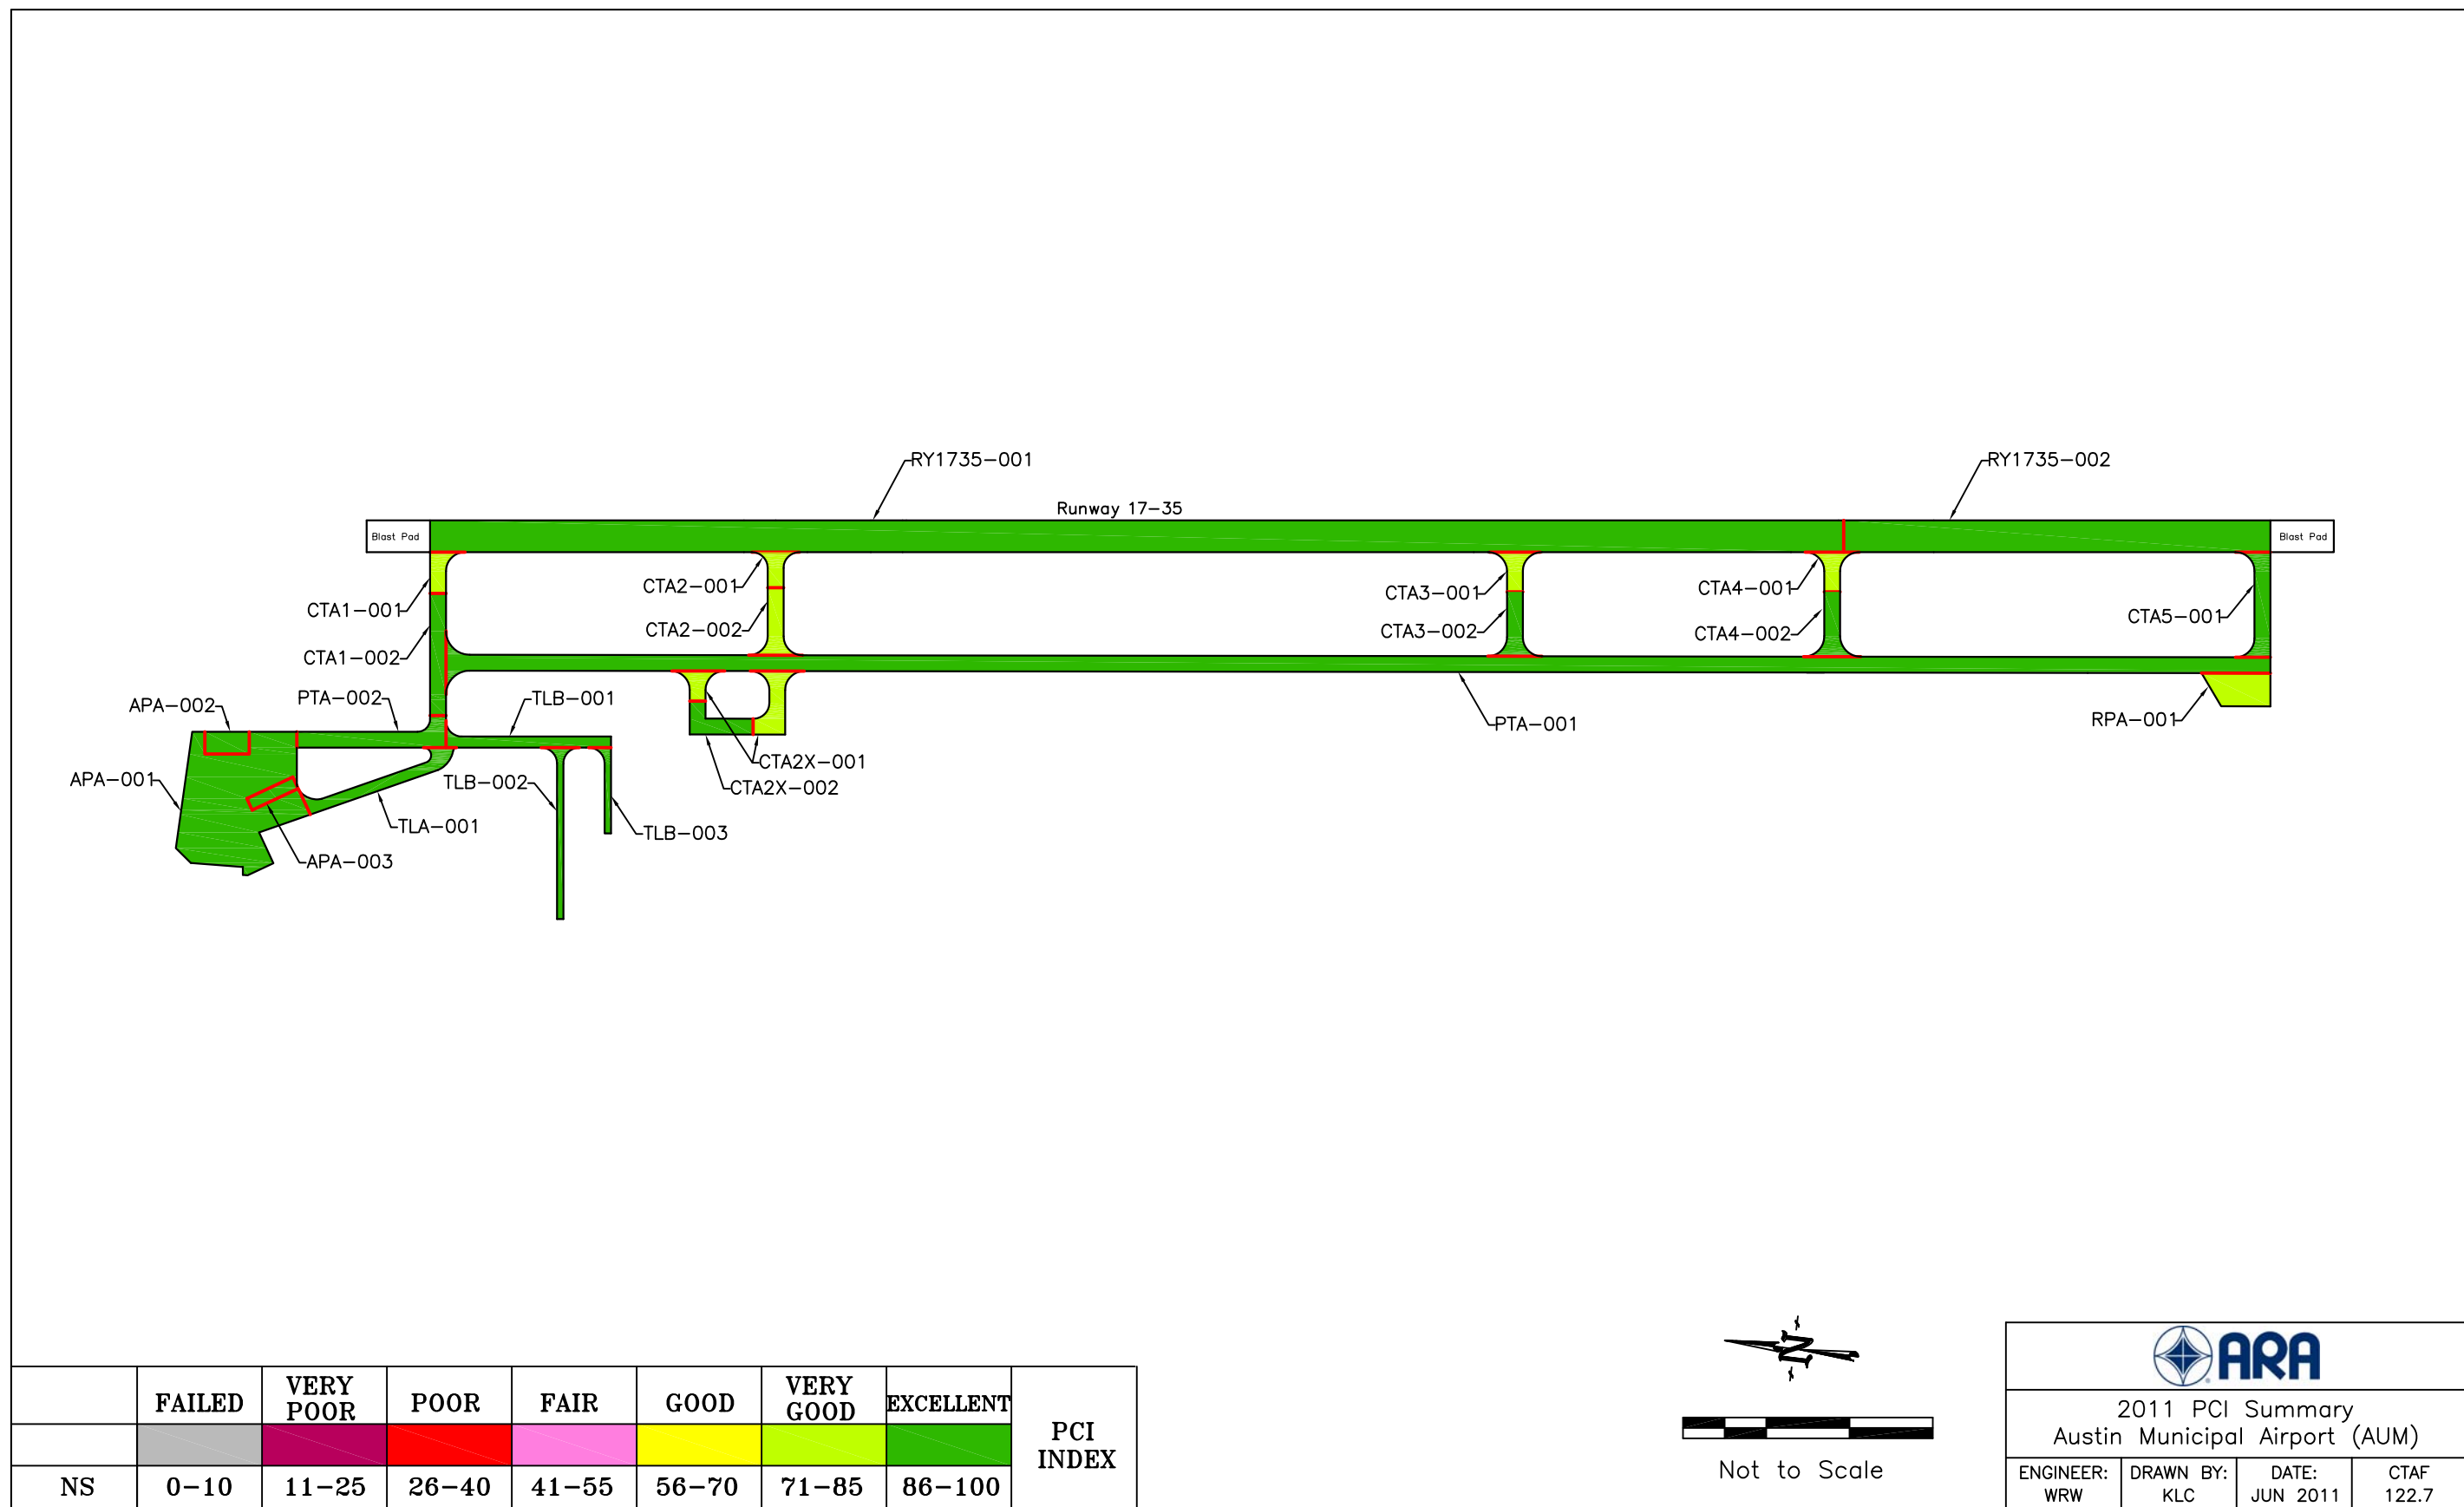
Figure 4. 2011 Pavement Condition Index Rating at Austin Municipal Airport (AUM).

The results of the 2011 PCI inspection are presented in figure 4. The overall area-weighted PCI for AUM is 94. When summarizing PCI values, an area-weighted calculation is used instead of a straight mathematical average because the area-weighted calculations eliminate the skewing of the PCI due to the disparity of the section sizes.
