Minnesota Airport System Pavement Evaluation 2011 Update

Baudette International Airport (BDE)

Baudette, Minnesota

January 2012

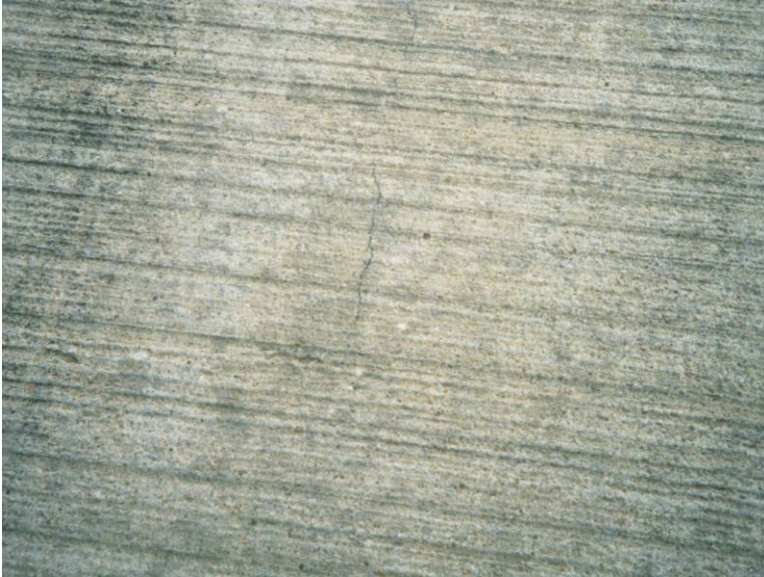
Example of Shrinkage Cracking

Shrinkage cracks are small, nonworking (no spalling along edge) cracks that are visible at the surface but do not penetrate through the full depth of concrete. Shrinkage cracks most commonly occur shortly after construction due to concrete shrinkage during the curing process. Shrinkage cracks are usually so small that they are not visible until staining or material loss at crack edges begins to take place. Shrinkage cracks do not represent a structural weakness, and no corrective action is prescribed.

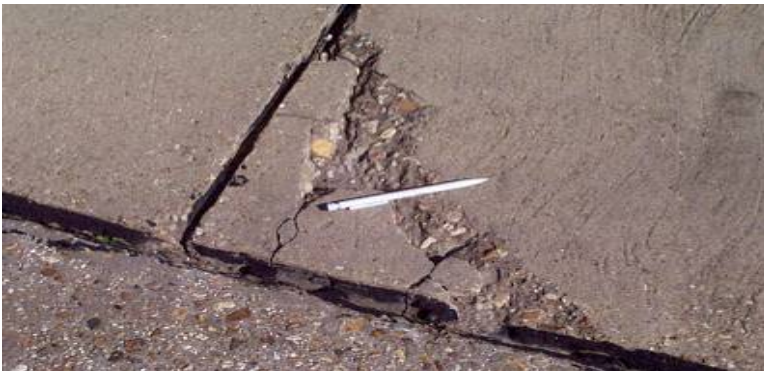
Example of Joint and Corner Spalling

Spalls at slab joints and corners are caused by excessive internal stress in the pavement. Spalls occur when these stresses exceed the shear strength of the concrete. Spalling usually results from thermal expansion during warm or hot weather. As slabs expand, they push against one another at joints. If the joints are filled with incompressibles, such as sand, or if adjacent slabs offset slightly, stresses can become severe, causing spalls. Spalling can be reduced significantly by conscientious maintenance of joint sealant.

Spall repair requires patching. The extent and severity of spalling on a pavement surface suggests appropriate action. For example, at low severity, spalled concrete remains securely in place in the slab. A low-severity spall should be monitored closely for further

deterioration and should be patched when spalled particles become loose in place, or at the next scheduled patching activity in the section. Medium- and high-severity spalls should be repaired immediately to prevent the incidence of FOD. If the pavement can be restored to serviceable condition, spalls should be carefully patched for long-term service. If the pavement is beyond repair, temporary patching should be considered to control FOD.

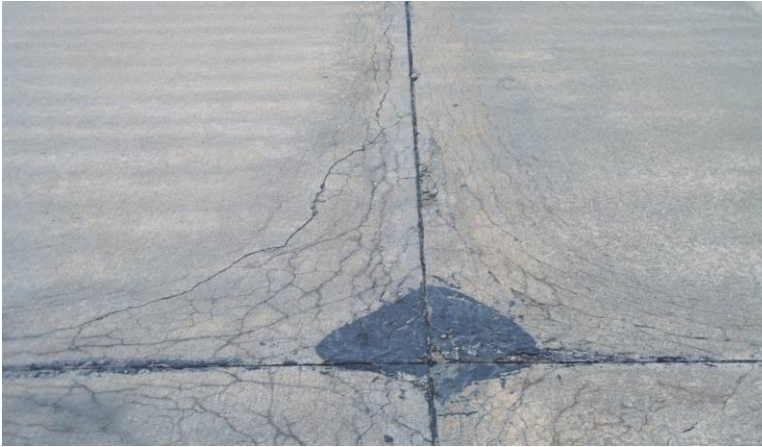
Example of Durability Cracking

Durability cracking (D-cracking) is caused by environmental factors, the most common of which is freezing/thawing. It usually appears as a pattern of hairline cracks running parallel to a joint or crack, or in a corner, where water tends to collect. This type of cracking eventually leads to disintegration of the pavement, creating FOD potential. At low severity, D-cracking is evident, but no disintegration has occurred. As the distress advances to medium severity, the distress pattern is evident over a significant area of the slab, and some disintegration and FOD potential exists. High severity durability cracking is evidenced by extensive cracking with loose and missing pieces and significant FOD potential.
