# Minnesota Airport System Pavement Evaluation 2011 Update

Houston County Airport (CHU)

Caledonia, Minnesota

January 2012

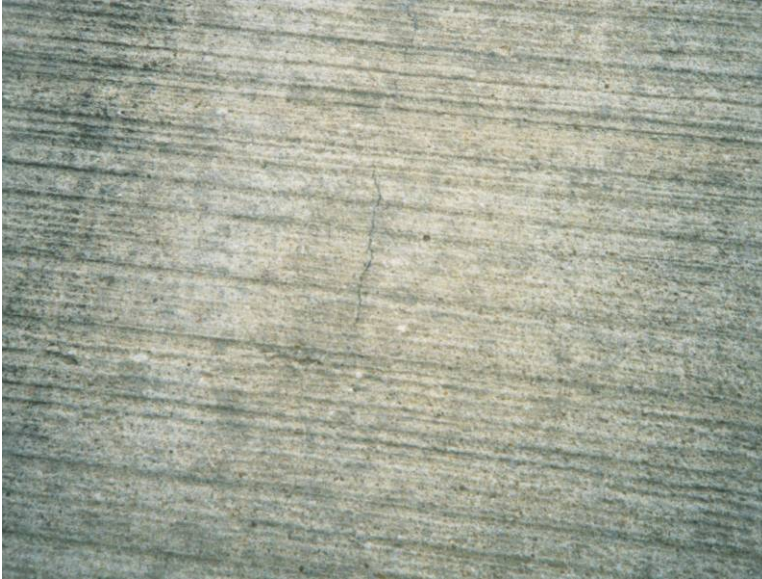
### Example of Shrinkage Cracking

Shrinkage cracks are small, nonworking (no spalling along edge) cracks that are visible at the surface but do not penetrate through the full depth of concrete. Shrinkage cracks most commonly occur shortly after construction due to concrete shrinkage during the curing process. Shrinkage cracks are usually so small that they are not visible until staining or material loss at crack edges begins to take place. Shrinkage cracks do not represent a structural weakness, and no corrective action is prescribed.
