# Minnesota Airport System Pavement Evaluation 2011 Update

Sky Harbor Airport (DYT)

Duluth, Minnesota

January 2012

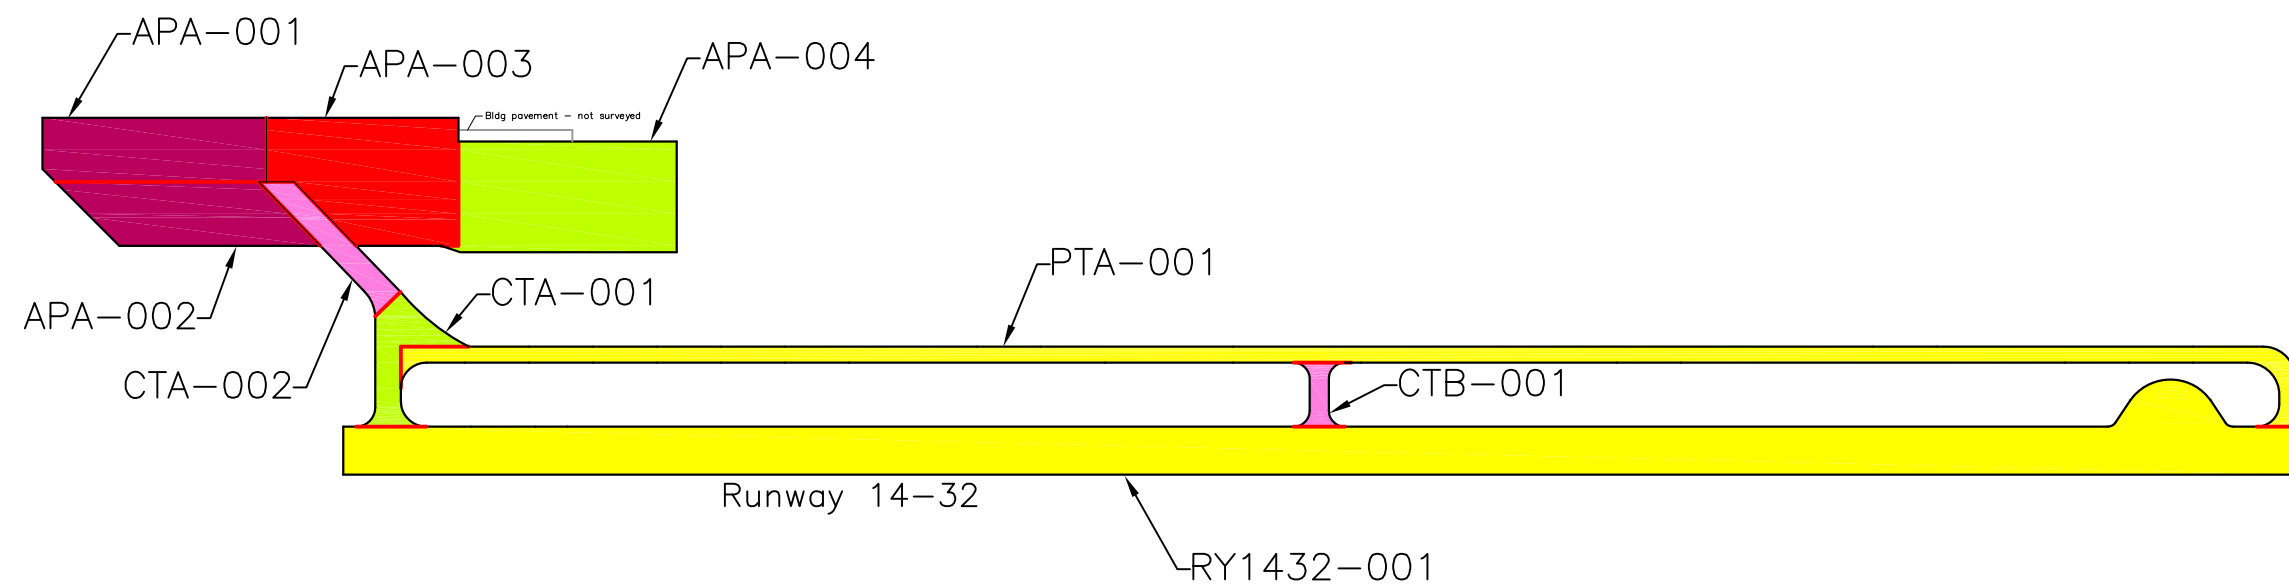
Figure 4. 2011 Pavement Condition Index Rating at Duluth Sky Harbor Airport (DYT).

The results of the 2011 PCI inspection are presented in figure 4. The overall area-weighted PCI for DYT is 55. When summarizing PCI values, an area-weighted calculation is used instead of a straight mathematical average because the area-weighted calculations eliminate the skewing of the PCI due to the disparity of the section sizes.
