# Minnesota Airport System Pavement Evaluation 2011 Update

Wheaton Municipal Airport (ETH)

Wheaton, Minnesota

January 2012

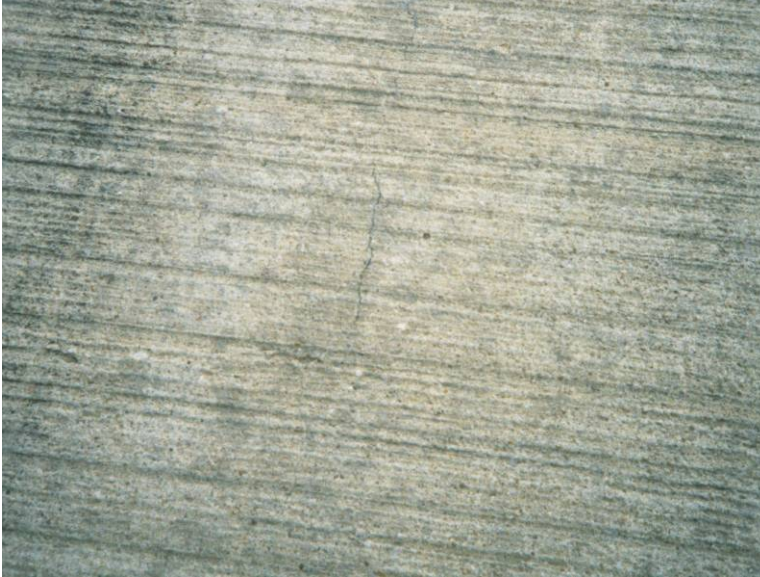
### Example of Shrinkage Cracking

Shrinkage cracks are small, nonworking (no spalling along edge) cracks that are visible at the surface but do not penetrate through the full depth of concrete. Shrinkage cracks most commonly occur shortly after construction due to concrete shrinkage during the curing process. Shrinkage cracks are usually so small that they are not visible until staining or material loss at crack edges begins to take place. Shrinkage cracks do not represent a structural weakness, and no corrective action is prescribed.

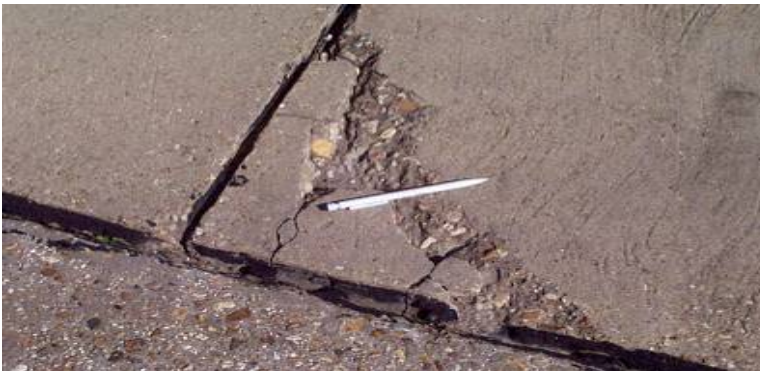
### Example of Joint and Corner Spalling

Spalls at slab joints and corners are caused by excessive internal stress in the pavement. Spalls occur when these stresses exceed the shear strength of the concrete. Spalling usually results from thermal expansion during warm or hot weather. As slabs expand, they push against one another at joints. If the joints are filled with incompressibles, such as sand, or if adjacent slabs offset slightly, stresses can become severe, causing spalls. Spalling can be reduced significantly by conscientious maintenance of joint sealant.

Spall repair requires patching. The extent and severity of spalling on a pavement surface suggests appropriate action. For example, at low severity, spalled concrete remains securely in place in the slab. A low-severity spall should be monitored closely for further

deterioration and should be patched when spalled particles become loose in place, or at the next scheduled patching activity in the section. Medium- and high-severity spalls should be repaired immediately to prevent the incidence of FOD. If the pavement can be restored to serviceable condition, spalls should be carefully patched for long-term service. If the pavement is beyond repair, temporary patching should be considered to control FOD.

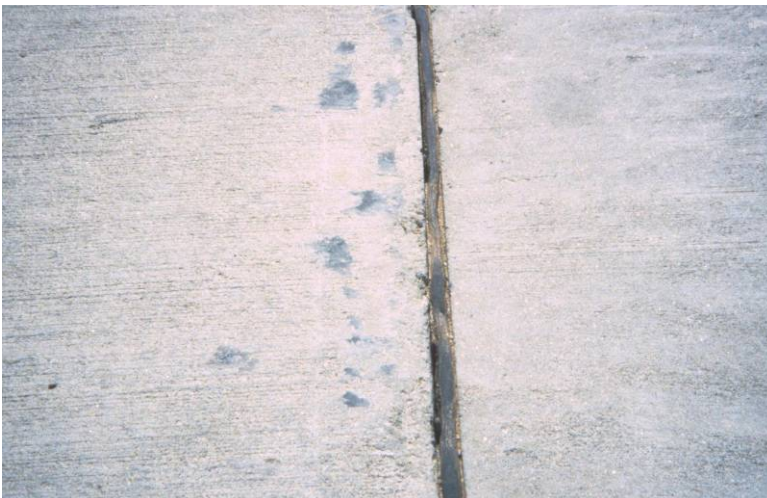
#### Example of Joint Seal Damage

Joint seal damage is recorded at three severities: low, medium, and high. When joint sealant is in perfect condition (no damage), it is not a distress. At low severity, at least 10 percent of the sealant is debonded but still in contact with the joint edges (i.e., joint sealant is in serviceable condition but should be monitored for evidence of more serious failure). Medium-severity joint seal damage is recorded when at least 10 percent of the sealant has visible gaps smaller than 1/8th inch and is an indicator that replacement should be programmed as soon as is practicable. In the mean time, aggressive inspection and sustaining maintenance is recommended to minimize subsurface damage from moisture penetration. At high severity, visible gaps exceed 1/8th inch and the amount and degree of joint seal damage is such that repair is no longer feasible. The only appropriate corrective action is sealant replacement.

On serviceable pavement, deteriorated joint sealant should be repaired or replaced to preserve pavement and subgrade integrity and prolong service life. The issue is not so clear-cut with unserviceable pavement. Pavement that can be restored to serviceable condition by maintenance activities such as patching and joint seal repair, or by slab replacement, should be so maintained as long as the process is cost-effective. However, when age and condition preclude economical return to serviceable condition by such means, joint seal repair would no longer be cost-effective and should be suspended except for an interim maintenance program to control FOD potential.
