# Minnesota Airport System Pavement Evaluation 2011 Update

Fairmont Municipal Airport (FRM)

Fairmont, Minnesota

January 2012

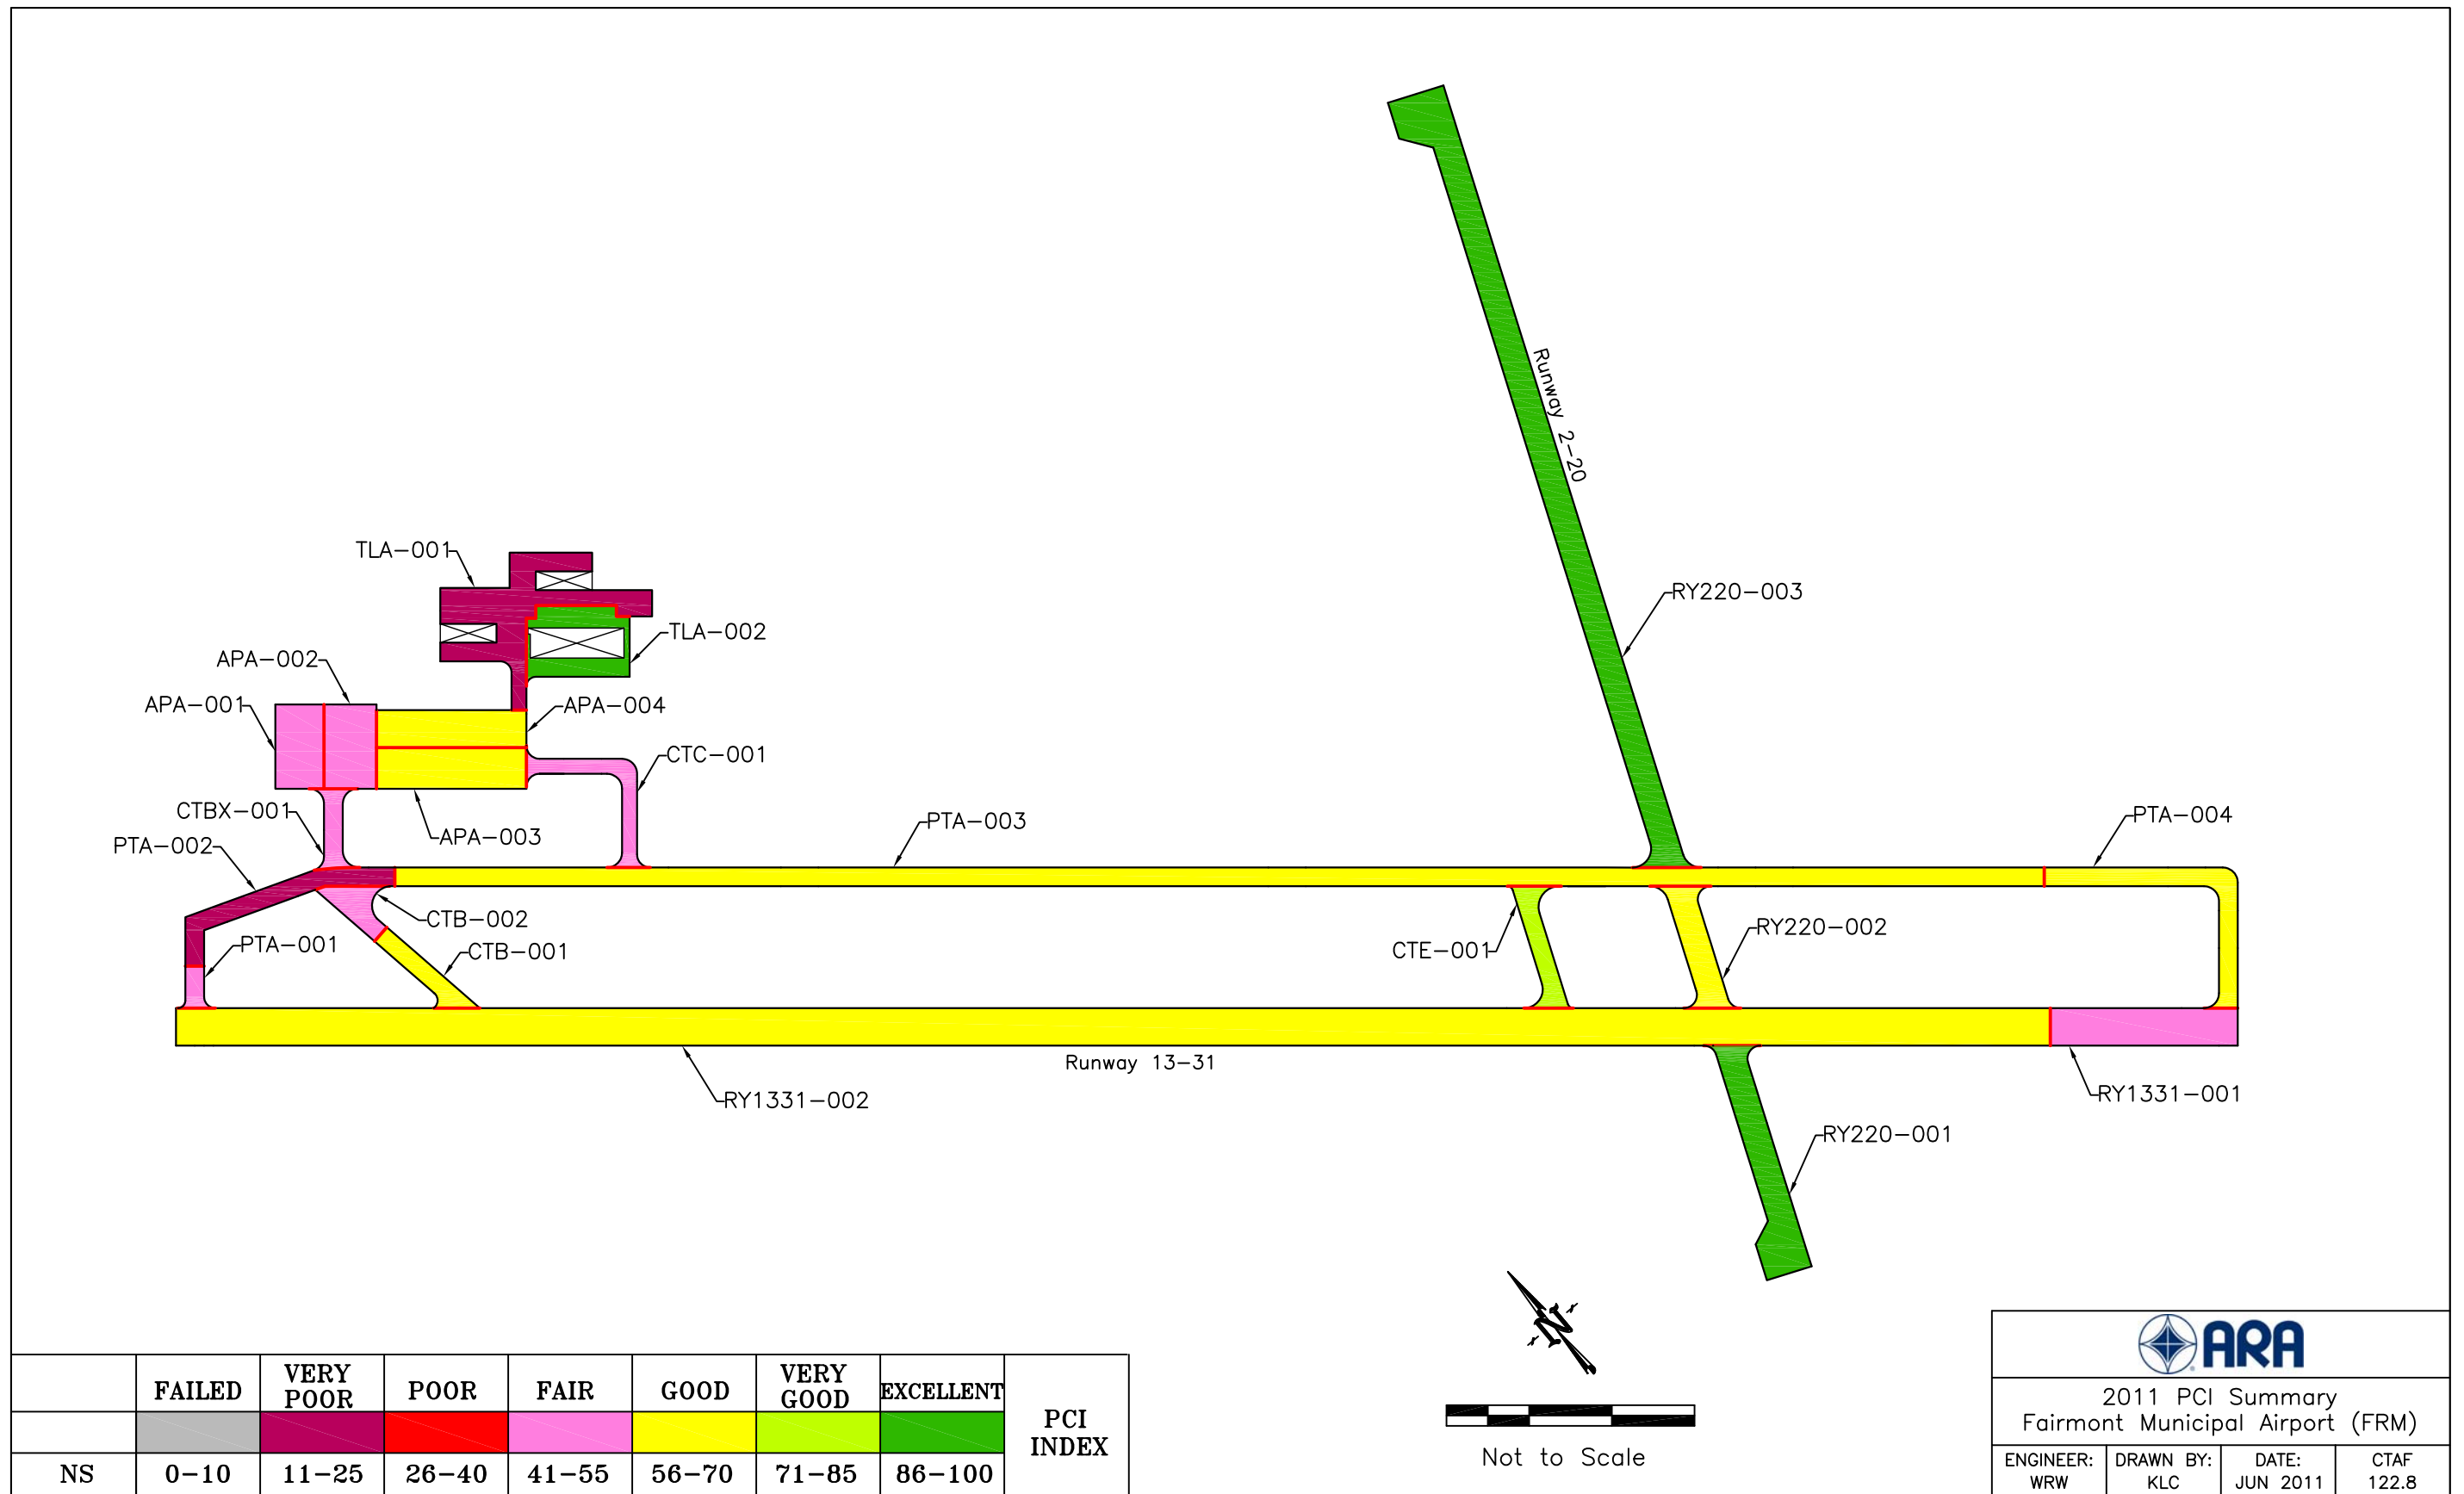
Figure 4. 2011 Pavement Condition Index Rating at Fairmont Municipal Airport (FRM).

The results of the 2011 PCI inspection are presented in figure 4. The overall area-weighted PCI for FRM is 64. When summarizing PCI values, an area-weighted calculation is used instead of a straight mathematical average because the area-weighted calculations eliminate the skewing of the PCI due to the disparity of the section sizes.

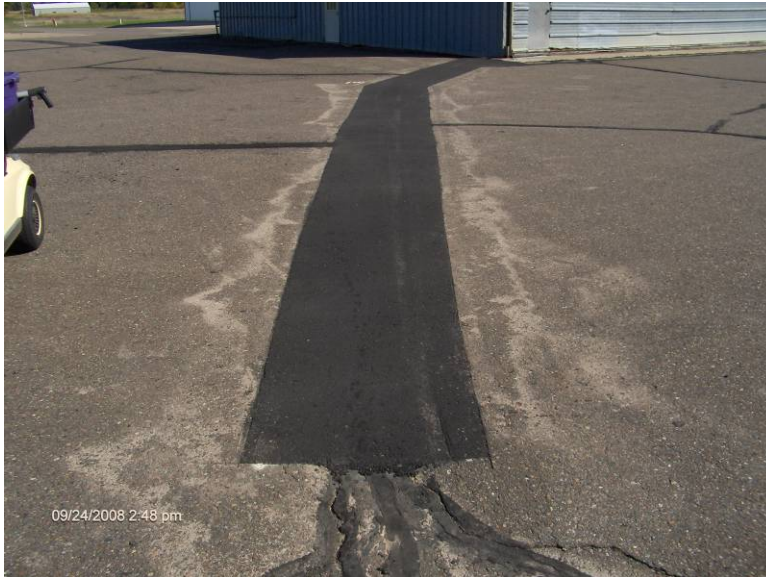
### Example of Patching

Patched areas are defined when a portion of the original pavement is replaced with a material intended as a semi-permanent repair. A patch is documented as a defect because it is considered a break in the integrity of the pavement structure. Patches are constructed for a variety of reasons including utility repairs, correcting grade issues, and addressing a defect in the original pavement.

The severity level of patches is determined by the amount of distress (i.e. cracking, depression, weathering/raveling, etc.) occurring within the limits of the patched area.

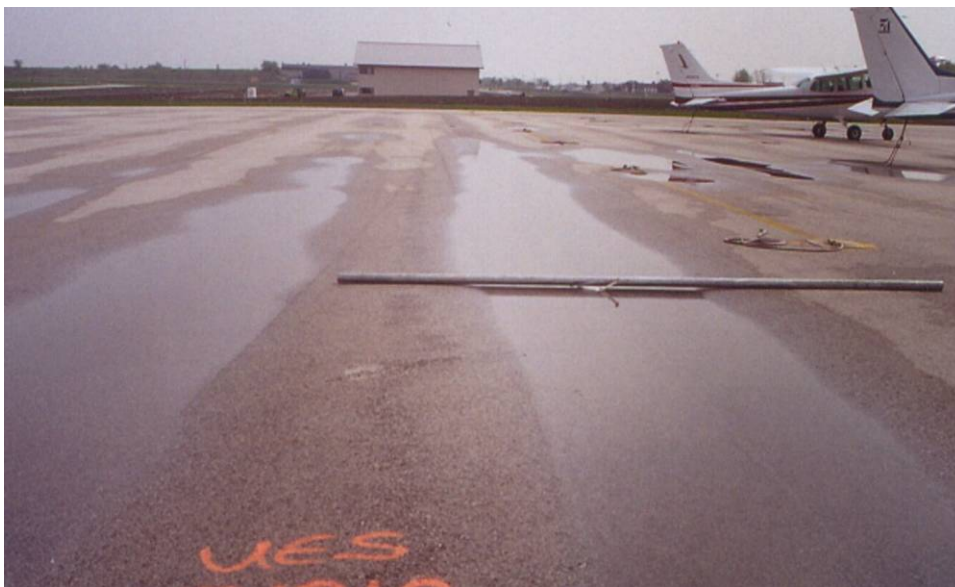
### Example of Rutting

Ruts are localized, load related, areas of pavement having elevations lower than the surrounding sections. Rutting is due to base and subgrade consolidation, caused by

excessive wheel loads or poor compactions. Ruts indicate structural failure, and can cause hydroplaning. At low severity, ruts have an average depth of  $\frac{1}{4}$  to  $\frac{1}{2}$  inches. At medium severity, ruts have an average depth of  $\frac{1}{2}$  to 1 inch. High severity, ruts have an average depth greater than 1 inch.

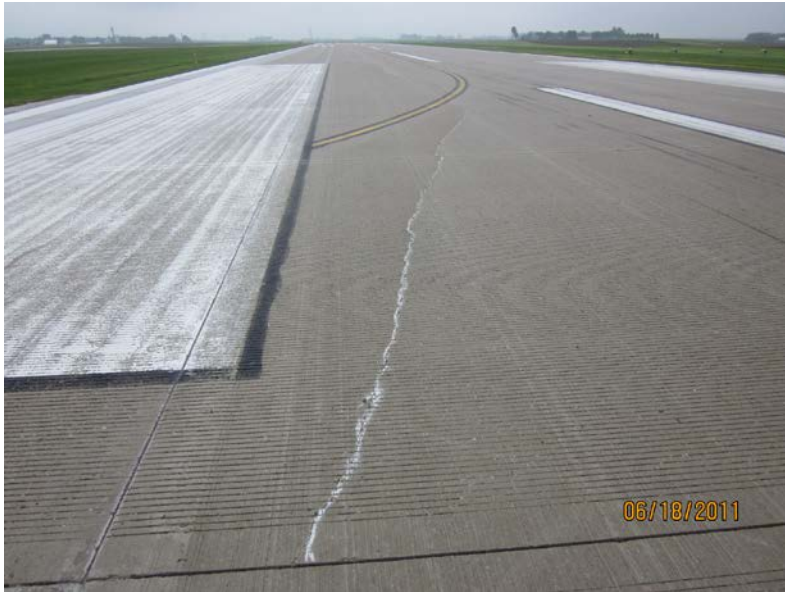
#### Example of Longitudinal, Transverse, and Diagonal Cracking

LTD cracking is most often a result of externally applied loads and/or constrained temperature deformations. External loads cause LTD cracking through flexure. Temperature changes on restrained slabs will result in stresses due to friction or curling. When any of these stresses exceed the strength of the slab, cracking will occur. LTD cracking is recorded at low, medium, or high severity, depending on the width of crack opening and degree of deterioration. At low severity, the crack is less than  $\frac{1}{8}$ th inch wide with little spalling and no corrective action is indicated. At medium severity, LTD cracks can be up to 1 inch wide with moderate spalling, and should be repaired and sealed using procedures similar to joint sealing. At high severity, cracks exceed 1 inch in width and may be severely spalled. High-severity LTD cracking is evidence of serious load failure of the slab, and correction may require patching or slab replacement. If the distress occurs in several adjacent slabs at medium or high severity, major rehabilitation of that pavement area is indicated.

When a slab is divided by LTD cracks into four or more pieces, the slab is said to be "divided" or "shattered." Shattered slab is a separate distress category and is indicative of significant structural failure as the slab loses its ability to distribute loads to subgrade and further slab deterioration can be expected. Shattered slabs are rated in three severities, with slab replacement recommended for medium and high severities.

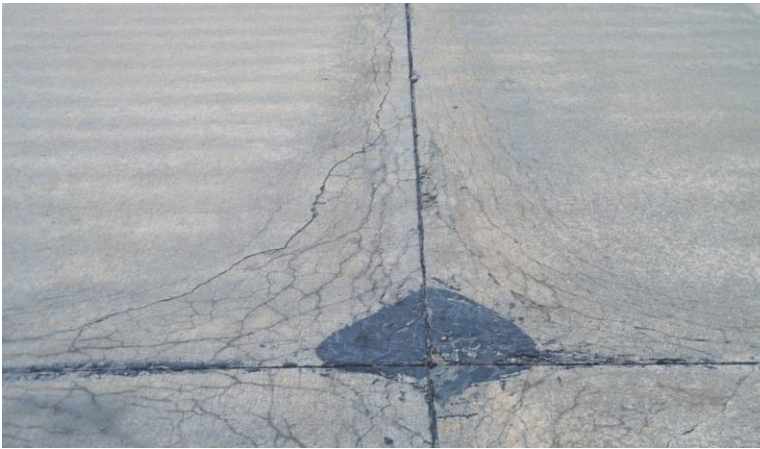
#### Example of Durability Cracking

Durability cracking (D-cracking) is caused by environmental factors, the most common of which is freezing/thawing. It usually appears as a pattern of hairline cracks running parallel to a joint or crack, or in a corner, where water tends to collect. This type of cracking eventually leads to disintegration of the pavement, creating FOD potential. At low severity, D-cracking is evident, but no disintegration has occurred. As the distress advances to medium severity, the distress pattern is evident over a significant area of the slab, and some disintegration and FOD potential exists. High severity durability cracking is evidenced by extensive cracking with loose and missing pieces and significant FOD potential.

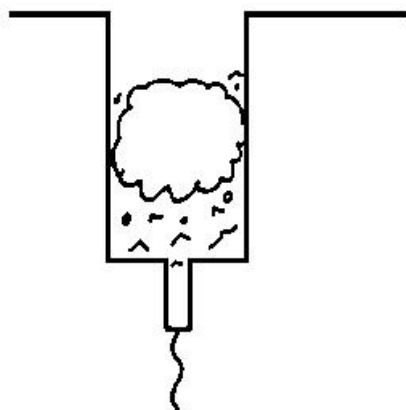
Typical joint with deficient sealant and a collection of debris & incompressibles.
