Minnesota Airport System Pavement Evaluation 2011 Update

Glenwood Municipal Airport (GHW)

Glenwood, Minnesota

January 2012

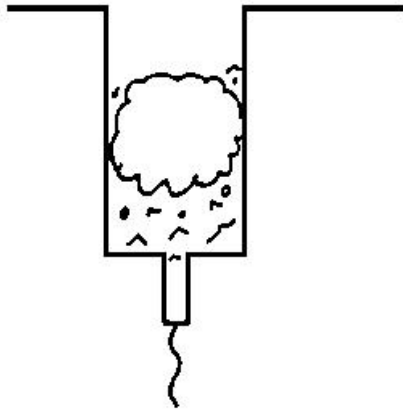
Typical joint with deficient sealant and a collection of debris & incompressibles.
