Minnesota Airport System Pavement Evaluation 2011 Update

Range Regional Airport (HIB)

Hibbing, Minnesota

January 2012

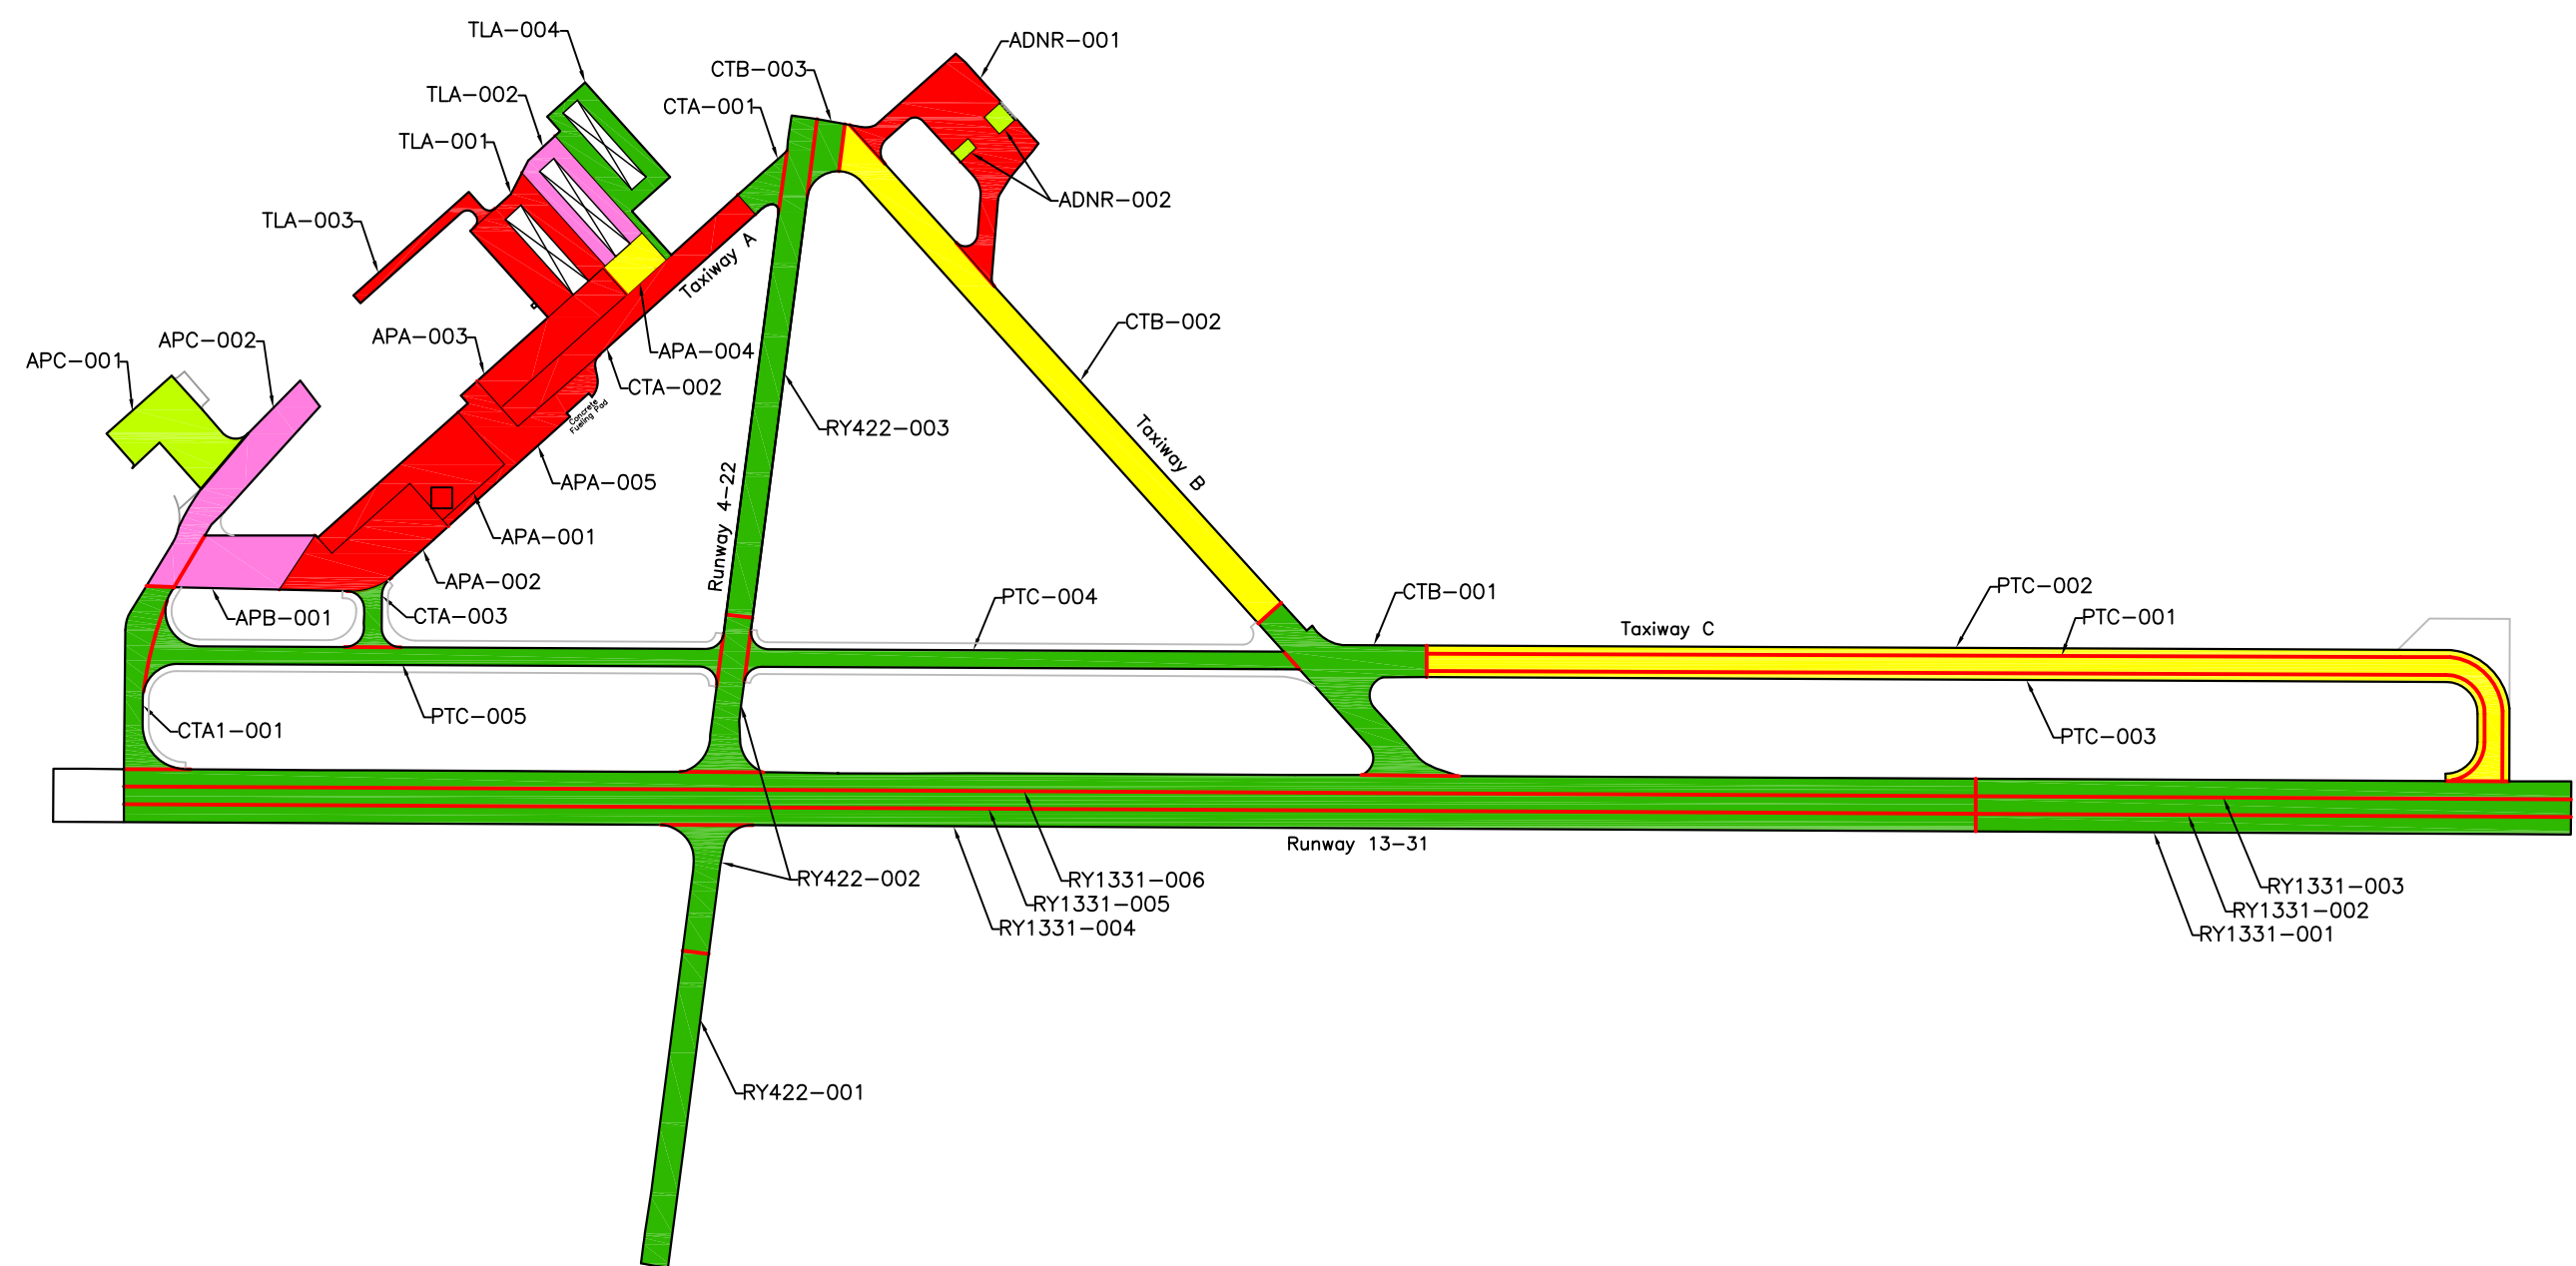
Figure 4. 2011 Pavement Condition Index Rating at Chisholm-Hibbing Municipal Airport (HIB).

The results of the 2011 PCI inspection are presented in figure 4. The overall area-weighted PCI for HIB is 79. When summarizing PCI values, an area-weighted calculation is used instead of a straight mathematical average because the area-weighted calculations eliminate the skewing of the PCI due to the disparity of the section sizes.

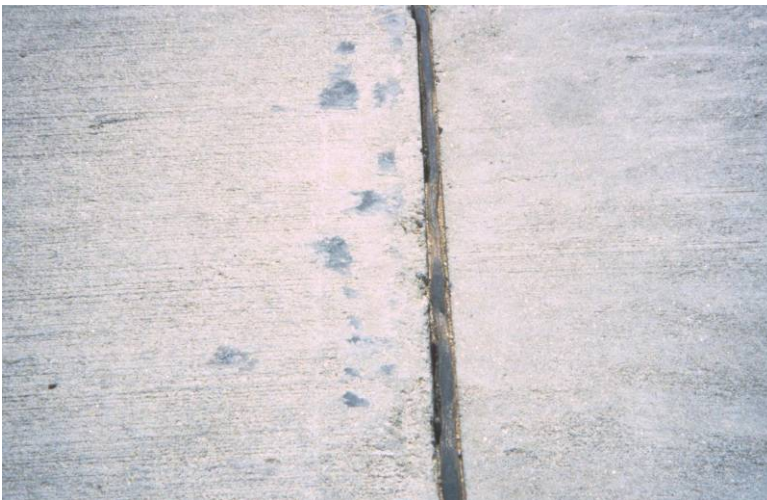
Example of Joint Seal Damage

Joint seal damage is recorded at three severities: low, medium, and high. When joint sealant is in perfect condition (no damage), it is not a distress. At low severity, at least 10 percent of the sealant is debonded but still in contact with the joint edges (i.e., joint sealant is in serviceable condition but should be monitored for evidence of more serious failure). Medium-severity joint seal damage is recorded when at least 10 percent of the sealant has visible gaps smaller than 1/8th inch and is an indicator that replacement should be programmed as soon as is practicable. In the mean time, aggressive inspection and sustaining maintenance is recommended to minimize subsurface damage from moisture penetration. At high severity, visible gaps exceed 1/8th inch and the amount and degree of joint seal damage is such that repair is no longer feasible. The only appropriate corrective action is sealant replacement.

On serviceable pavement, deteriorated joint sealant should be repaired or replaced to preserve pavement and subgrade integrity and prolong service life. The issue is not so clear-cut with unserviceable pavement. Pavement that can be restored to serviceable condition by maintenance activities such as patching and joint seal repair, or by slab replacement, should be so maintained as long as the process is cost-effective. However, when age and condition preclude economical return to serviceable condition by such means, joint seal repair would no longer be cost-effective and should be suspended except for an interim maintenance program to control FOD potential.

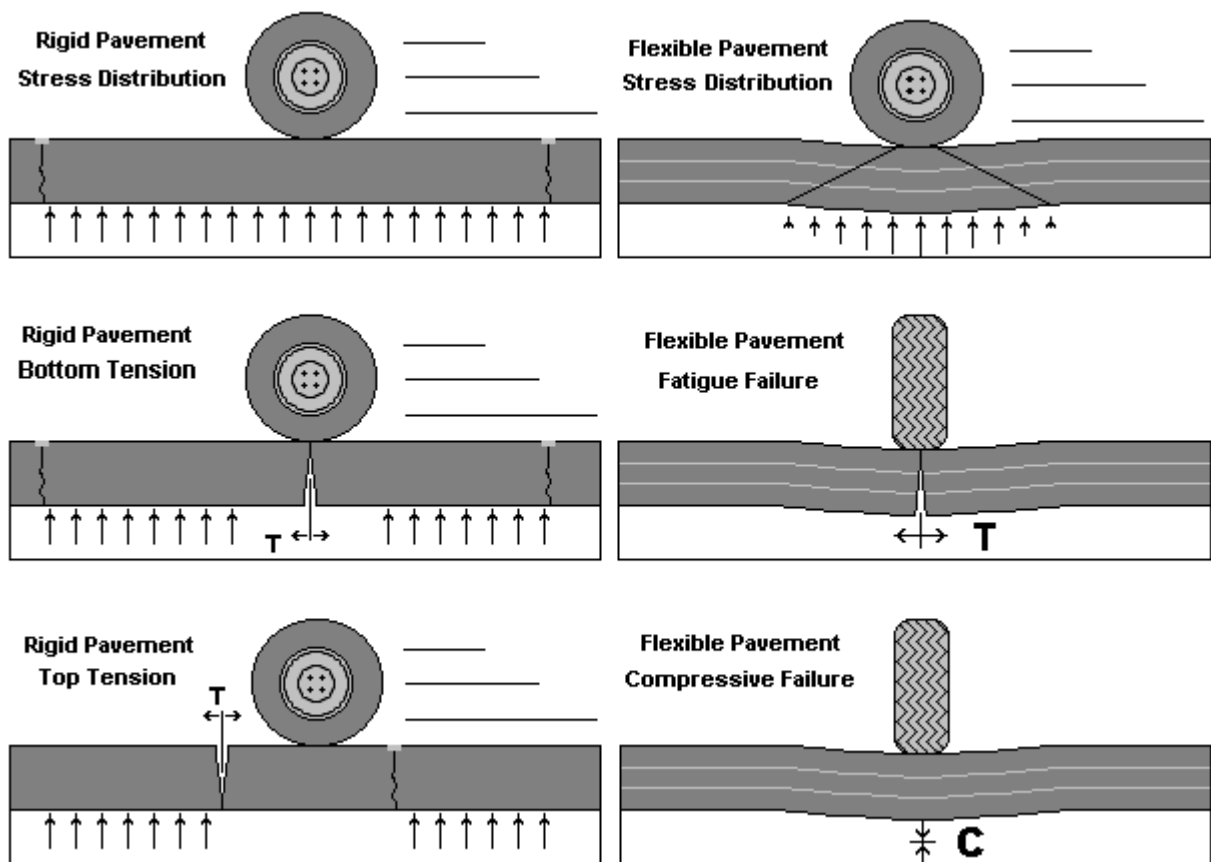
Figure 1. Pavement failure.

Load-related cracks can start at the top or bottom of a pavement section. In asphalt sections, load-related (fatigue) cracks start at the bottom. If a load-related crack reaches the surface, it usually indicates significant structural deficiency. In PCC pavement, corner breaks are caused by top tension, and the crack propagates downward. Mid-slab LTD cracks are examples of bottom tension.

Spalls can be caused by either wheel loads or environmental factors, anytime there is movement between adjacent slabs. If a small rock is allowed into a joint, a differential movement between adjacent slabs can cause a spall. Spalling can be minimized by keeping joint and crack sealant intact.

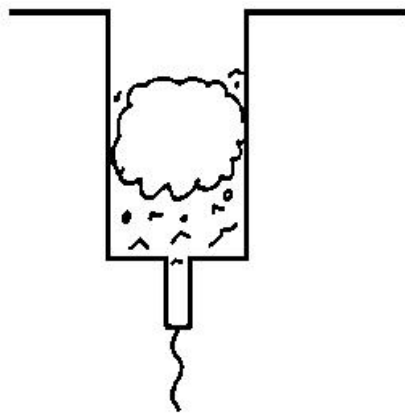
Typical joint with deficient sealant and a collection of debris & incompressibles.
