# Minnesota Airport System Pavement Evaluation 2011 Update

Mankato Municipal Airport (MKT)

Mankato, Minnesota

January 2012

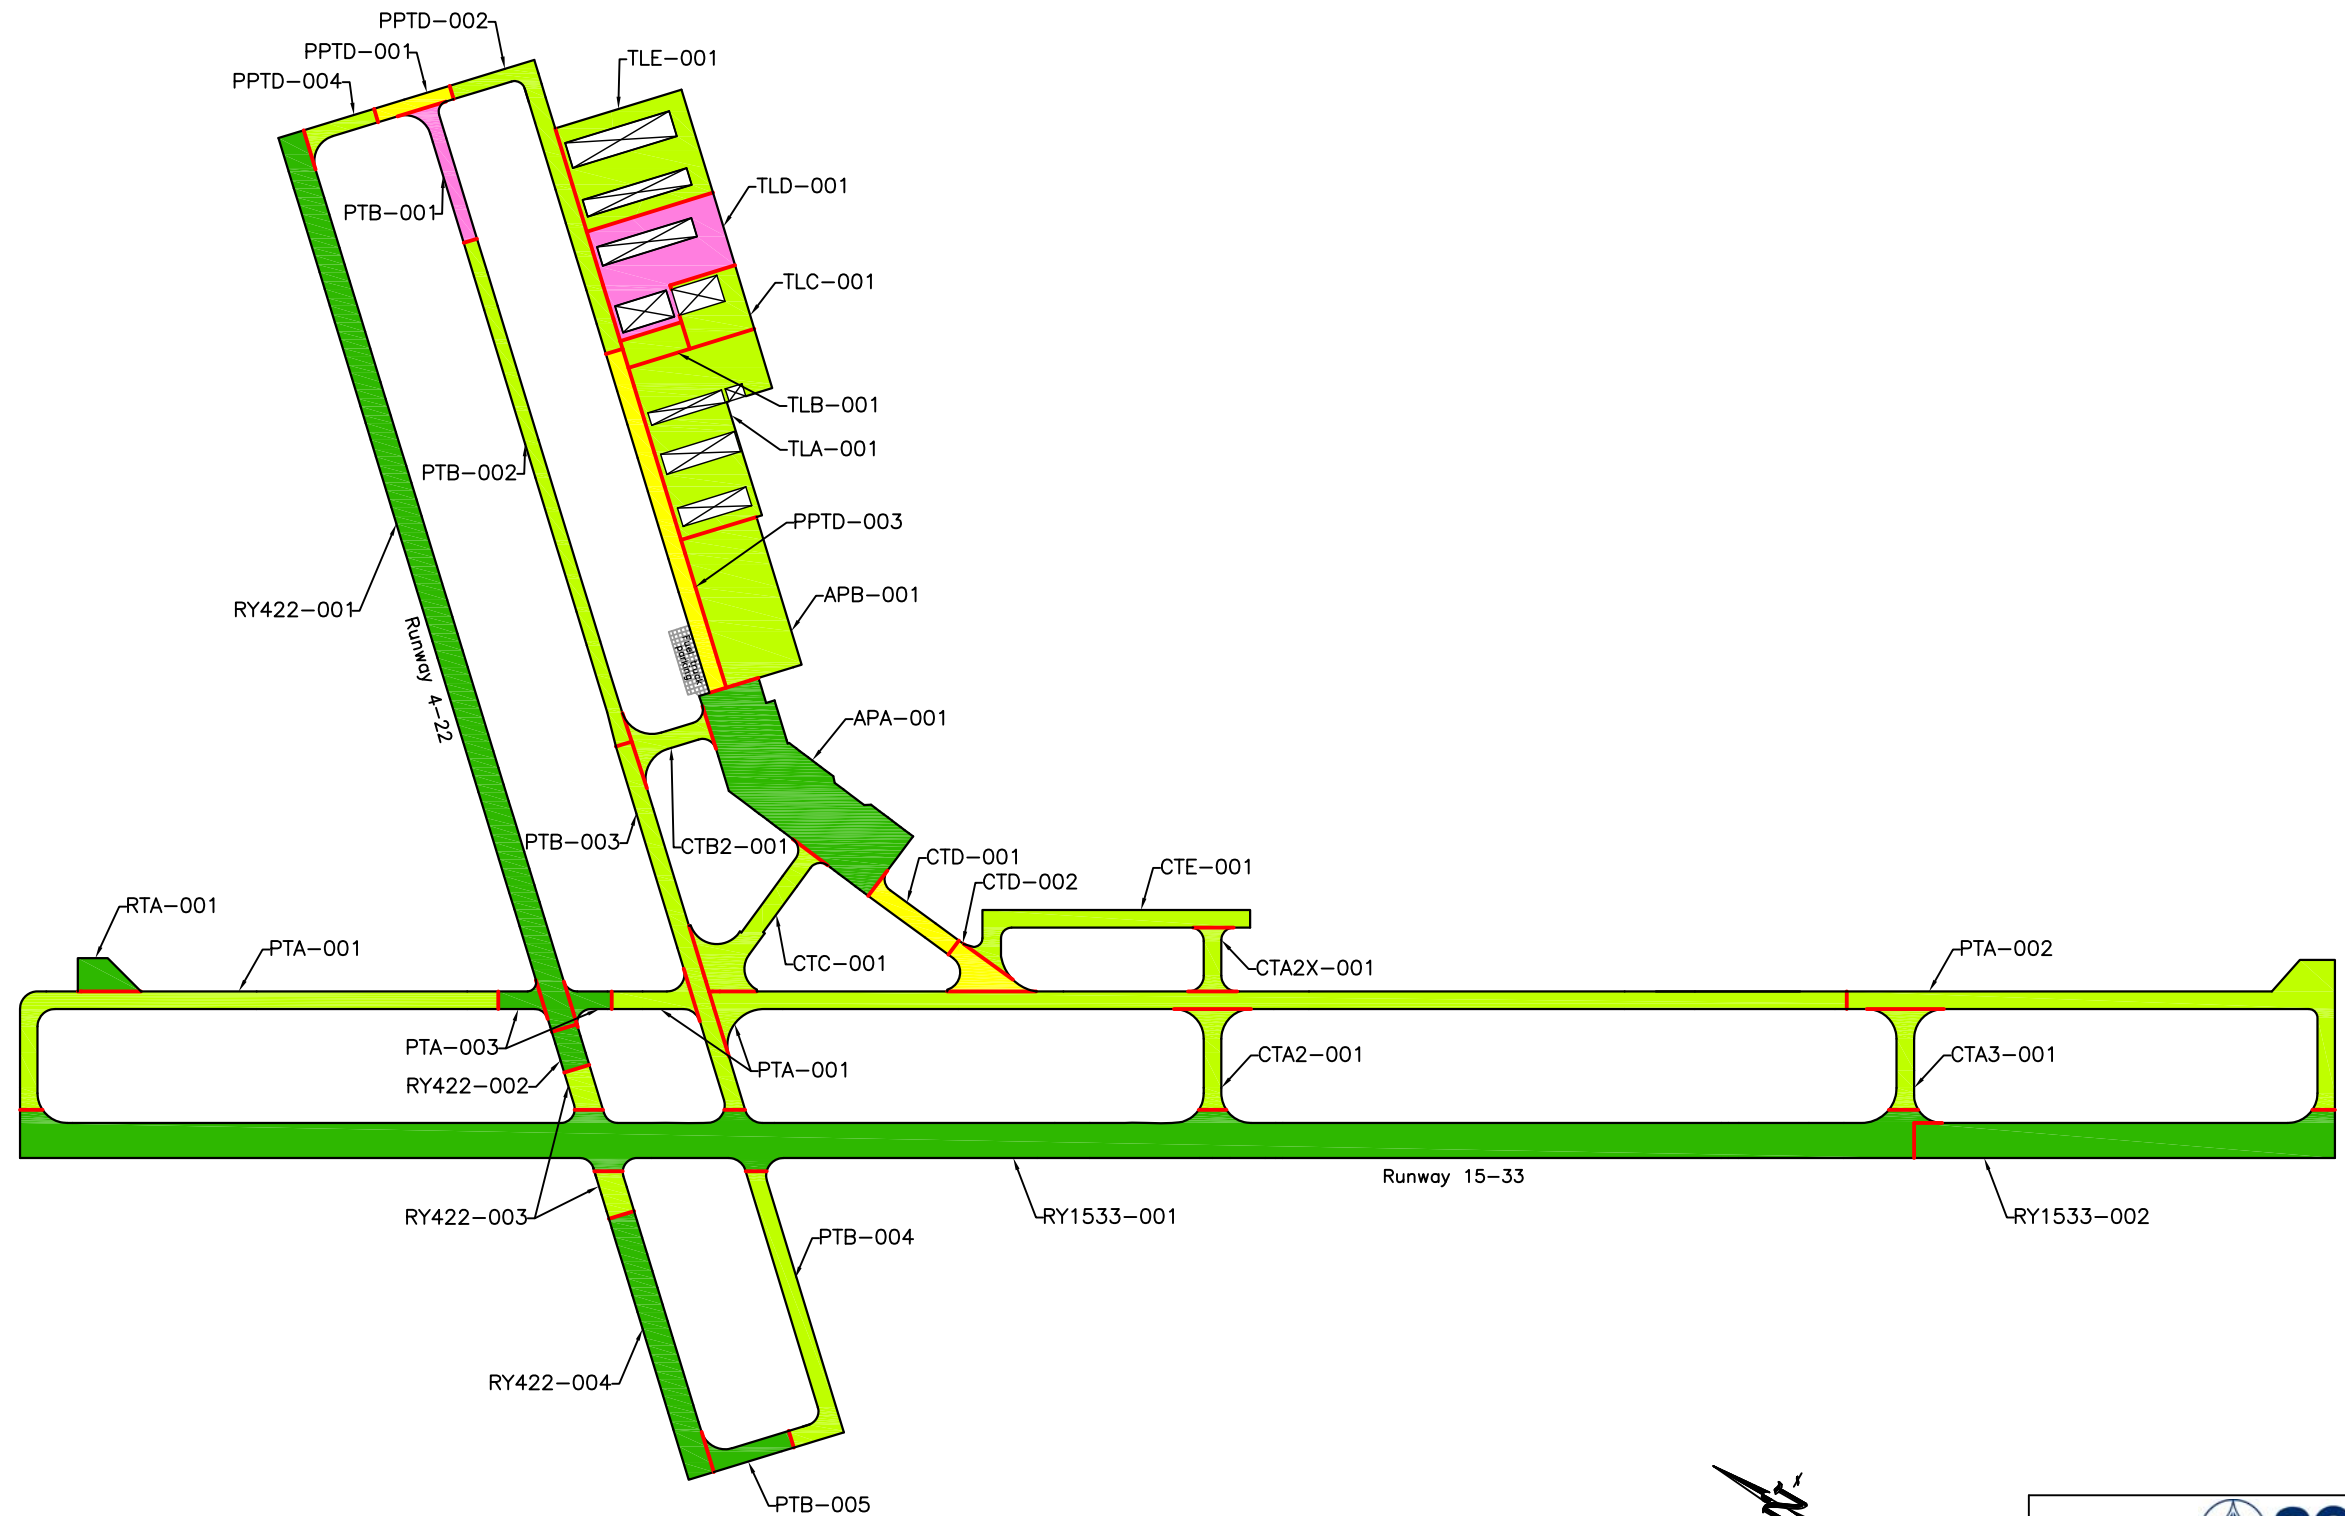
Figure 4. 2011 Pavement Condition Index Rating at Mankato Regional Airport (MKT).

The results of the 2011 PCI inspection are presented in figure 4. The overall area-weighted PCI for MKT is 82. When summarizing PCI values, an area-weighted calculation is used instead of a straight mathematical average because the area-weighted calculations eliminate the skewing of the PCI due to the disparity of the section sizes.
