Minnesota Airport System Pavement Evaluation 2011 Update

Red Wing Regional Airport (RGK)

Red Wing, Minnesota

January 2012

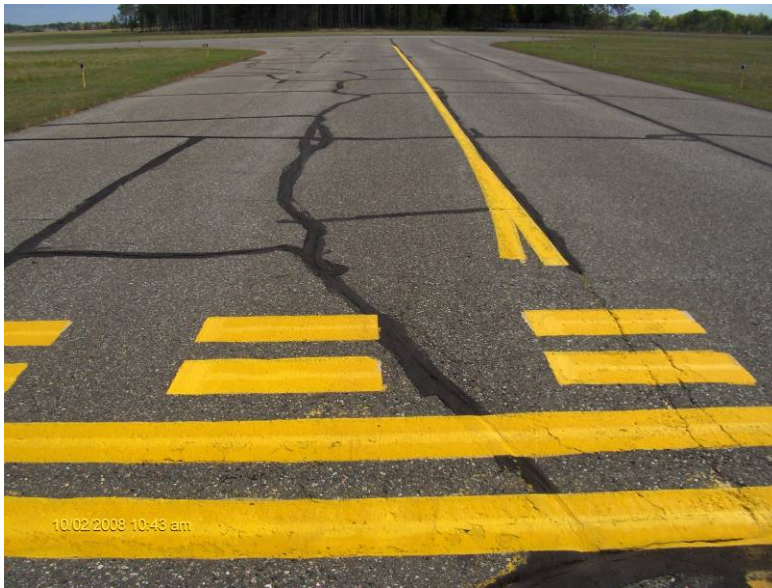
Example of Longitudinal and Transverse Cracking

Longitudinal and transverse cracks are caused by pavement aging, by construction, and by subsurface movement. Aging occurs as pavement loses some of its components to the atmosphere and becomes more brittle. Consistent application of pavement sealcoats can help to prevent the occurrence of age related cracks. Cracks will also develop along poorly constructed paving lane joints. Ensuring that joints are made when both sides are still hot, and near the same temperature, is one of the best ways to mitigate this potential problem. Seasonal movement caused by changes in moisture content or temperature differences can also cause pavement cracks. Asphalt pavement placed over a PCC pavement or cement stabilized base course may evidence reflective cracking from the underlying material. Longitudinal and transverse cracks are not caused by wheel loads, although traffic may worsen their condition.

Low severity longitudinal and transverse cracks are less than ¼ inch wide, or if sealed with suitable filler material in satisfactory condition can be any width, less than 3 inches, if they are not spalled. Maintenance usually is not indicated for low-severity cracking. Moderately spalled cracks and cracks wider than ¼ inch which are not satisfactorily sealed are at medium severity. Medium-severity cracks should be sealed with a high-

quality crack filling material. Severely spalled cracks and cracks wider than 3 inches are at high severity. High-severity L&T cracks normally require patching.

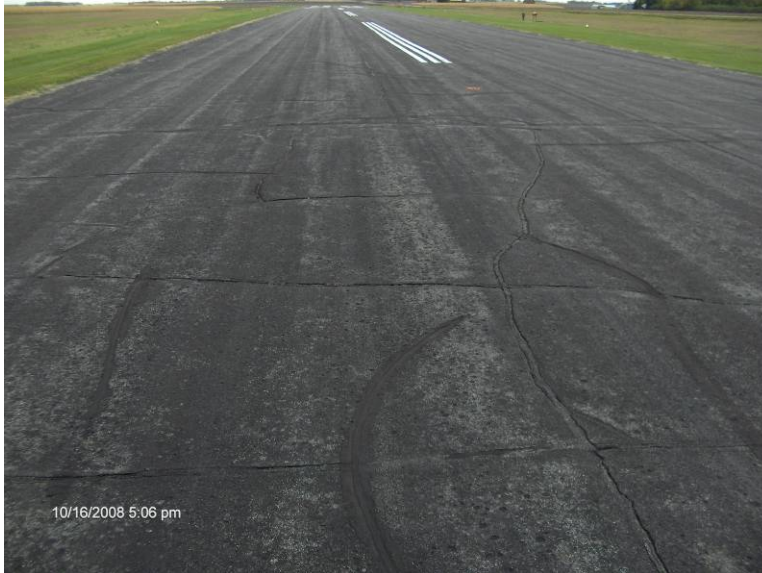
Example of Block Cracking

Block cracking is longitudinal and transverse cracking that has established a pattern of blocks ranging in size from 1ft x 1ft to 10ft x 10ft. This distress typically happens in older asphalt pavements and is an indication that the bituminous binder has lost most of its flexibility. The severity determination is basically determined by the crack width criteria defined for longitudinal and transverse cracking. Crack sealing typically is used to repair block cracking; however, the amount of required sealant can be extensive due to the high density of cracks.

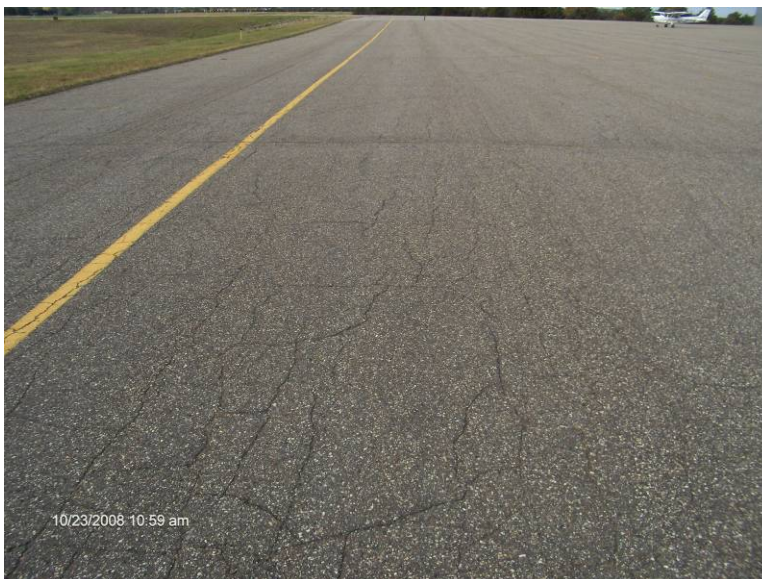
Example of Alligator Cracking

Alligator (or fatigue) cracks are a series of interconnected load-related cracks caused by fatigue of the asphalt surface. Alligator cracking is a significant structural distress and develops only in places subject to traffic loads. These cracks typically initiate at the bottom of the asphalt layer (where tensile strains are highest) and propagate upward - so once a fatigue crack is visible, significant damage has already occurred.

At low severity, alligator cracks are evidenced by a series of parallel hairline cracks (usually in a wheel path). Further traffic and deterioration leads to the interconnection of these cracks. Medium severity alligator cracking is a well-defined pattern of interconnected cracks, some spalling may be present. High severity alligator cracks have lost aggregate interlock between adjacent pieces, the cracks may be severely spalled with FOD potential, and most likely the pieces will move freely under traffic.

Alligator cracking is a structural failure and cannot be repaired with sealant, the proper repair is full-depth patching.

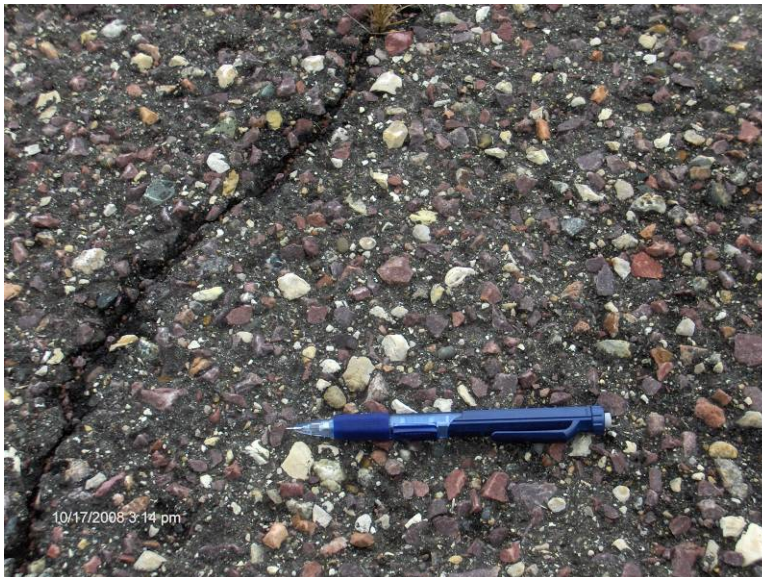
Example of Raveling/Weathering

Raveling and weathering are the wearing away of the pavement surface. Raveling is the condition where the mid- to large size aggregates are becoming dislodged; weathering is when the fine aggregate wears away exposing the edges of the larger aggregate. This distress is usually evident over large areas. Raveling and weathering may indicate that the asphalt binder has hardened significantly. At low severity, the surface has started to wear away with few (if any) loose particles and the coarse surface aggregate is exposed to 1/4 of its diameter. At medium severity, the aggregate and/or binder have worn away with some loose and missing particles, and the surface texture is moderately rough and pitted, but the average depth of erosion is less than 1/4 inch. At high severity, the aggregate and/or binder have worn away with a large amount of loose and missing particles, the surface texture is severely rough and pitted, and the top layer of aggregate has eroded away.

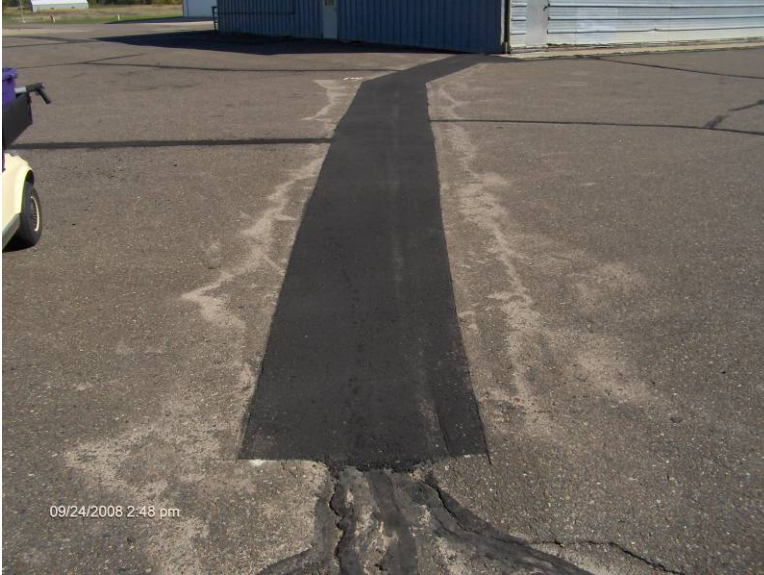
Example of Patching

Patched areas are defined when a portion of the original pavement is replaced with a material intended as a semi-permanent repair. A patch is documented as a defect because it is considered a break in the integrity of the pavement structure. Patches are constructed for a variety of reasons including utility repairs, correcting grade issues, and addressing a defect in the original pavement.

The severity level of patches is determined by the amount of distress (i.e. cracking, depression, weathering/raveling, etc.) occurring within the limits of the patched area.

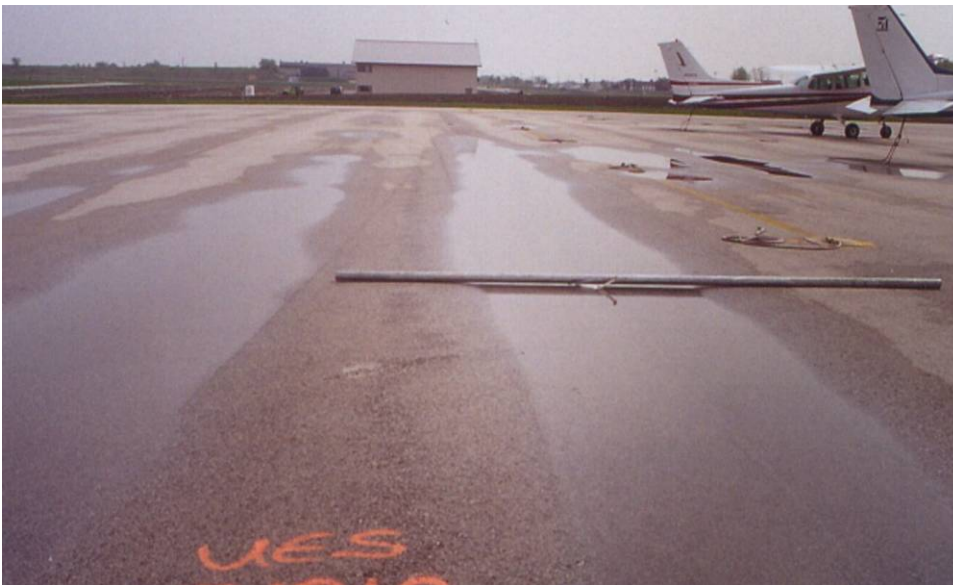
Example of Rutting

Ruts are localized, load related, areas of pavement having elevations lower than the surrounding sections. Rutting is due to base and subgrade consolidation, caused by

excessive wheel loads or poor compactions. Ruts indicate structural failure, and can cause hydroplaning. At low severity, ruts have an average depth of $\frac{1}{4}$ to $\frac{1}{2}$ inches. At medium severity, ruts have an average depth of $\frac{1}{2}$ to 1 inch. High severity, ruts have an average depth greater than 1 inch.

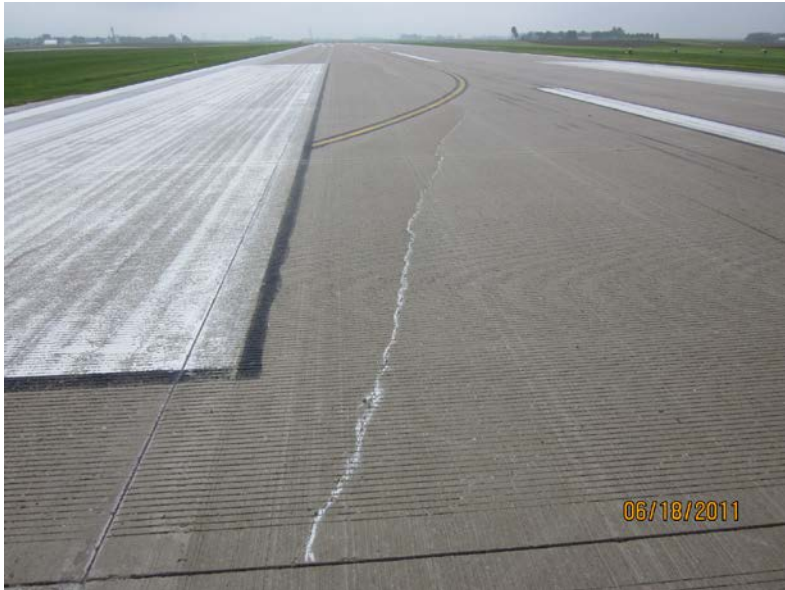
Example of Longitudinal, Transverse, and Diagonal Cracking

LTD cracking is most often a result of externally applied loads and/or constrained temperature deformations. External loads cause LTD cracking through flexure. Temperature changes on restrained slabs will result in stresses due to friction or curling. When any of these stresses exceed the strength of the slab, cracking will occur. LTD cracking is recorded at low, medium, or high severity, depending on the width of crack opening and degree of deterioration. At low severity, the crack is less than $\frac{1}{8}$ th inch wide with little spalling and no corrective action is indicated. At medium severity, LTD cracks can be up to 1 inch wide with moderate spalling, and should be repaired and sealed using procedures similar to joint sealing. At high severity, cracks exceed 1 inch in width and may be severely spalled. High-severity LTD cracking is evidence of serious load failure of the slab, and correction may require patching or slab replacement. If the distress occurs in several adjacent slabs at medium or high severity, major rehabilitation of that pavement area is indicated.

When a slab is divided by LTD cracks into four or more pieces, the slab is said to be "divided" or "shattered." Shattered slab is a separate distress category and is indicative of significant structural failure as the slab loses its ability to distribute loads to subgrade and further slab deterioration can be expected. Shattered slabs are rated in three severities, with slab replacement recommended for medium and high severities.

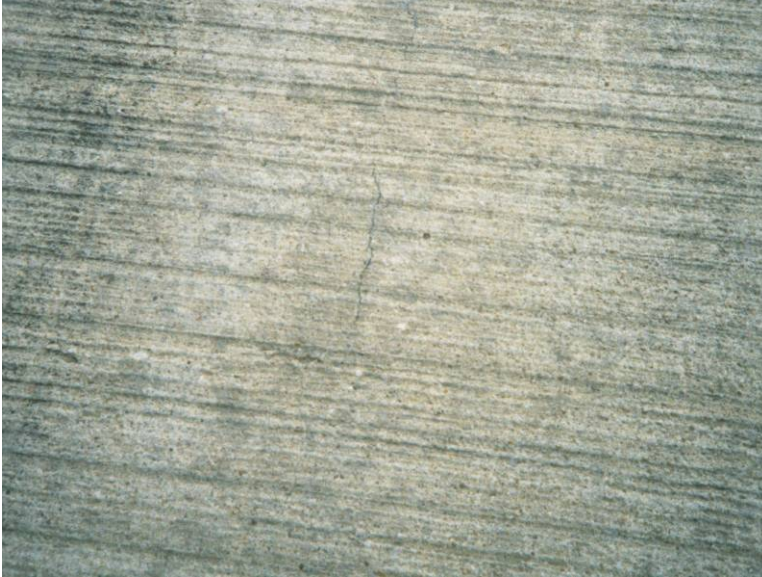
Example of Shrinkage Cracking

Shrinkage cracks are small, nonworking (no spalling along edge) cracks that are visible at the surface but do not penetrate through the full depth of concrete. Shrinkage cracks most commonly occur shortly after construction due to concrete shrinkage during the curing process. Shrinkage cracks are usually so small that they are not visible until staining or material loss at crack edges begins to take place. Shrinkage cracks do not represent a structural weakness, and no corrective action is prescribed.

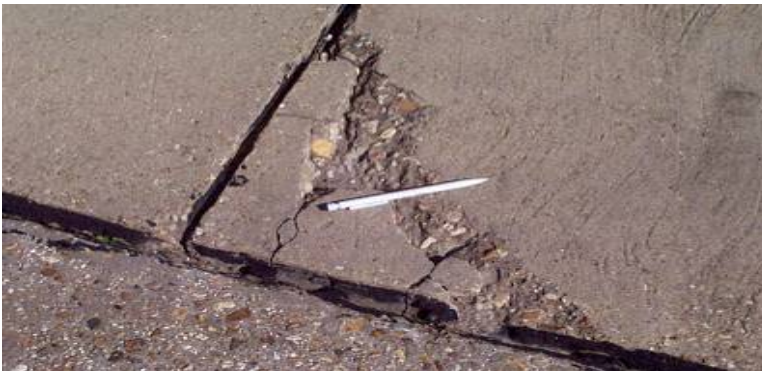
Example of Joint and Corner Spalling

Spalls at slab joints and corners are caused by excessive internal stress in the pavement. Spalls occur when these stresses exceed the shear strength of the concrete. Spalling usually results from thermal expansion during warm or hot weather. As slabs expand, they push against one another at joints. If the joints are filled with incompressibles, such as sand, or if adjacent slabs offset slightly, stresses can become severe, causing spalls. Spalling can be reduced significantly by conscientious maintenance of joint sealant.

Spall repair requires patching. The extent and severity of spalling on a pavement surface suggests appropriate action. For example, at low severity, spalled concrete remains securely in place in the slab. A low-severity spall should be monitored closely for further

deterioration and should be patched when spalled particles become loose in place, or at the next scheduled patching activity in the section. Medium- and high-severity spalls should be repaired immediately to prevent the incidence of FOD. If the pavement can be restored to serviceable condition, spalls should be carefully patched for long-term service. If the pavement is beyond repair, temporary patching should be considered to control FOD.

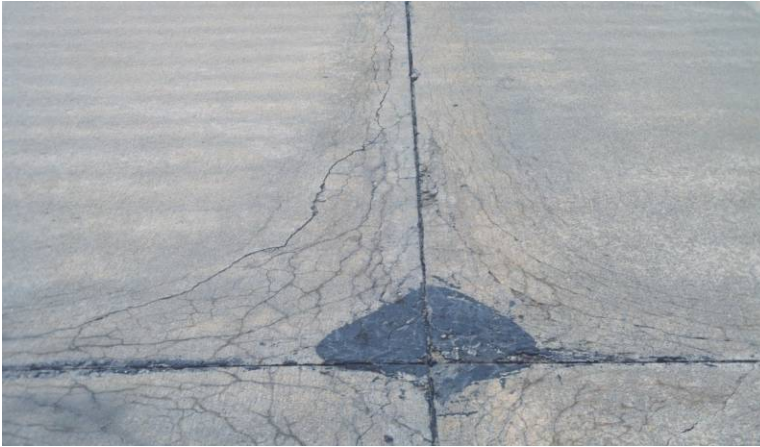
Example of Durability Cracking

Durability cracking (D-cracking) is caused by environmental factors, the most common of which is freezing/thawing. It usually appears as a pattern of hairline cracks running parallel to a joint or crack, or in a corner, where water tends to collect. This type of cracking eventually leads to disintegration of the pavement, creating FOD potential. At low severity, D-cracking is evident, but no disintegration has occurred. As the distress advances to medium severity, the distress pattern is evident over a significant area of the slab, and some disintegration and FOD potential exists. High severity durability cracking is evidenced by extensive cracking with loose and missing pieces and significant FOD potential.

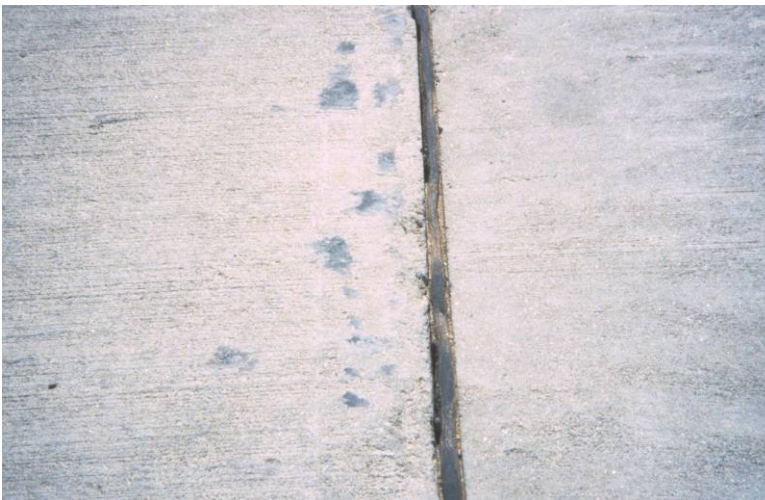
Example of Joint Seal Damage

Joint seal damage is recorded at three severities: low, medium, and high. When joint sealant is in perfect condition (no damage), it is not a distress. At low severity, at least 10 percent of the sealant is debonded but still in contact with the joint edges (i.e., joint sealant is in serviceable condition but should be monitored for evidence of more serious failure). Medium-severity joint seal damage is recorded when at least 10 percent of the sealant has visible gaps smaller than 1/8th inch and is an indicator that replacement should be programmed as soon as is practicable. In the mean time, aggressive inspection and sustaining maintenance is recommended to minimize subsurface damage from moisture penetration. At high severity, visible gaps exceed 1/8th inch and the amount and degree of joint seal damage is such that repair is no longer feasible. The only appropriate corrective action is sealant replacement.

On serviceable pavement, deteriorated joint sealant should be repaired or replaced to preserve pavement and subgrade integrity and prolong service life. The issue is not so clear-cut with unserviceable pavement. Pavement that can be restored to serviceable condition by maintenance activities such as patching and joint seal repair, or by slab replacement, should be so maintained as long as the process is cost-effective. However, when age and condition preclude economical return to serviceable condition by such means, joint seal repair would no longer be cost-effective and should be suspended except for an interim maintenance program to control FOD potential.
