# Minnesota Airport System Pavement Evaluation 2011 Update

Roseau Municipal Airport (ROX)

Roseau, Minnesota

January 2012

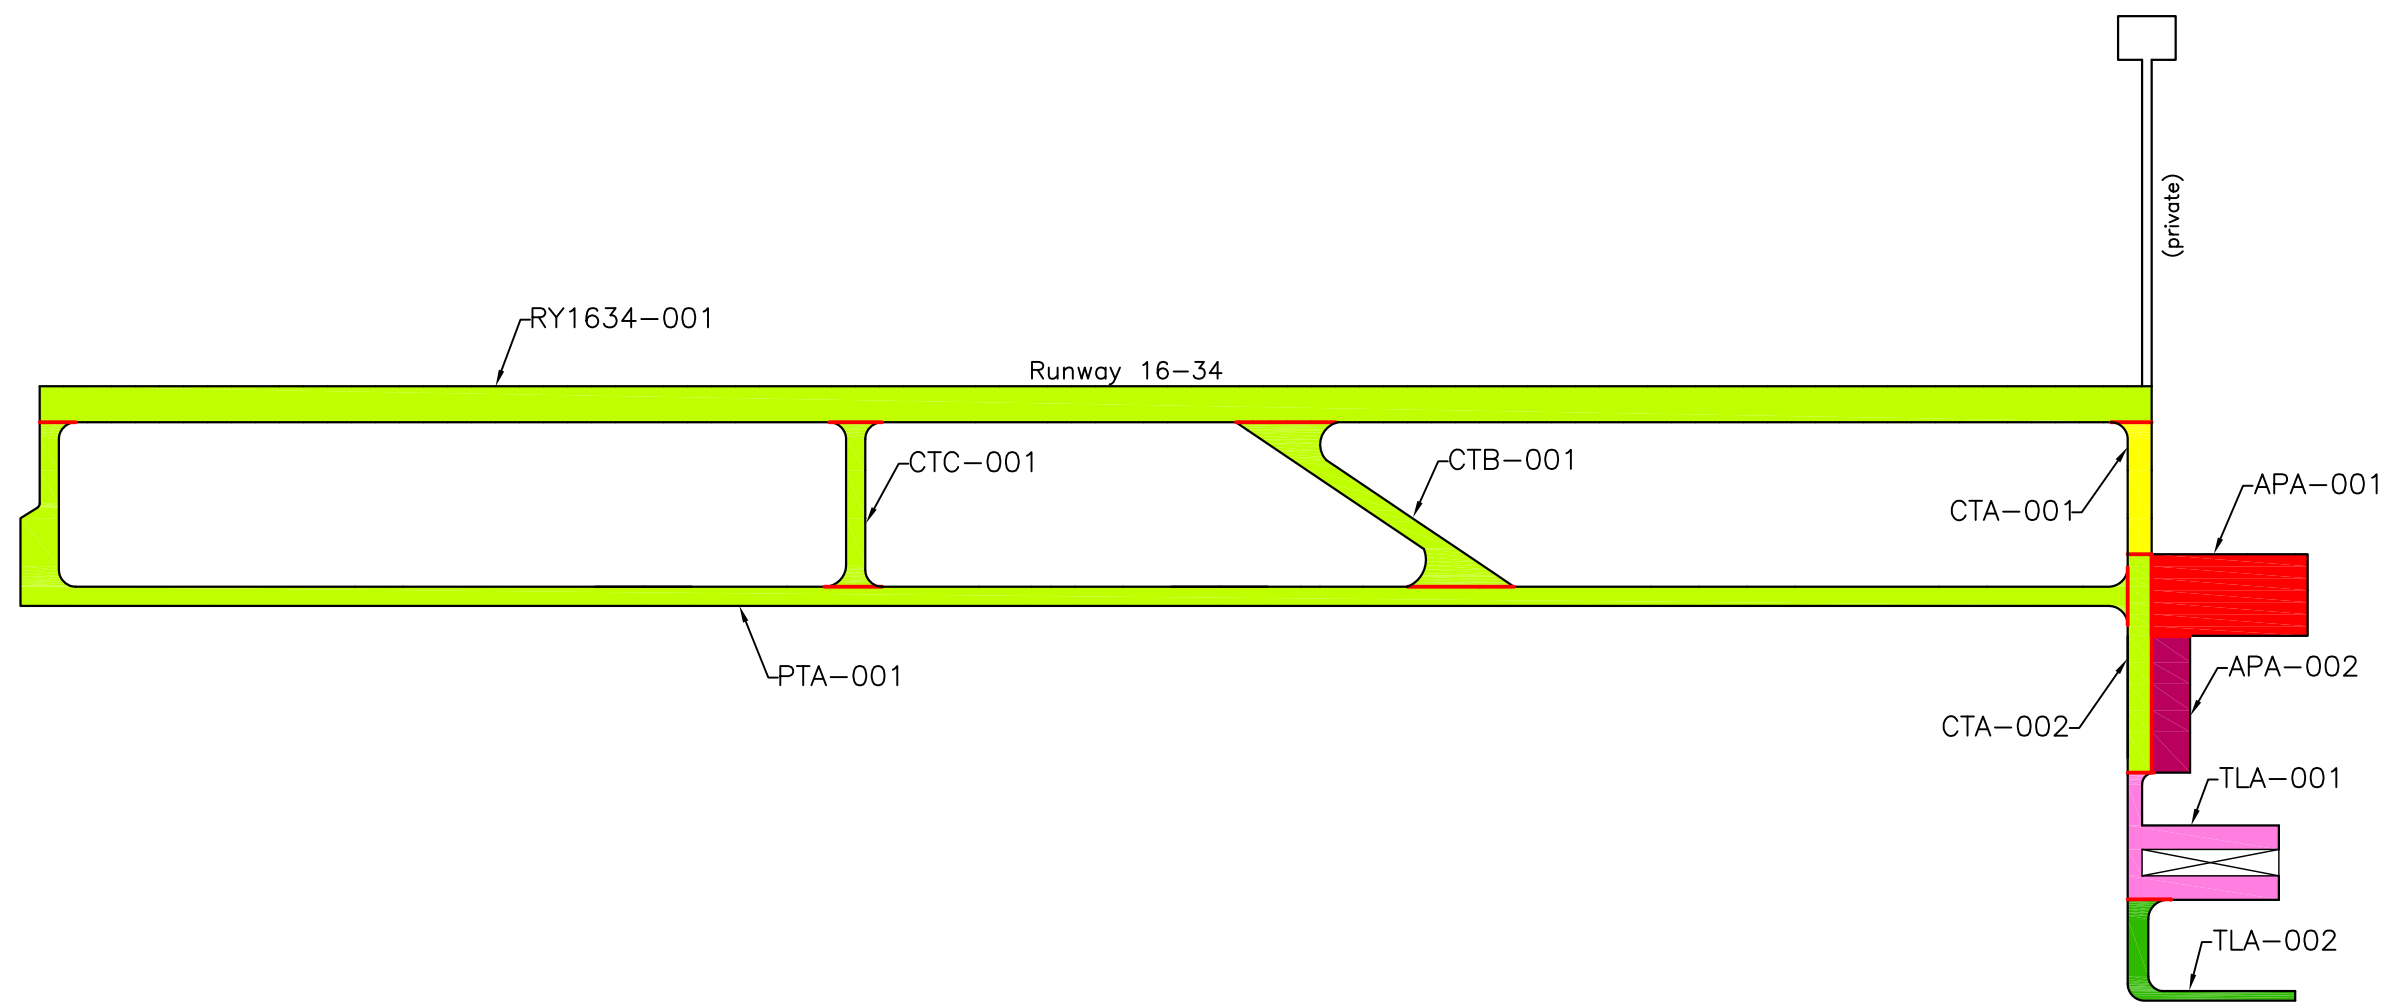
Figure 4. 2011 Pavement Condition Index Rating at Roseau Municipal Airport (ROX).

The results of the 2011 PCI inspection are presented in figure 4. The overall area-weighted PCI for ROX is 67. When summarizing PCI values, an area-weighted calculation is used instead of a straight mathematical average because the area-weighted calculations eliminate the skewing of the PCI due to the disparity of the section sizes.
