Minnesota Airport System Pavement Evaluation 2011 Update

Richard B. Helgeson Airport (TWM)

Two Harbors, Minnesota

January 2012

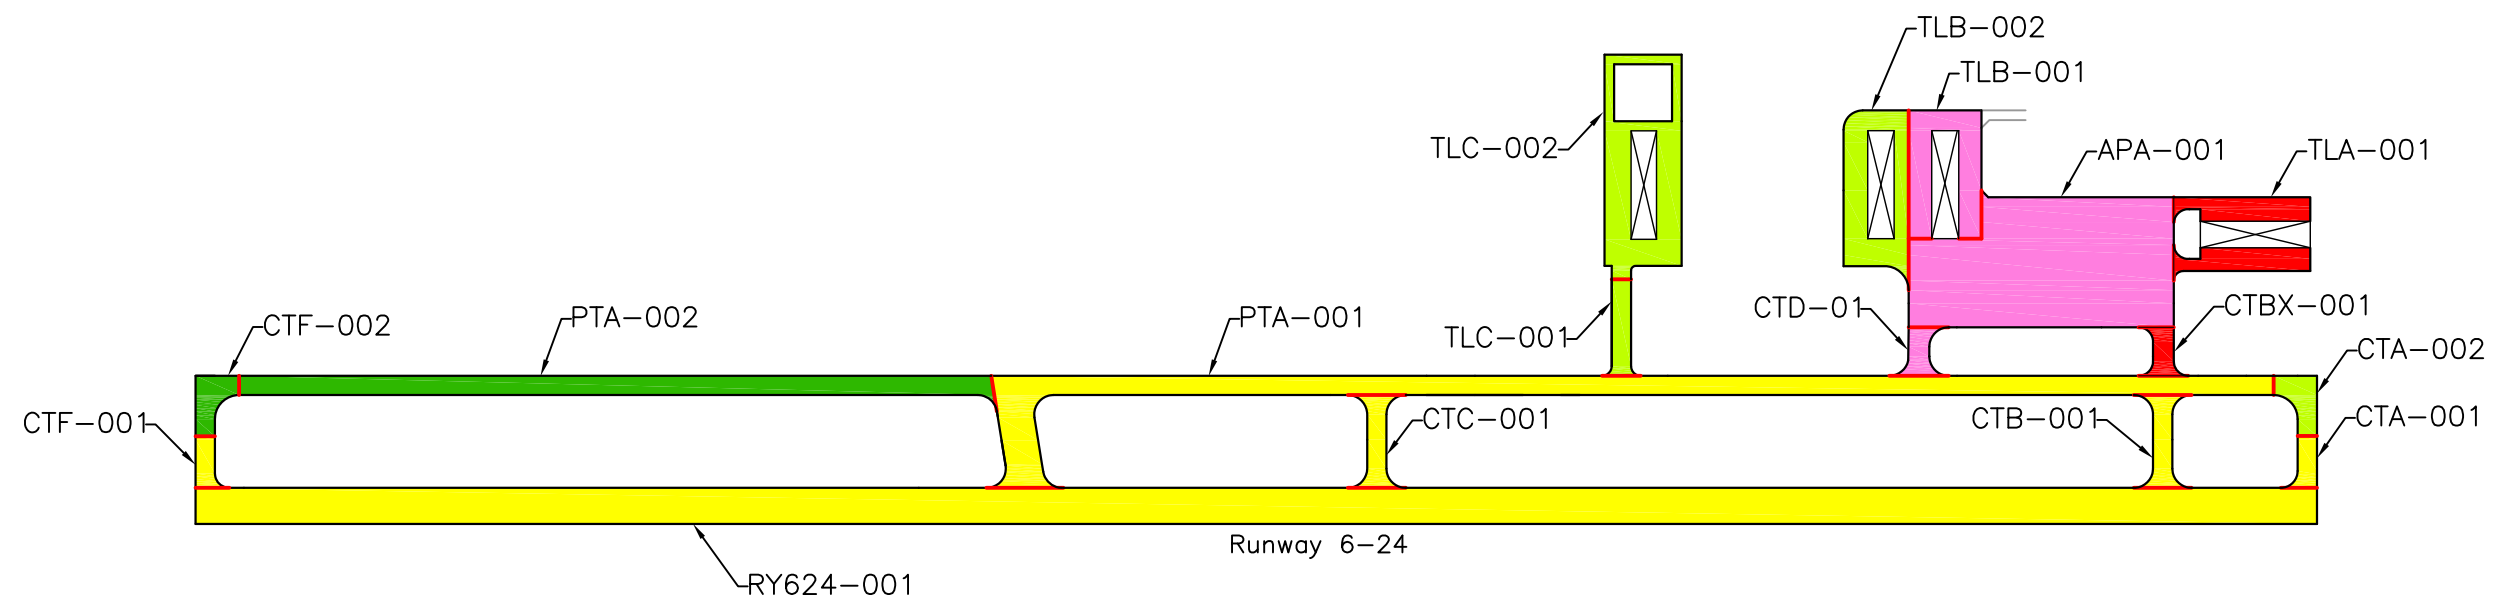
Figure 4. 2011 Pavement Condition Index Rating at Two Harbors – Richard B. Helgeson Municipal Airport (TWM).

The results of the 2011 PCI inspection are presented in figure 4. The overall area-weighted PCI for TWM is 62. When summarizing PCI values, an area-weighted calculation is used instead of a straight mathematical average because the area-weighted calculations eliminate the skewing of the PCI due to the disparity of the section sizes.

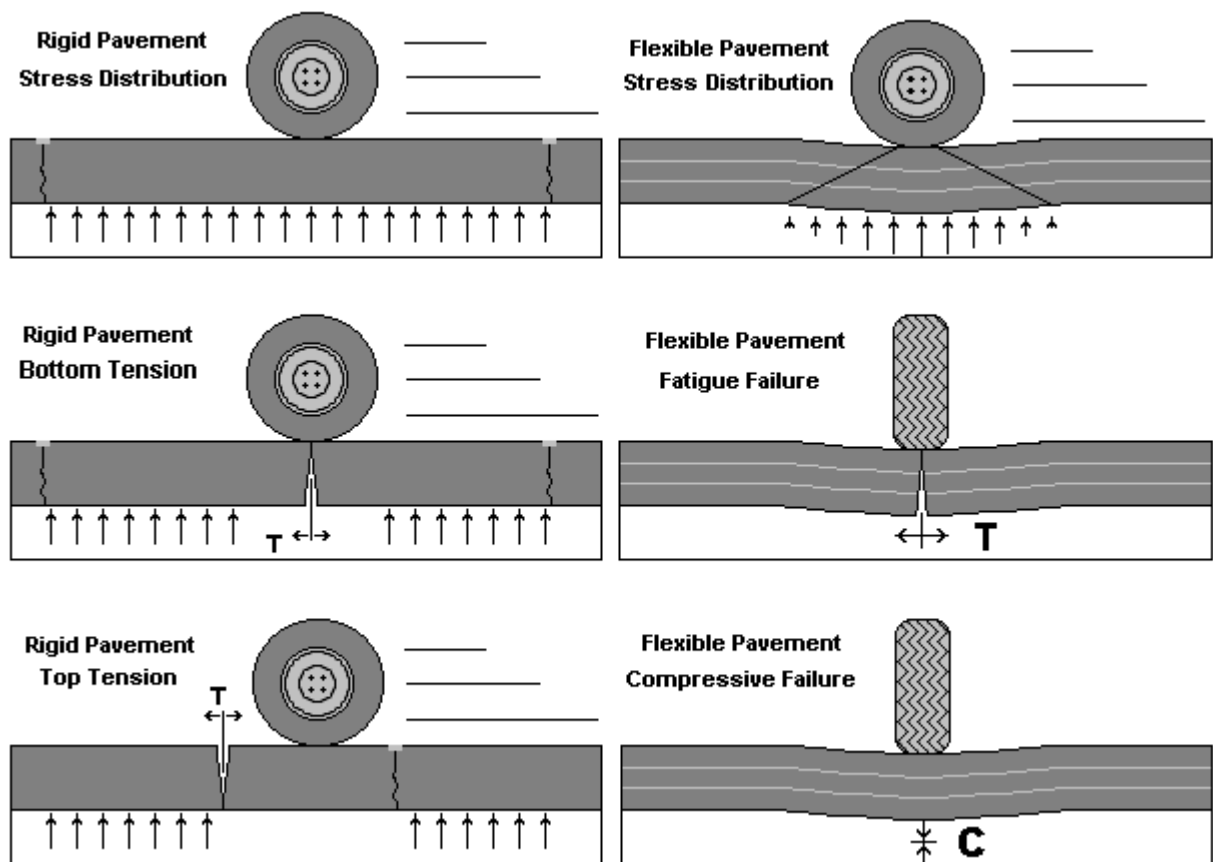
Figure 1. Pavement failure.

Load-related cracks can start at the top or bottom of a pavement section. In asphalt sections, load-related (fatigue) cracks start at the bottom. If a load-related crack reaches the surface, it usually indicates significant structural deficiency. In PCC pavement, corner breaks are caused by top tension, and the crack propagates downward. Mid-slab LTD cracks are examples of bottom tension.

Spalls can be caused by either wheel loads or environmental factors, anytime there is movement between adjacent slabs. If a small rock is allowed into a joint, a differential movement between adjacent slabs can cause a spall. Spalling can be minimized by keeping joint and crack sealant intact.
