# Minnesota Airport System Pavement Evaluation 2012 Update

Bemidji Regional Airport (BJI)

Bemidji, Minnesota

January 2013

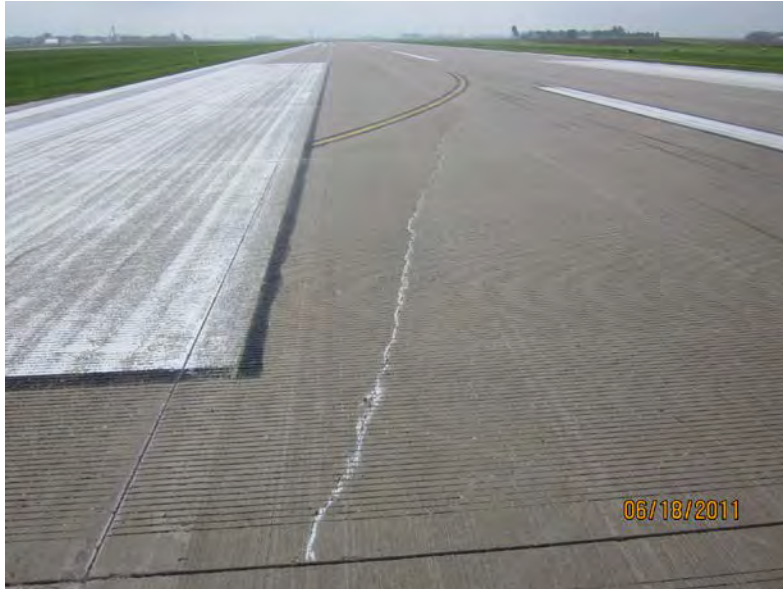
### *Example of Longitudinal, Transverse, and Diagonal Cracking*

LTD cracking is most often a result of externally applied loads and/or constrained temperature deformations. External loads cause LTD cracking through flexure. Temperature changes on restrained slabs will result in stresses due to friction or curling. When any of these stresses exceed the strength of the slab, cracking will occur. LTD cracking is recorded at low, medium, or high severity, depending on the width of crack opening and degree of deterioration. At low severity, the crack is less than 1/8th inch wide with little spalling and no corrective action is indicated. At medium severity, LTD cracks can be up to 1 inch wide with moderate spalling, and should be repaired and sealed using procedures similar to joint sealing. At high severity, cracks exceed 1 inch in width and may be severely spalled. High-severity LTD cracking is evidence of serious load failure of the slab, and correction may require patching or slab replacement. If the distress occurs in several adjacent slabs at medium or high severity, major rehabilitation of that pavement area is indicated.

When a slab is divided by LTD cracks into four or more pieces, the slab is said to be "divided" or "shattered." Shattered slab is a separate distress category and is indicative of significant structural failure as the slab loses its ability to distribute loads to subgrade and further slab deterioration can be expected. Shattered slabs are rated in three severities, with slab replacement recommended for medium and high severities.

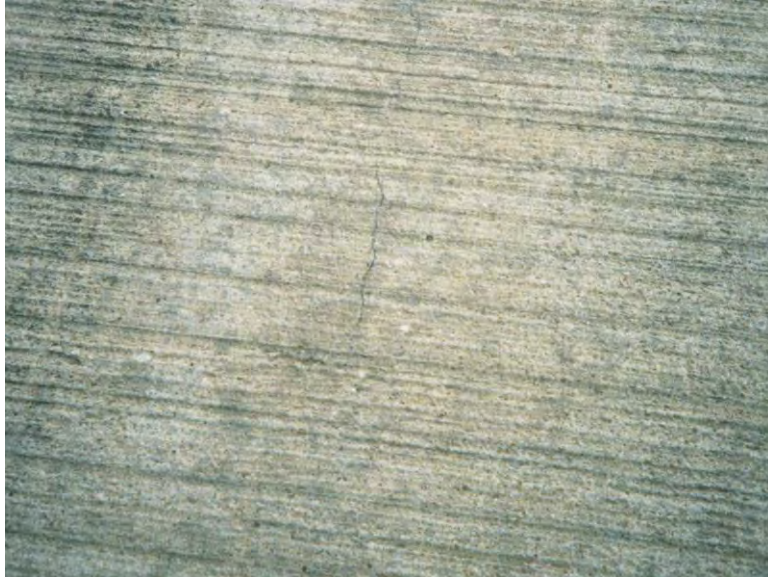
### *Example of Shrinkage Cracking*

Shrinkage cracks are small, nonworking (no spalling along edge) cracks that are visible at the surface but do not penetrate through the full depth of concrete. Shrinkage cracks most commonly occur shortly after construction due to concrete shrinkage during the curing process. Shrinkage cracks are usually so small that they are not visible until staining or material loss at crack edges begins to take place. Shrinkage cracks do not represent a structural weakness, and no corrective action is prescribed.

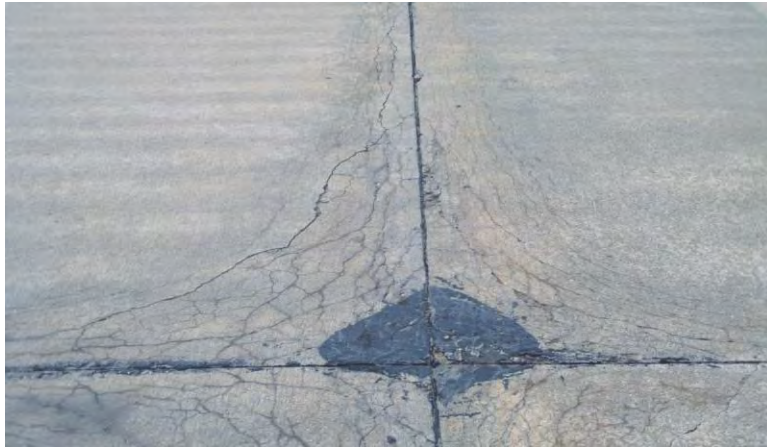
#### ***Example of Durability Cracking***

Durability cracking (D-cracking) is caused by environmental factors, the most common of which is freezing/thawing. It usually appears as a pattern of hairline cracks running parallel to a joint or crack, or in a corner, where water tends to collect. This type of cracking eventually leads to disintegration of the pavement, creating FOD potential. At low severity, D-cracking is evident, but no disintegration has occurred. As the distress advances to medium severity, the distress pattern is evident over a significant area of the slab, and some disintegration and FOD potential exists. High severity durability cracking is evidenced by extensive cracking with loose and missing pieces and significant FOD potential.

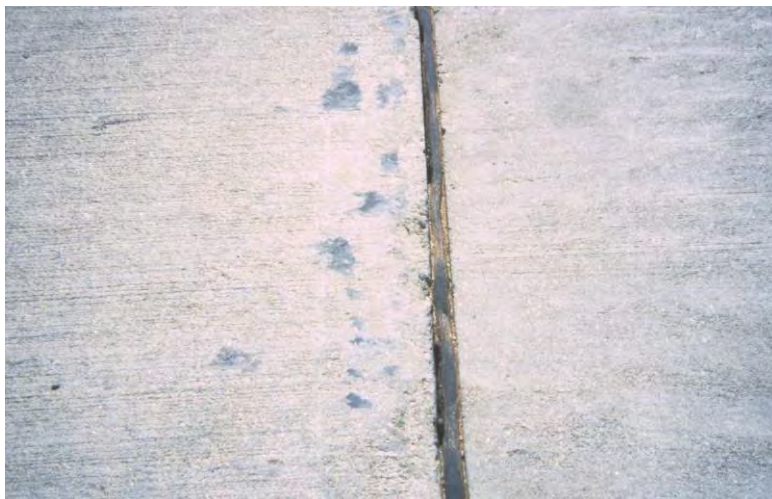
#### ***Example of Joint Seal Damage***

Joint seal damage is recorded at three severities: low, medium, and high. When joint sealant is in perfect condition (no damage), it is not a distress. At low severity, at least 10 percent of the sealant is debonded but still in contact with the joint edges (i.e., joint sealant is in serviceable condition but should

be monitored for evidence of more serious failure). Medium-severity joint seal damage is recorded when at least 10 percent of the sealant has visible gaps smaller than 1/8th inch and is an indicator that replacement should be programmed as soon as is practicable. In the meantime, aggressive inspection and sustaining maintenance is recommended to minimize subsurface damage from moisture penetration. At high severity, visible gaps exceed 1/8th inch and the amount and degree of joint seal damage is such that repair is no longer feasible. The only appropriate corrective action is sealant replacement.

On serviceable pavement, deteriorated joint sealant should be repaired or replaced to preserve pavement and subgrade integrity and prolong service life. The issue is not so clear-cut with unserviceable pavement. Pavement that can be restored to serviceable condition by maintenance activities such as patching and joint seal repair, or by slab replacement, should be so maintained as long as the process is cost-effective. However, when age and condition preclude economical return to serviceable condition by such means, joint seal repair would no longer be cost-effective and should be suspended except for an interim maintenance program to control FOD potential.
