Minnesota Airport System Pavement Evaluation 2012 Update

Benson Municipal Airport (BBB)

Benson, Minnesota

Final Report

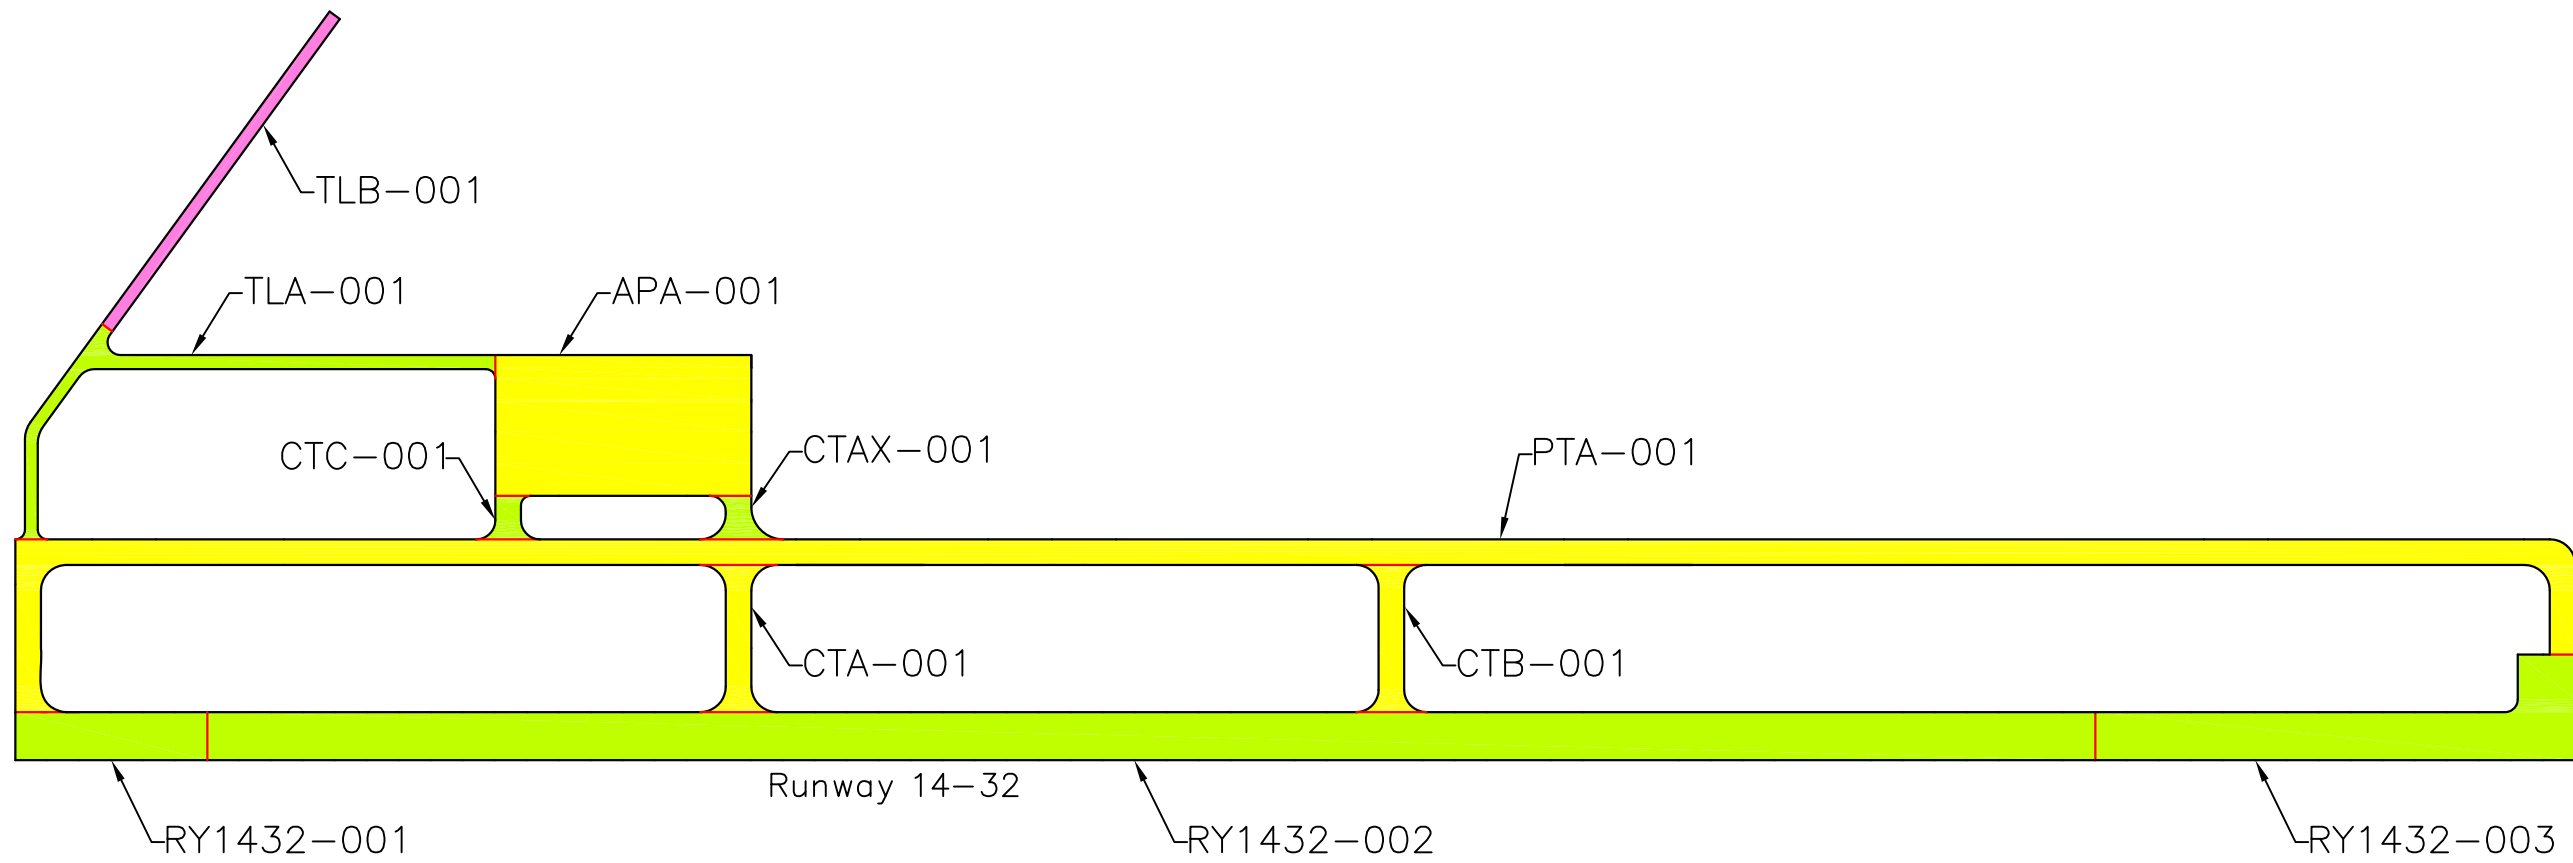
Figure 4. 2012 Pavement Condition Index Rating at Benson Municipal Airport (BBB).

The results of the 2012 PCI inspection are presented in figure 4. The overall area-weighted PCI for BBB is 70. When summarizing PCI values, an area-weighted calculation is used instead of a straight mathematical average because the area-weighted calculations eliminate the skewing of the PCI due to the disparity of the section sizes.

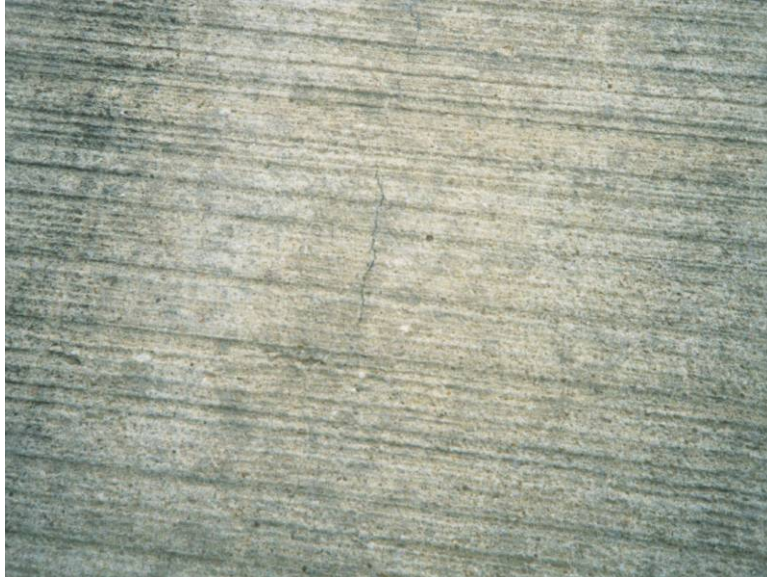
Example of Shrinkage Cracking

Shrinkage cracks are small, nonworking (no spalling along edge) cracks that are visible at the surface but do not penetrate through the full depth of concrete. Shrinkage cracks most commonly occur shortly after construction due to concrete shrinkage during the curing process. Shrinkage cracks are usually so small that they are not visible until staining or material loss at crack edges begins to take place. Shrinkage cracks do not represent a structural weakness, and no corrective action is prescribed.
