Minnesota Airport System Pavement Evaluation 2012 Update

Grand Marais-Cook County Airport (CKC)

Final Report

Mn/DOT Airport Pavement Management System 2012

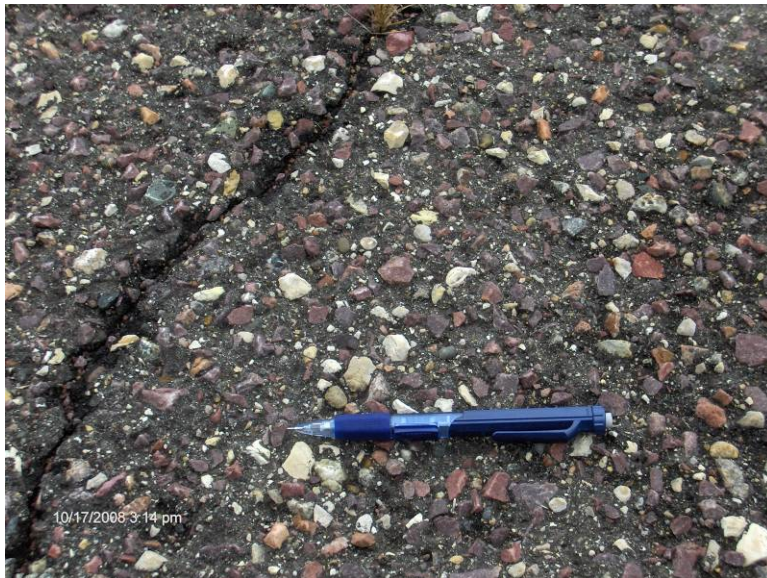
Example of Raveling/Weathering

Raveling and weathering are the wearing away of the pavement surface. Raveling is the condition where the mid- to large size aggregates are becoming dislodged; weathering is when the fine aggregate wears away exposing the edges of the larger aggregate. This distress is usually evident over large areas. Raveling and weathering may indicate that the asphalt binder has hardened significantly. At low severity, the surface has started to wear away with few (if any) loose particles and the coarse surface aggregate is exposed to 1/4 of its diameter. At medium severity, the aggregate and/or binder have worn away with some loose and missing particles, and the surface texture is moderately rough and pitted, but the average depth of erosion is less than ¼ inch. At high severity, the aggregate and/or binder have worn away with a large amount of loose and missing particles, the surface texture is severely rough and pitted, and the top layer of aggregate has eroded away.

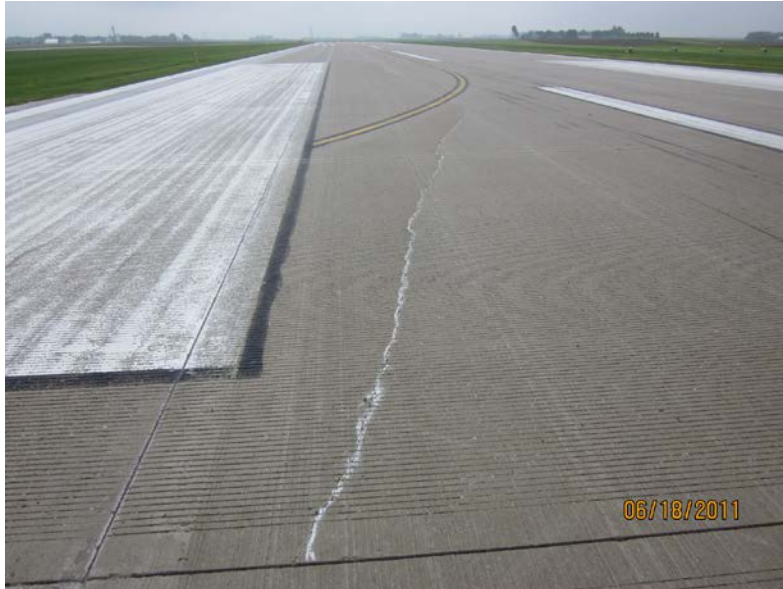
Example of Longitudinal, Transverse, and Diagonal Cracking

LTD cracking is most often a result of externally applied loads and/or constrained temperature deformations. External loads cause LTD cracking through flexure. Temperature changes on restrained slabs will result in stresses due to friction or curling. When any of these stresses exceed the strength of the slab, cracking will occur. LTD cracking is recorded at low, medium, or high severity, depending on the width of crack opening and degree of deterioration. At low severity, the crack is less than 1/8th inch wide with little spalling and no corrective action is indicated. At medium severity, LTD cracks can be up to 1 inch wide with moderate spalling, and should be repaired and sealed using procedures similar to joint sealing. At high severity, cracks exceed 1 inch in width and may be severely spalled. High-severity LTD cracking is evidence of serious load failure of the slab, and correction may require patching or slab replacement. If the distress occurs in several adjacent slabs at medium or high severity, major rehabilitation of that pavement area is indicated.

When a slab is divided by LTD cracks into four or more pieces, the slab is said to be "divided" or "shattered." Shattered slab is a separate distress category and is indicative of significant structural failure as the slab loses its ability to distribute loads to subgrade and further slab deterioration can be expected. Shattered slabs are rated in three severities, with slab replacement recommended for medium and high severities.

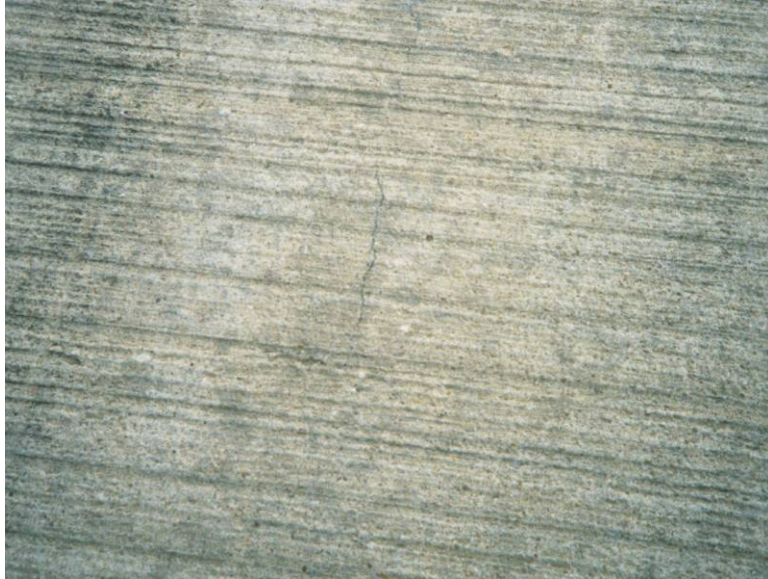
Example of Shrinkage Cracking

Shrinkage cracks are small, nonworking (no spalling along edge) cracks that are visible at the surface but do not penetrate through the full depth of concrete. Shrinkage cracks most commonly occur shortly after construction due to concrete shrinkage during the curing process. Shrinkage cracks are usually so small that they are not visible until staining or material loss at crack edges begins to take place. Shrinkage cracks do not represent a structural weakness, and no corrective action is prescribed.

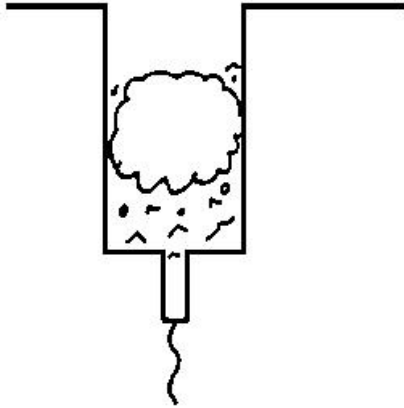
Typical joint with deficient sealant and a collection of debris & incompressibles.
