# Minnesota Airport System Pavement Evaluation 2012 Update

Hector Municipal Airport (1D6)

Hector, Minnesota

January 2013

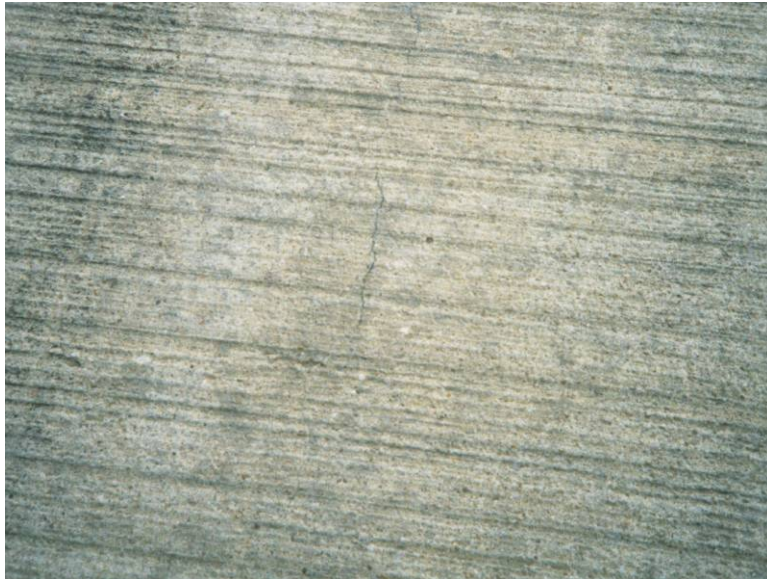
### *Example of Shrinkage Cracking*

Shrinkage cracks are small, nonworking (no spalling along edge) cracks that are visible at the surface but do not penetrate through the full depth of concrete. Shrinkage cracks most commonly occur shortly after construction due to concrete shrinkage during the curing process. Shrinkage cracks are usually so small that they are not visible until staining or material loss at crack edges begins to take place. Shrinkage cracks do not represent a structural weakness, and no corrective action is prescribed.

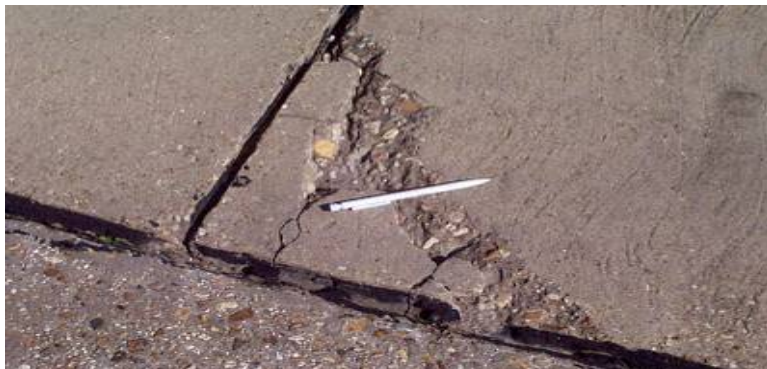
### *Example of Joint and Corner Spalling*

Spalls at slab joints and corners are caused by excessive internal stress in the pavement. Spalls occur when these stresses exceed the shear strength of the concrete. Spalling usually results from thermal expansion during warm or hot weather. As slabs expand, they push against one another at joints. If the joints are filled with incompressibles, such as sand, or if adjacent slabs offset slightly, stresses can become severe, causing spalls. Spalling can be reduced significantly by conscientious maintenance of joint sealant.

Spall repair requires patching. The extent and severity of spalling on a pavement surface suggests appropriate action. For example, at low severity, spalled concrete remains securely in place in the slab. A low-severity spall should be monitored closely for further deterioration and should be patched when

spalled particles become loose in place, or at the next scheduled patching activity in the section. Medium- and high-severity spalls should be repaired immediately to prevent the incidence of FOD. If the pavement can be restored to serviceable condition, spalls should be carefully patched for long-term service. If the pavement is beyond repair, temporary patching should be considered to control FOD.
