Minnesota Airport System Pavement Evaluation 2012 Update

Moorhead Municipal Airport (JKJ)

January 2013

Final Report

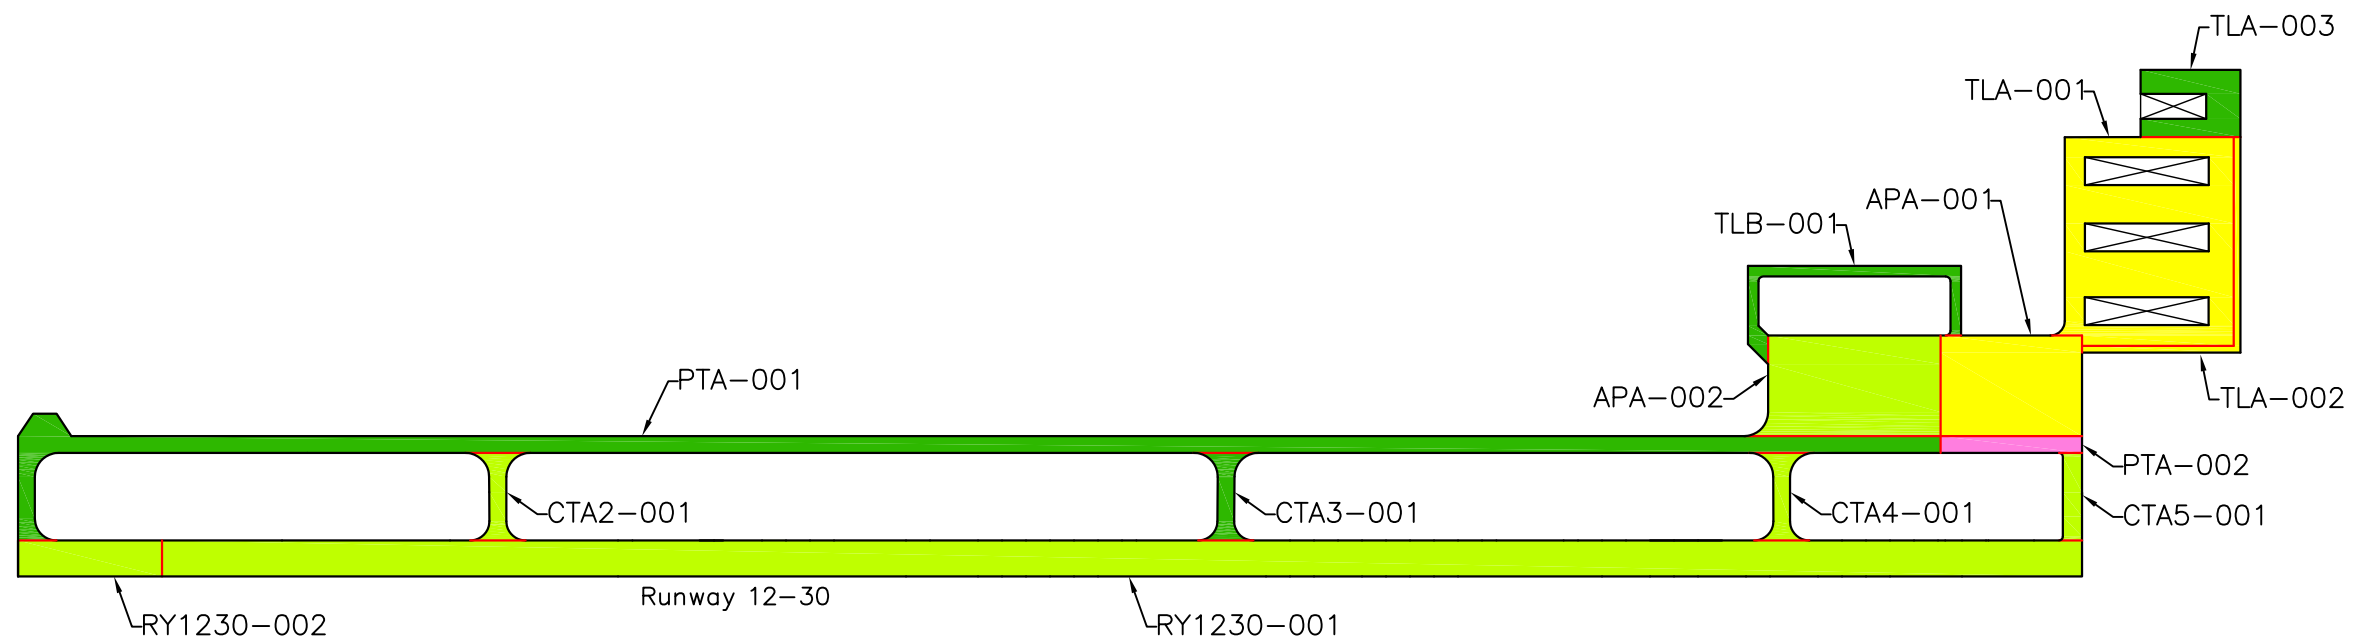
Figure 4. 2012 Pavement Condition Index Rating at Moorhead Municipal Airport (JKJ).

The results of the 2012 PCI inspection are presented in figure 4. The overall area-weighted PCI for JKJ is 76. When summarizing PCI values, an area-weighted calculation is used instead of a straight mathematical average because the area-weighted calculations eliminate the skewing of the PCI due to the disparity of the section sizes.
