Minnesota Airport System Pavement Evaluation 2012 Update

Olivia Regional Airport (OVL)

Final Report

Mn/DOT Airport Pavement Management System 2012

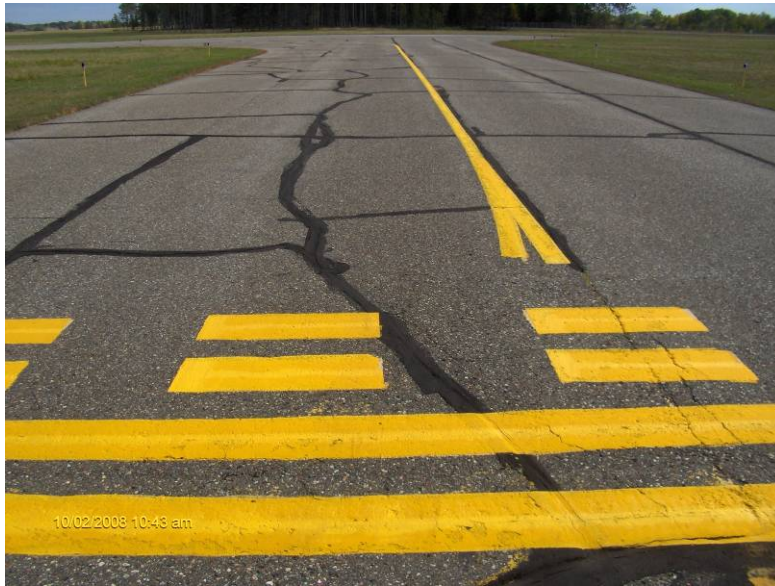
Example of Longitudinal and Transverse Cracking (L&T cracking)

Longitudinal and transverse cracks are caused by pavement aging, by construction, and by subsurface movement. Aging occurs as pavement loses some of its components to the atmosphere and becomes more brittle. Consistent application of pavement sealcoats can help to prevent the occurrence of age related cracks. Cracks will also develop along poorly constructed paving lane joints. Ensuring that joints are made when both sides are still hot, and near the same temperature, is one of the best ways to mitigate this potential problem. Seasonal movement caused by changes in moisture content or temperature differences can also cause pavement cracks. Asphalt pavement placed over a PCC pavement or cement stabilized base course may evidence reflective cracking from the underlying material. Longitudinal and transverse cracks are not caused by wheel loads, although traffic may worsen their condition.

Low severity longitudinal and transverse cracks are less than $\frac{1}{4}$ inch wide, or if sealed with suitable filler material in satisfactory condition can be any width, less than 3 inches, if they are not spalled. Maintenance usually is not indicated for low-severity cracking. Moderately spalled cracks and cracks wider than $\frac{1}{4}$ inch which are not satisfactorily sealed are at medium severity. Medium-severity cracks should be sealed with a high-quality crack filling material. Severely spalled cracks and cracks wider than 3 inches are at high severity. High-severity L&T cracks normally require patching.

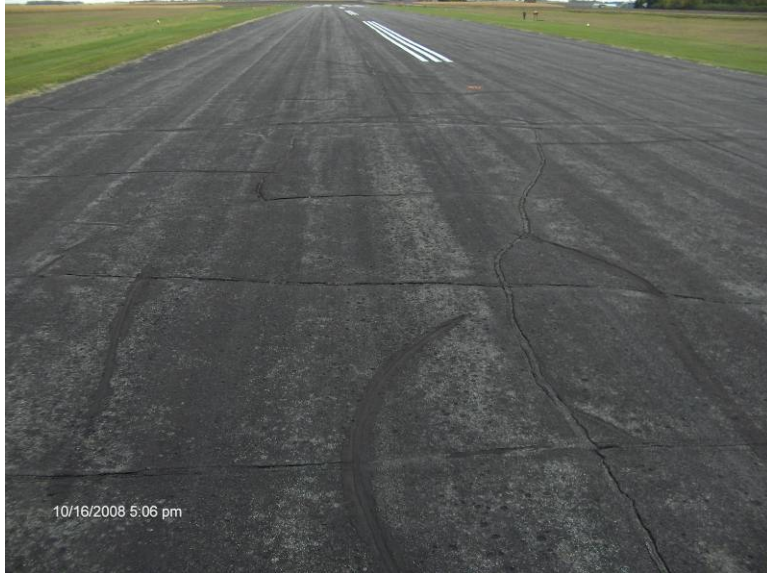
Example of Block Cracking

Block cracking is longitudinal and transverse cracking that has established a pattern of blocks ranging in size from 1ft x 1ft to 10ft x 10ft. This distress typically happens in older asphalt pavements and is an indication that the bituminous binder has lost most of its flexibility. The severity determination is basically determined by the crack width criteria defined for longitudinal and transverse cracking. Crack sealing typically is used to repair block cracking; however, the amount of required sealant can be extensive due to the high density of cracks.

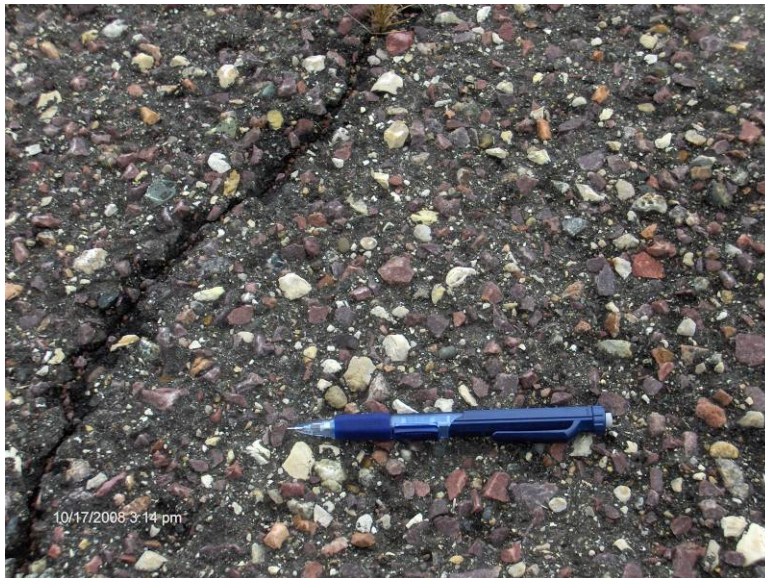
Example of Raveling/Weathering

Raveling and weathering are the wearing away of the pavement surface. Raveling is the condition where the mid- to large size aggregates are becoming dislodged; weathering is when the fine aggregate wears away exposing the edges of the larger aggregate. This distress is usually evident over large areas. Raveling and weathering may indicate that the asphalt binder has hardened significantly. At low severity, the surface has started to wear away with few (if any) loose particles and the coarse surface aggregate is exposed to 1/4 of its diameter. At medium severity, the aggregate and/or binder have worn away with some loose and missing particles, and the surface texture is moderately rough and pitted, but the average depth of erosion is less than ¼ inch. At high severity, the aggregate and/or binder have worn away with a large amount of loose and missing particles, the surface texture is severely rough and pitted, and the top layer of aggregate has eroded away.

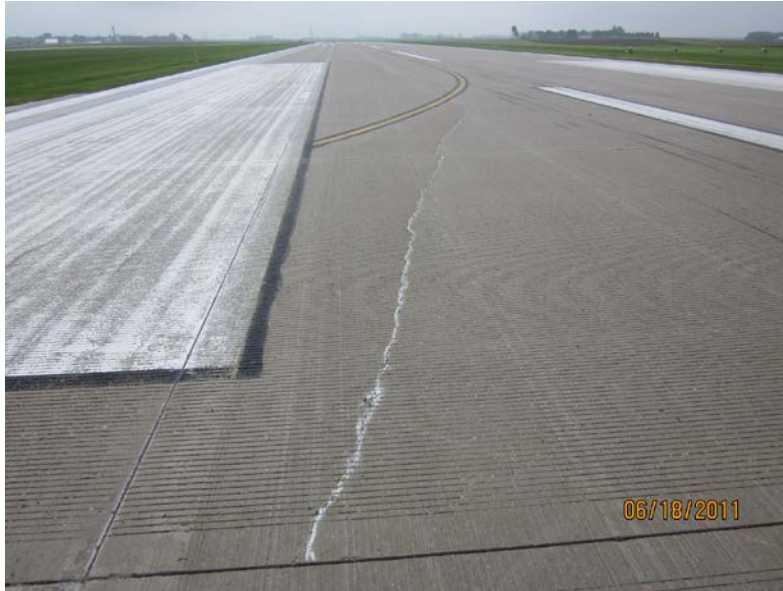
Example of Longitudinal, Transverse, and Diagonal Cracking

LTD cracking is most often a result of externally applied loads and/or constrained temperature deformations. External loads cause LTD cracking through flexure. Temperature changes on restrained slabs will result in stresses due to friction or curling. When any of these stresses exceed the strength of the slab, cracking will occur. LTD cracking is recorded at low, medium, or high severity, depending on the width of crack opening and degree of deterioration. At low severity, the crack is less than 1/8th inch wide with little spalling and no corrective action is indicated. At medium severity, LTD cracks can be up to 1 inch wide with moderate spalling, and should be repaired and sealed using procedures similar to joint sealing. At high severity, cracks exceed 1 inch in width and may be severely spalled. High-severity LTD cracking is evidence of serious load failure of the slab, and correction may require patching or slab replacement. If the distress occurs in several adjacent slabs at medium or high severity, major rehabilitation of that pavement area is indicated.

When a slab is divided by LTD cracks into four or more pieces, the slab is said to be "divided" or "shattered." Shattered slab is a separate distress category and is indicative of significant structural failure as the slab loses its ability to distribute loads to subgrade and further slab deterioration can be expected. Shattered slabs are rated in three severities, with slab replacement recommended for medium and high severities.

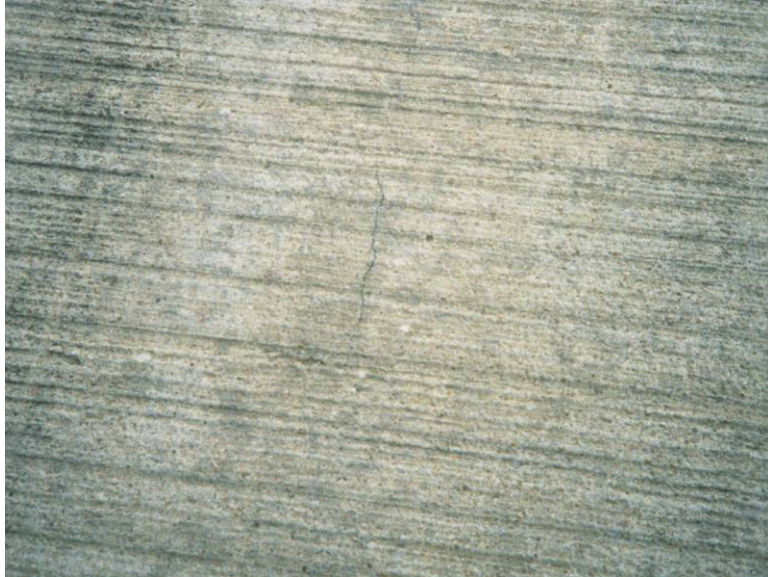
Example of Shrinkage Cracking

Shrinkage cracks are small, nonworking (no spalling along edge) cracks that are visible at the surface but do not penetrate through the full depth of concrete. Shrinkage cracks most commonly occur shortly after construction due to concrete shrinkage during the curing process. Shrinkage cracks are usually so small that they are not visible until staining or material loss at crack edges begins to take place. Shrinkage cracks do not represent a structural weakness, and no corrective action is prescribed.

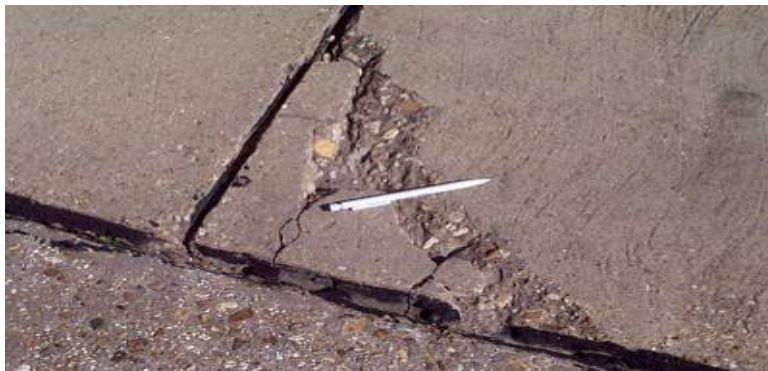
Example of Joint and Corner Spalling

Spalls at slab joints and corners are caused by excessive internal stress in the pavement. Spalls occur when these stresses exceed the shear strength of the concrete. Spalling usually results from thermal expansion during warm or hot weather. As slabs expand, they push against one another at joints. If the joints are filled with incompressibles, such as sand, or if adjacent slabs offset slightly, stresses can become severe, causing spalls. Spalling can be reduced significantly by conscientious maintenance of joint sealant.

Spall repair requires patching. The extent and severity of spalling on a pavement surface suggests appropriate action. For example, at low severity, spalled concrete remains securely in place in the slab. A low-severity spall should be monitored closely for further deterioration and should be patched when

spalled particles become loose in place, or at the next scheduled patching activity in the section. Medium- and high-severity spalls should be repaired immediately to prevent the incidence of FOD. If the pavement can be restored to serviceable condition, spalls should be carefully patched for long-term service. If the pavement is beyond repair, temporary patching should be considered to control FOD.

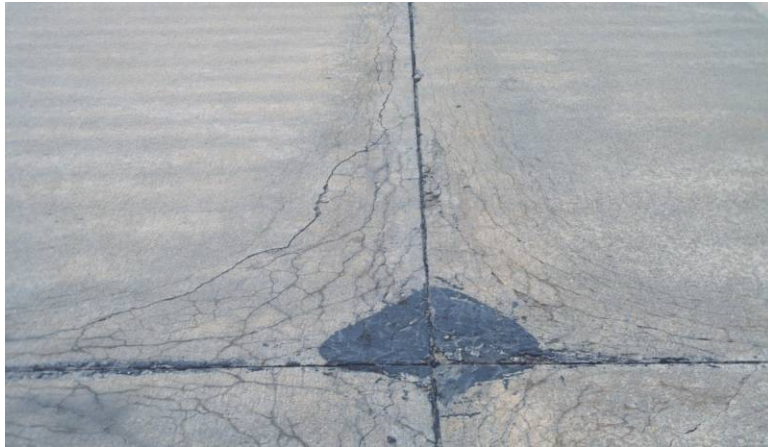
Example of Durability Cracking

Durability cracking (D-cracking) is caused by environmental factors, the most common of which is freezing/thawing. It usually appears as a pattern of hairline cracks running parallel to a joint or crack, or in a corner, where water tends to collect. This type of cracking eventually leads to disintegration of the pavement, creating FOD potential. At low severity, D-cracking is evident, but no disintegration has occurred. As the distress advances to medium severity, the distress pattern is evident over a significant area of the slab, and some disintegration and FOD potential exists. High severity durability cracking is evidenced by extensive cracking with loose and missing pieces and significant FOD potential.

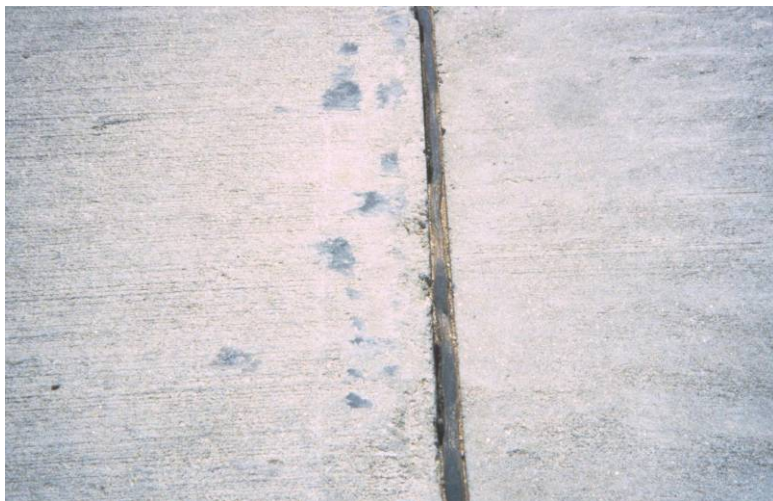
Example of Joint Seal Damage

Joint seal damage is recorded at three severities: low, medium, and high. When joint sealant is in perfect condition (no damage), it is not a distress. At low severity, at least 10 percent of the sealant is debonded but still in contact with the joint edges (i.e., joint sealant is in serviceable condition but should

be monitored for evidence of more serious failure). Medium-severity joint seal damage is recorded when at least 10 percent of the sealant has visible gaps smaller than 1/8th inch and is an indicator that replacement should be programmed as soon as is practicable. In the meantime, aggressive inspection and sustaining maintenance is recommended to minimize subsurface damage from moisture penetration. At high severity, visible gaps exceed 1/8th inch and the amount and degree of joint seal damage is such that repair is no longer feasible. The only appropriate corrective action is sealant replacement.
